## PETRINJA M6.2 EARTHQUAKE IN 2020 DAMAGED ALSO SOLID LINEAR INFRASTRUCTURE: ARE THERE SIMILAR ACTIVE FAULTS IN CROATIA?

Tvrtko Korbar<sup>1\*</sup>, Snježana Markušić<sup>2</sup>, Davor Stanko<sup>3</sup>, Davorin Penava<sup>4</sup>

### Abstract

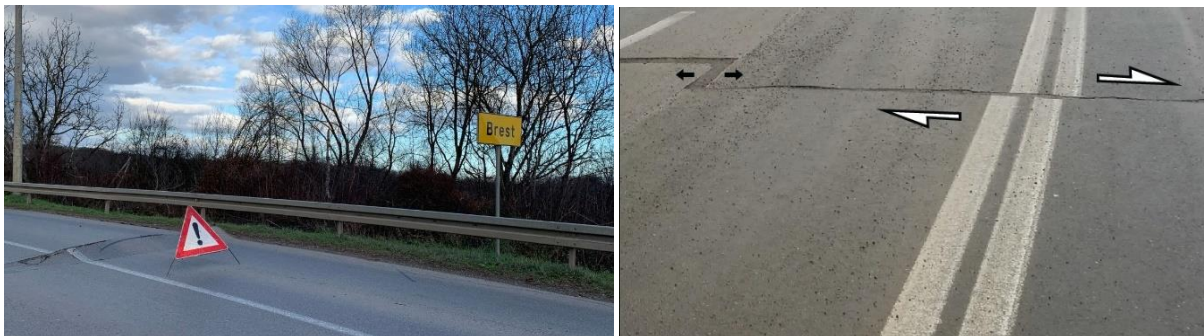
Numerous reports in media allowed quick online research of the ground surface failures and infrastructure damage that appear along approx. 30 km long portion of sinistral NE-SW striking Petrinja Fault (Figure 1). A coseismic damage was observed in two locations on the Petrinja-Brest road (Figures 2a and 2b). A quick field inspection revealed that cracks on the road, built on the bedrock of Hrastovička gora at Župić, appeared mostly along Pokupsko Fault, and revealed the clear dextral coseismic strike-slip displacements (Figure 2c).

Figure 2. a) Coseismic cracks and small transpressional structure along one of the fault lines of the creeping sinistral Petrinja Fault crossing Petrinja-Brest road south of Brest (CREDIT: Public media); b) Coseismic dextral ~10 cm displacement (white arrows) and tensional cracks (black arrows) along the main fault line of the Pokupsko Fault crossing Petrinja-Glina road west of Župić. (CREDIT: M. Vukovski, HGI)

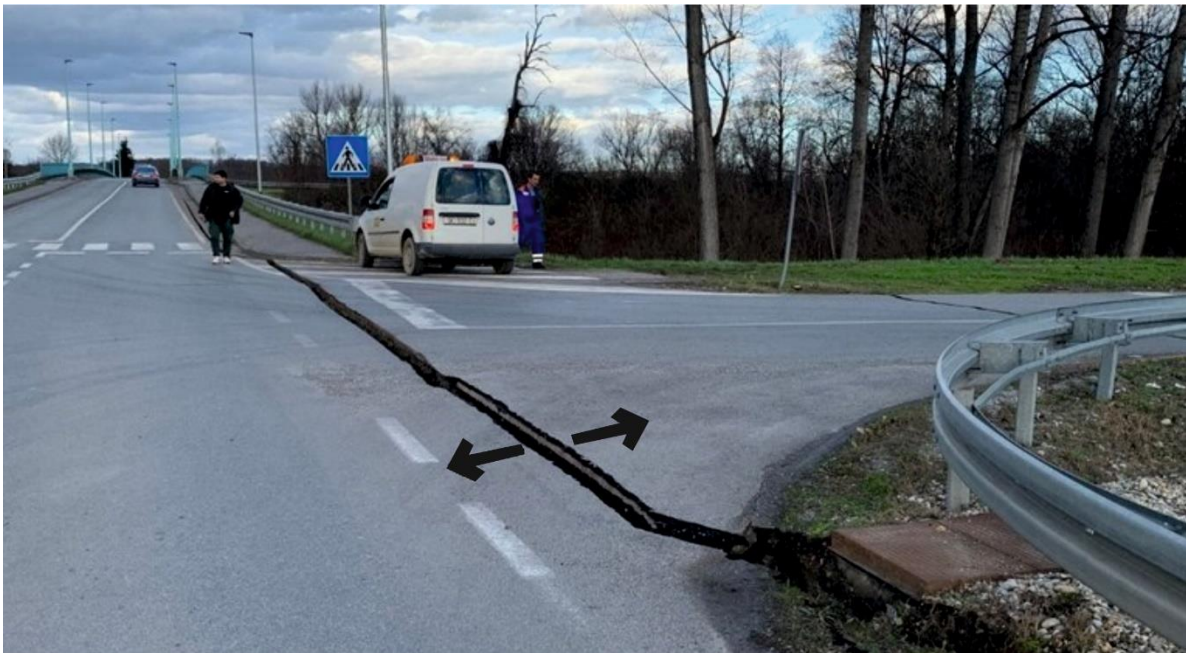
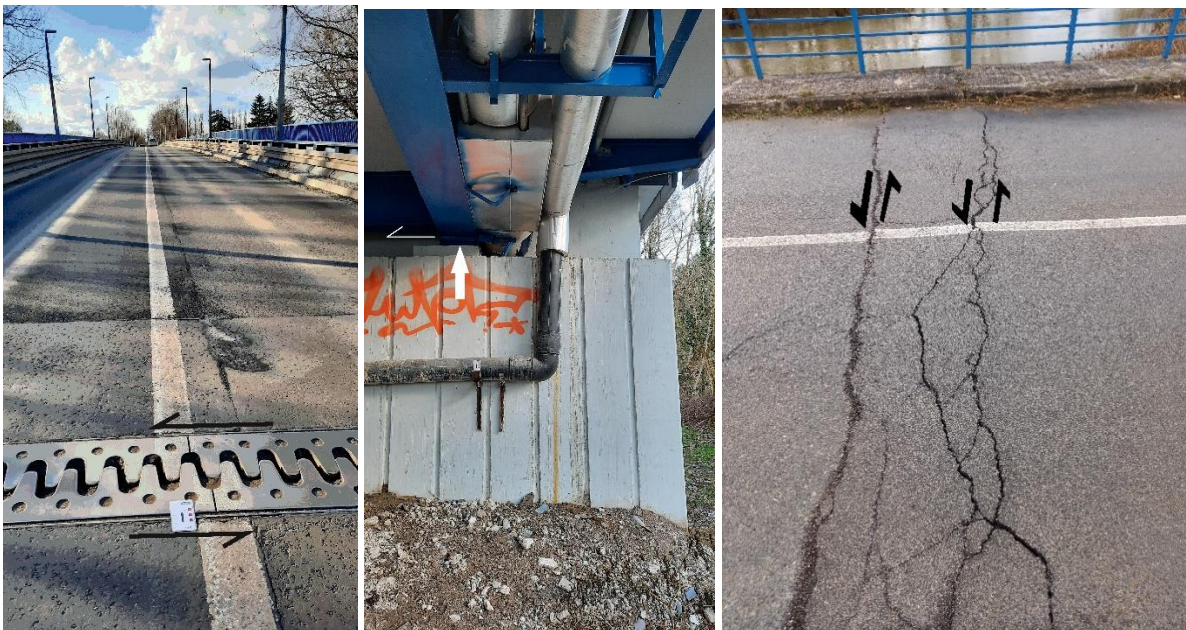
Beside the cracked road along the Petrinja Fault north and south of Brest Bridge on Kupa River, there was a significant damage on the bridge itself, since the bridge was possibly slightly rotated between the two sinistral faults that belong to Petrinja Fault zone (Figure 3a).

The new bridge at Galdovo (Sisak) on Sava River has been displaced along a left-lateral fault line striking N-S that is still not mapped (Figure 3b). The bridge is displaced for ~10 cm over the eastern basement (Figure 3c). The bridge on Glina River at Prekopa was cracked and displaced left-lateral for a few cm along the Petrinja-Glina Fault line (Figure 3d).

Figure 3. a) Coseismic tensional cracks south of Brest Bridge located between two fault lines of the creeping sinistral Petrinja Fault (CREDIT: Public media); b) Coseismic sinistral displacement along N-S fault line of the activated complex fault system crossing the Galdovo Bridge (Sisak); c) shifted construction of Galdovo Bridge (thick arrow) because of sinistral movement (thin arrow) of the blocks along the fault line crossing eastern tip of Galdovo Bridge; d) Coseismic fractures along the main sinistral Sisak-Petrinja-Glina-Topusko Fault line crossing Glina River at Prekopa Bridge (CREDIT: D. Palenik, HGI).

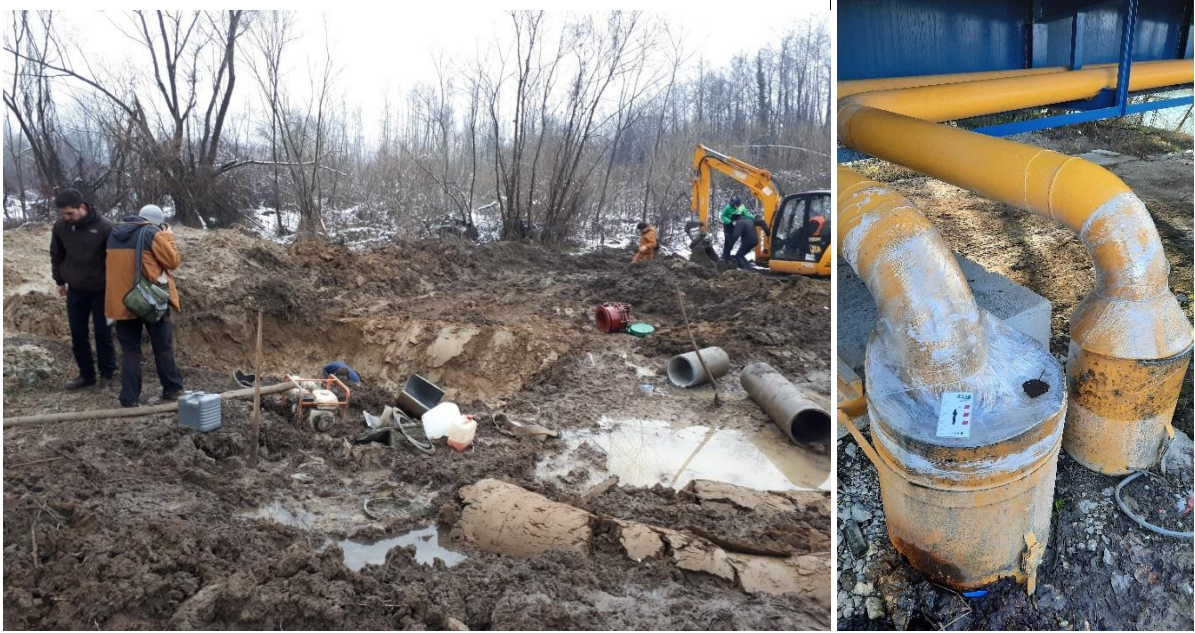
Water pipeline at Cepeliš was broken due to coseismic dextral movement of the fault blocks along dextral Pokupsko Fault (Figure 4a). The gas pipeline at Galdovo Bridge (Sisak) was damaged during the Petrinja earthquake, as well (Figures 3b and 4b).

Figure 4. a) Re-construction works on water pipeline at Cepeliš that is crossed by regional Pokupsko Fault (CREDIT: HGI EQ Team); b) Temporarily repaired Gas pipeline damaged because of sinistral coseismic displacement of Galdovo Bridge.

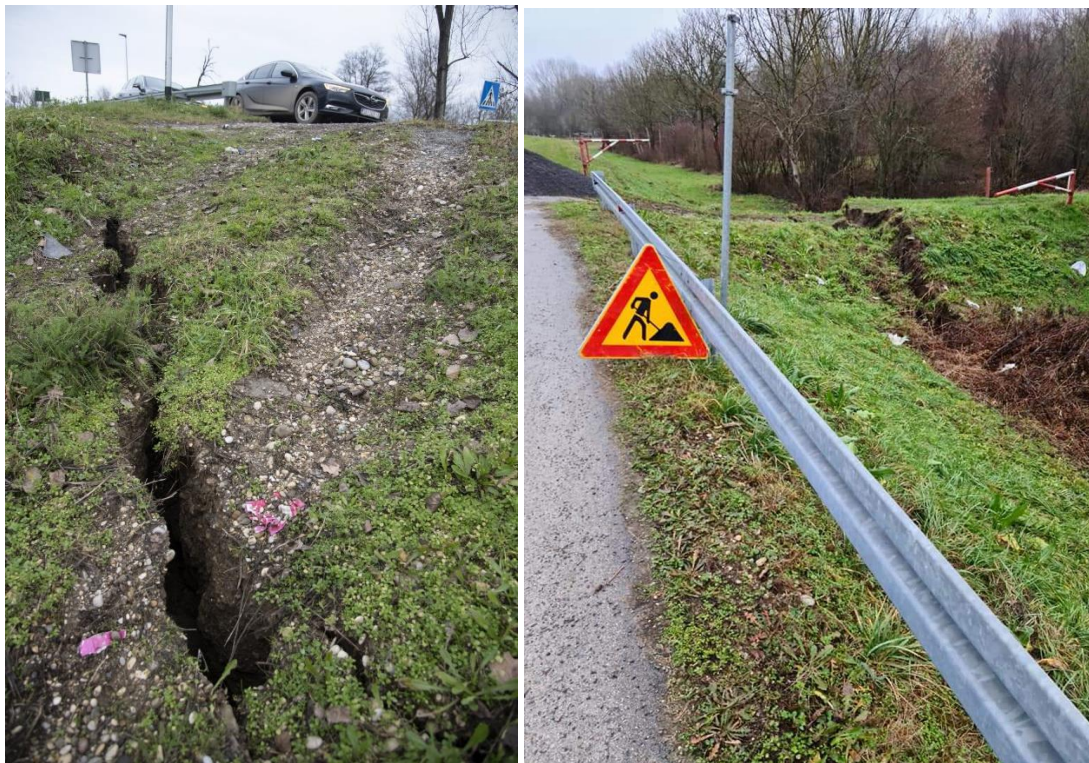
There were numerous cracks along the activated Petrinja Fault that crosses Kupa and Sava River's artificial riverbanks at Brest (Figure 5a) Drenčina, Pračno and Tišina. Besides, some conjugated faults from the system damaged the Sava riverbanks at Palanjek (Figure 5b) and Galdovo.

Figure 5. a) Surface fault crossing the Kupa riverbank at Brest Bridge; b) Surface fault rupture crossing the Sava riverbank at Palanjek (CREDIT: Public media).
