Geotechnical Study of Raspadalica Cliff Rockfall, Croatia

Abstract: The Raspadalica Cliff is an almost vertical 100 m high limestone cliff with a railway line at its foot and is known for numerous rockfall occurrences in the past. This article presents the results of the geotechnical study of the cliff based on a traditional geological and geotechnical field survey and remote sensing analysis. Both the traditional geological and geotechnical field survey and remote sensing surveys and analyses enabled the establishment of the structural model of the Raspadalica Cliff and the determination of the discontinuity sets and discontinuity features, such as orientation, spacing, persistence, roughness, discontinuity wall strength, aperture, degree of weathering of discontinuity wall, seepage conditions, and the presence and hardness of discontinuity filling. Kinematic analyses were performed on five cliff zones with slightly different structural features, indicating a relatively low probability of typical failures in the cliff rock mass that precede the rockfall occurrences. Although rockfall phenomena from the cliff face are relatively frequent, the kinematic analyses did not indicate a

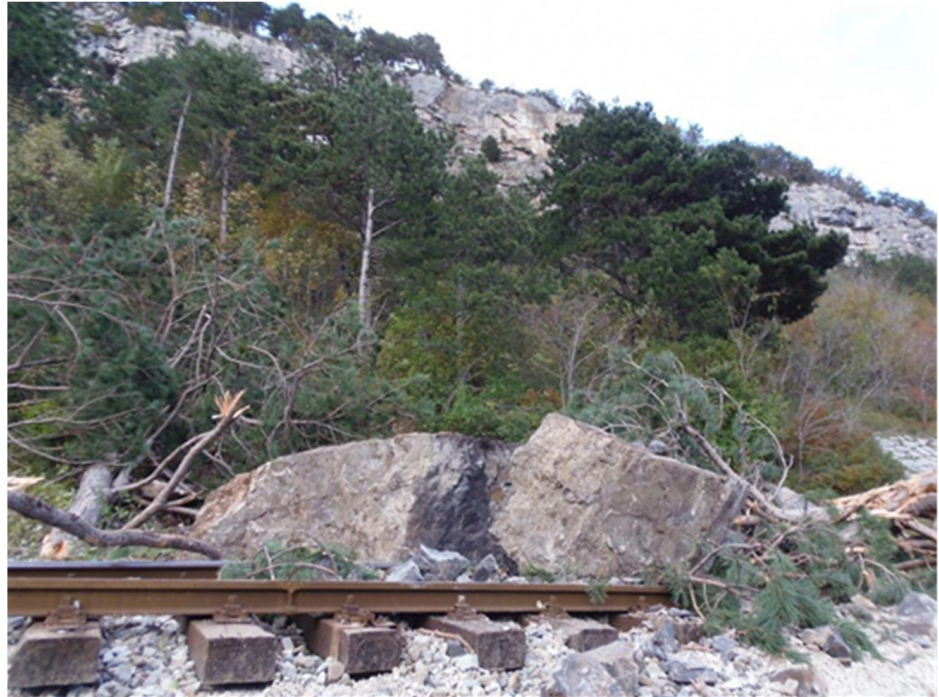
The last major rockfall occurred on 16 December 2013 (Figure 5), which caused an interruption to railway traffic lasting several months. Following this, the construction of rockfall protection measures was conducted based on field investigations [12] and rockfall

Figure 5. Photo of the rockfall originating from the Raspadalica Cliff on 16 December 2013.
