Rockfall analyses and rockfall protection at the Raspadalica Rockfall, Croatia

Željko Arbanas

ABSTRACT: The Raspadalica rockfall is well known location with numerous rockfall occurrences from 100 m high limestone cliff in the past that caused significant damages and victims at the railway Buzet - Pula in Istria, Croatia. Structural and kinematic analysis of possible future rockfall were carried out following the modern approaches and recent techniques in rockfall hazard analysis. Modern approaches include application of remote-sensing techniques enabled to ensure digital terrain models (DTM) from three-dimensional high-resolution point cloud (3D HRPC) of the cliff surface; engineering geological mapping using combination of remote-sensing techniques and field mapping. In this paper the methods and results of field and remote sensing investigation of the cliff structural and kinematic analysis results, identification of rockfall sources, as well as analysis of necessary protection measures and their positions at the slope above the railway route.

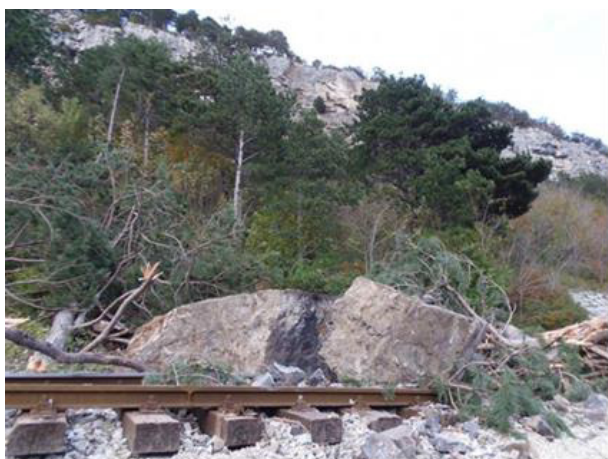
significant rockfall occurred on 16 December 2013 (Figure 2) that caused interruption of railway traffic for several months and it was followed by rockfall protection measures based on field investigations in 2012.

Figure 2. Photo of the rockfall originated from the Raspadalica Cliff on 16 December 2013 (Udovič et al., 2021).

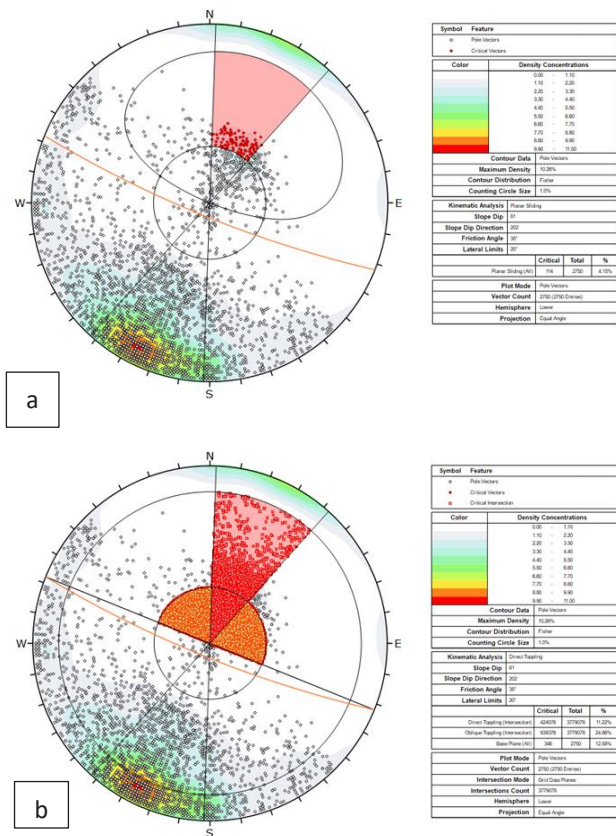
The results of conducted analyses pointed to almost no probability of wedge failure because of almost orthogonal orientation of two subvertical joint sets (Join set 1 and 2), where the Joint set 1 is parallel to the cliff face. The remaining three analyzed failure mechanisms (plane, block or direct toppling and flexural toppling) (Wyllie and Mah, 2004), indicated the presence structural conditions likely to cause these failures in several parts of the cliff in all cliff zones but with relatively low probability of occurrence. Results of conducted analyses are presented in Figure 5 for Zone III, where the major rockfalls occurred in the past, for sliding and toppling failure mechanisms.

Figure 5. Results of conducted kinematic analyses for Zone III using Rocscience *Dips* software.

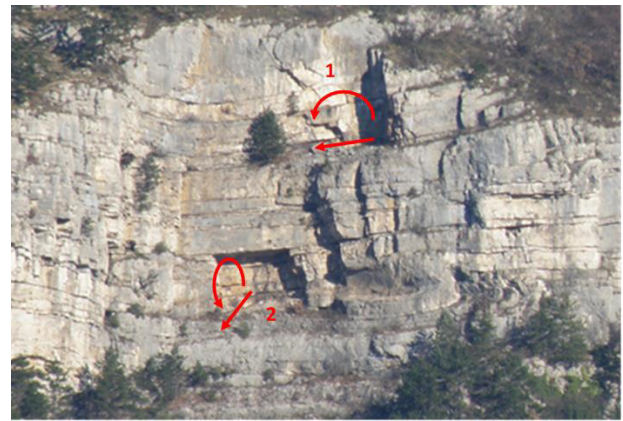
Figure 6. A view at the middle part of Raspadalica Cliff (Zone III) with two signs of the rockfall instability in the past (1,2).

Figure 6 presents a part of the Zone III in the middle part of the cliff. Instability 1 in the upper part of the cliff face was caused by joint influence of sliding and toppling mechanisms and both movements (displacement and rotation) were parallel to the cliff face. Stability analyses pointed on satisfying factor of safety (FoS) for each particular mechanism, and only a combination of mechanisms caused the rock block detachment. The instability 2 in the lower part of the cliff face was caused by joint influence of sliding and toppling mechanisms and both movements (displacement and rotation) were almost orthogonal to the cliff face. The bedding plane is to slightly inclined to cause block sliding, while the bed above the fallen block prevented rotation, but simultaneous action of two mechanisms enabled rockfall initiation.

These two joint mechanisms are associated with some other processes which had influences on weakening of joint friction forces caused by lateral stress relaxation, weathering and softening of joints infilling (coal interlayer) caused by freeze and thaw process, rock mass weathering processes, as well as caused by water (hydrostatic pressure of water in subvertical discontinuities, impact on reduction of effective stresses at bedding planes) and temperature impacts (pressure after water freezing in subvertical discontinuities, spreading and shrinking of rock mass during temperature effects of insolation).

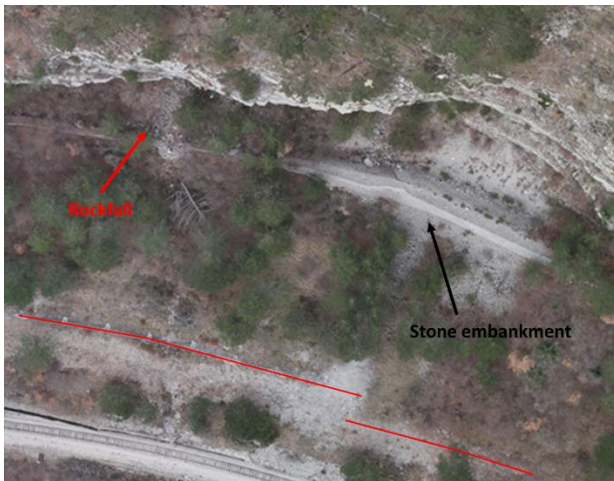
Figure 7. Digital orthophoto map of the western part of the Raspadalica Cliff. On the left side (red arrow) is location of the rockfall occurred on 16 December 2013 that destroyed stone masonry wall; on the right side (black arrow) part of stone embankment. Red lines are rockfall barriers installed above the railway facilities.

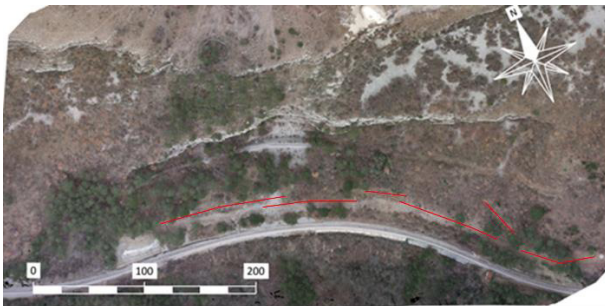
Figure 8. Locations of installed rockfall barriers (red lines) below the Raspadalica Cliff at the digital orthophoto map.

The rockfall barriers were designed (Grošić, 2012b) and installed in several segments above the railway facilities in total length of 400 m (Figure 8). The rockfall protection barriers were installed as it follows: one barrier 100 m length, 3 m height with energy absorption capacity of 1.000 kJ; one barrier 90 m length, 3 m height with energy absorption capacity of 500 kJ; and three barriers 60, 60 and 90 m length, 3 and 2,50 m height with energy absorption capacity of 250 kJ. All barriers were installed in the lower part of the slope, just above the tracks. In selection of barrier locations, height and energy absorption capacity, 2d and 3d block rockfall analyzes were not performed, and barrier locations were selected based on assumed rockfall trajectories based on historical occurrences. Preliminary analyses of the fall of the relevant volume block have shown that the barriers do not satisfy with their height and energy absorption capacity. The installed rockfall barriers definitely cannot retain bigger rockfall volumes, but for now successfully stops smaller running blocks.
