Design of the rockfall protection at the Špičunak location, Gorski kotar, Croatia

Maroje Sušac⁽¹⁾, Mirjana Vugrinski⁽¹⁾, Dalibor Udovič⁽¹⁾, Davor Marušić⁽²⁾, Željko Arbanas⁽³⁾

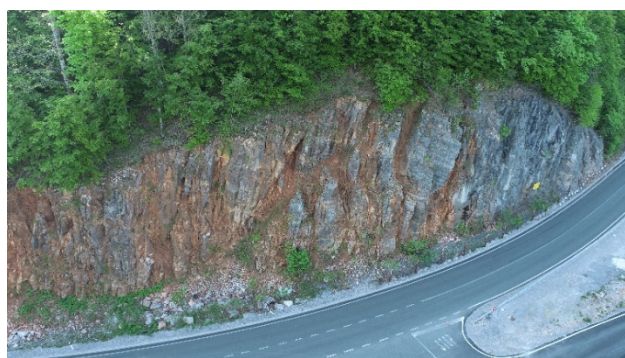
Problems due to sliding and rockfalls at the Špičunak location existed more than 50 years and caused numerous traffic interruptions. The road construction was repaired several times while the slide remediation was completed in 2021. Rockfall protection measures were applied to the rock cut several times, last time in 2005, according to then available techniques (Arbanas et al. 2012) and only to one part of the cut. Due to further rock mass weathering as well as freezing and thawing process, numerous rockfalls were triggered during winters followed by fallen blocks at

Figure 2 A view at the rock cut at the Špičunak location.

the road, indicating the need of new rockfall protection design and implementation which started in 2021.

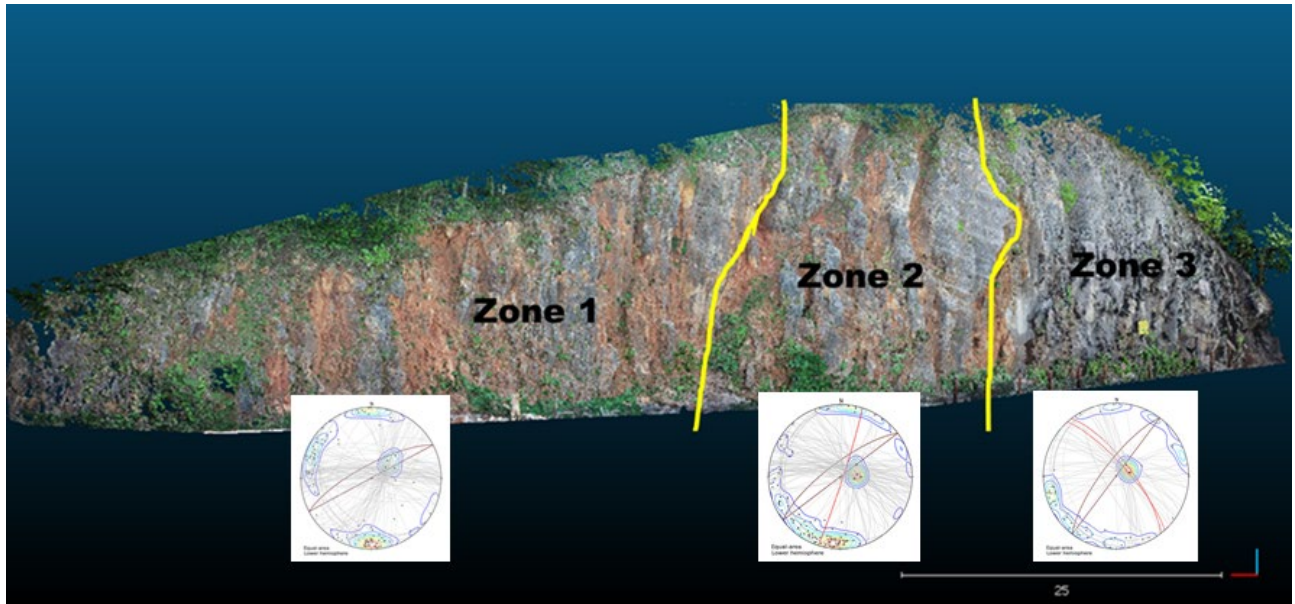
Detailed analyses of field survey and remote sensing data pointed to three different zones, based on their properties and rock block standings according to the general orientation and dip of the rock cut face. These zones (Zone I to III) are presented at the 3D HRPC (Fig. 3) while the borders that separate zones were determined analysing changes in orientation and dips of the main joint sets as well as changes in rock block volumes. The *Cloud Compare* software (CloudCompare 2015) was employed to identify discontinuity sets. The rock cut face was divided in three zones (Fig. 3), and for each segmented zone an extraction of joint planes using the *Cloud Compare Facet* and *Compass* plugins (Dewez et al. 2016; Nagendran et al. 2019) (*Fast Marching* procedure) were employed to identify their orientations (dip directions and dips). The spacing between the joints for each joint set necessary to determine block volumes was determined using the *Cloud Compare Distances* tool, while the persistence of joints in accessible rock cut face zones were measured *in situ*. The other discontinuity features (separation, infilling, discontinuity wall roughness and weathering grade) were obtained by *in situ* traditional geological and geotechnical surveys.

Figure 1 The three-dimensional high-resolution point cloud (3D HRPC) of the Špičunak rock cut with different zones and stereonet plots for each zone.

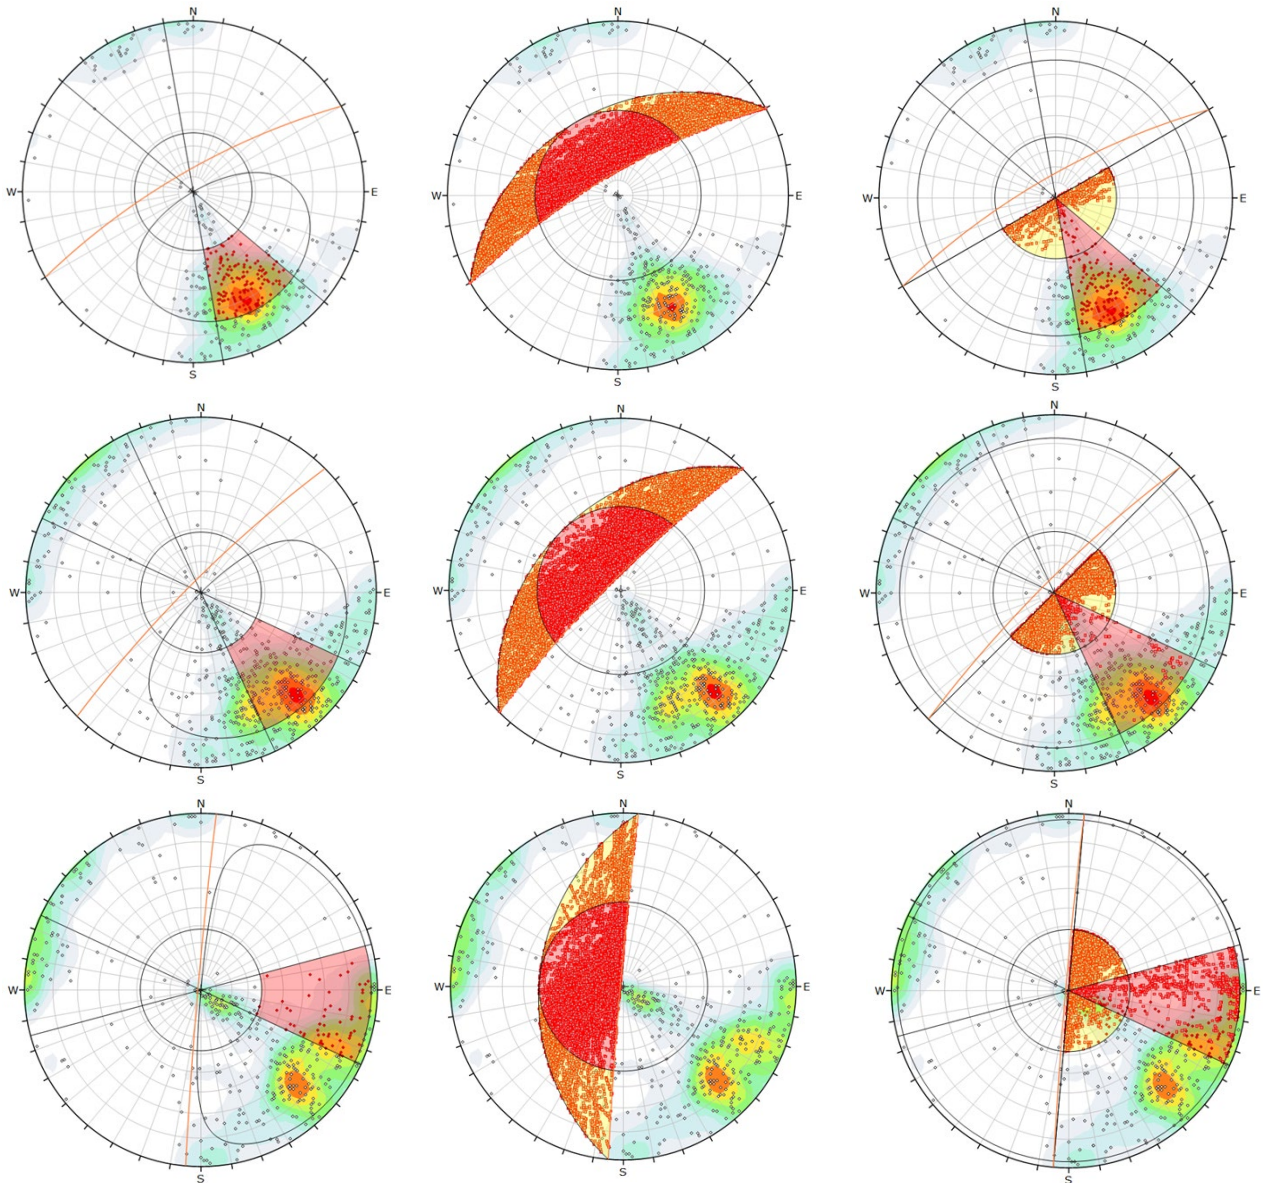
In Zone 1, analyses were conducted for 296 discontinuities that daylighting in the rock face analyses at dip and dip orientation of 76/330°. The results pointed on probability of 45.27% for planar failure, 51.16% for wedge failure and 53.38% for toppling.

In Zone 2, analyses were conducted for 515 discontinuities that daylighting in the rock face analyses at dip and dip orientation of 82/315°. The results pointed on probability of 31.65% for planar failure, 47.66% for wedge failure and 41.94% for toppling.

In Zone 3, analyses were conducted for 364 discontinuities that daylighting in the rock face analyses at dip and dip orientation of 88/275°. The results pointed on probability of 16.15% for planar failure, 33.41% for wedge failure and 33.33% for toppling.

The results of the analyses indicated a nearly high probability of all three failure mechanisms, that it was expected according to hard jointed rock mass and relatively small volumes of rock blocks at the cut face. The results and rock mass structure in all three zones of the cut, indicate on an approach that will include protection of the entire rock cut face and does not consider measures to support individual blocks at the slope, except in Zone 3, where bigger rock blocks are present.

Figure 4 Kinematic analyses of the Špičunak rock cut by cut zones according to planar sliding, wedge and direct toppling, conducted using *Rocscience Dips* software. The results are presented in rows for each zone (e.g., Zone Z₁ is in the first row). The results of planar sliding are in the first column, wedge failure in the second column, and direct toppling in the third column.

According to the results of slope stability and kinematic analyses, as well as rock mass structure in the cut, rockfall protection measures were designed. Two design approaches were considered (Arbanas et al 2012): (i) the prevention of rockfalls by removing potentially unstable rock mass or by installing rock mass support systems and (ii) the reduction of rockfall mass energy and suspension of running rockfall mass using rockfall protection ditches, walls or barriers (Volkwein et al 2011). After analyses of technical and economic aspects of possible remedial and protection measures, application of rock mass support system in combination with rockfall protection walls in the foot of the cut was selected.

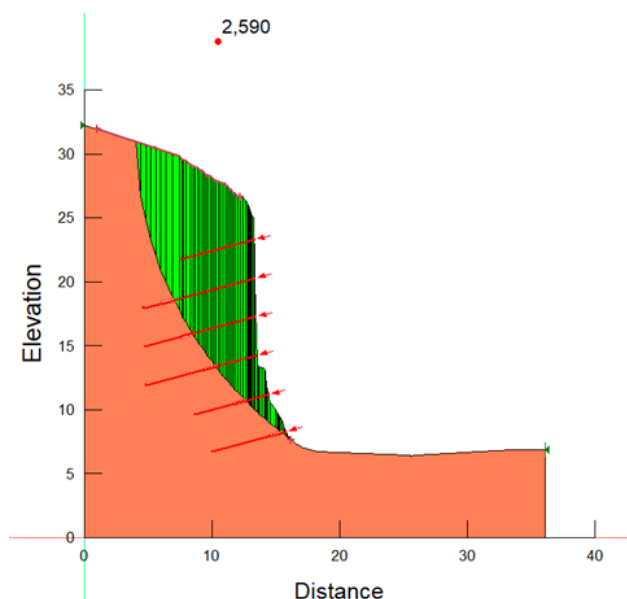
Figure 5 Results of global rock cut stability analysis with applied slope protection measures in Zone 2, conducted using RocSlide software.

In Zone 1, with the lowest cut heights and relatively distant from the road, the rock cut protection is designed using rockfall protection fences that enable detachment of small blocks and their fall to the slope toe, but without reaching the road. In Zone 2, where the rockfall hazard and a possibility that detached running blocks reach the road and endanger vehicles, the support system consisted of rockbolts and multi-layered reinforced shotcrete that will cover overall cut face was designed. Rockbolts designed on a raster of 3.0 x 3.0 m, lengths of 6.0 and 9.0 m, and bearing capacity of 240 kN in combination with two-layered shotcrete lining will have significant impact on complete prevention of further rockfall occurrences as well as an increasing of global slope stability, Fig. 5.
