Contribution of fire barriers in preventing fire spread across façades – experimental testing performed by University of Zagreb

Keywords: fire safety of façades, fire barriers, large-scale testing, ETICS systems

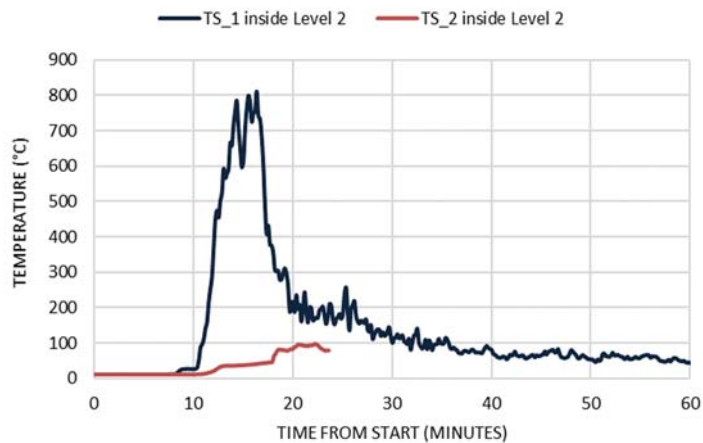
*Fig.2. Average temperature within thermal insulation layer at Level 2 on main façade during
a) first testing, b) second testing*

Analysis of average temperatures, developed during both tests within thermal insulation layer, shows that test specimen TS_2 has considerably lower temperatures compared to test specimen TS_1. Obviously, fire barrier has limited the fire development within the insulation material in test specimen TS_2 where, at Level 2, the temperatures remained below or around 100°C. The adverse effect occurred in specimen TS_1, i.e. the thermal insulation in this specimen was caught by fire where temperature peak rose above 700°C (Fig. 2).

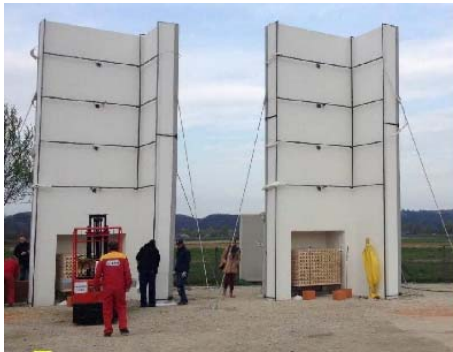
Fig. 3. Start of the test

Visual appearances - Figs. 3-8 present the pattern of behaviour of two façade systems during second testing. As it can be seen from figures, only the glass fibre mesh and finishing render was left of test specimen TS_1, while the entire thermal insulation burned up in less than 40 min after the start of fire. At test specimen TS_2, once the fire propagated over the fire barrier above the combustion chamber, the thermal insulation started to melt and burning droplets were released and felt around the specimen. The thermal insulation melted only partially at this test specimen.

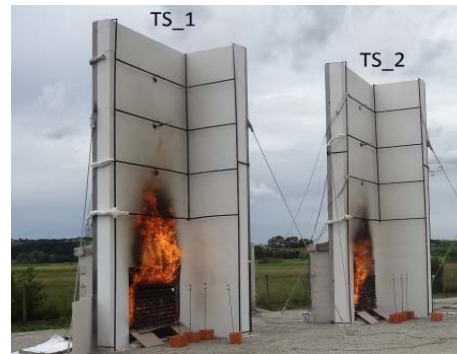
Fig. 4. 9 min from the start

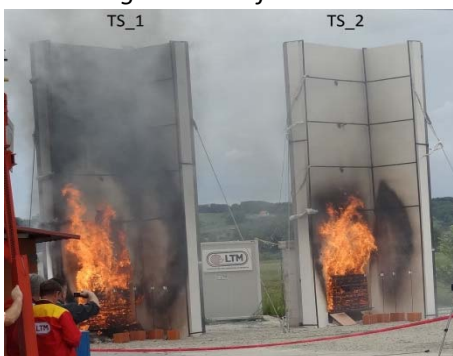
Fig. 5. 19 min from the start

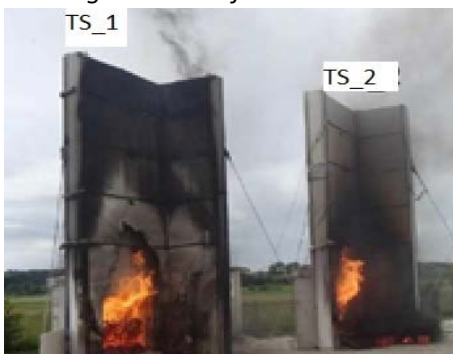
Fig. 7. 37 min from the start

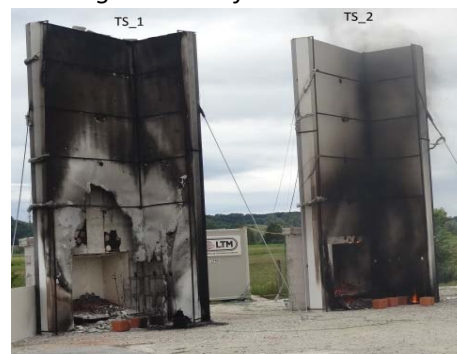
Fig. 8. 57 min from the start
