Article

A Multiscale Framework for Sustainable Management of Tufa-Forming Watercourses: A Case Study of National Park “Krka”, Croatia

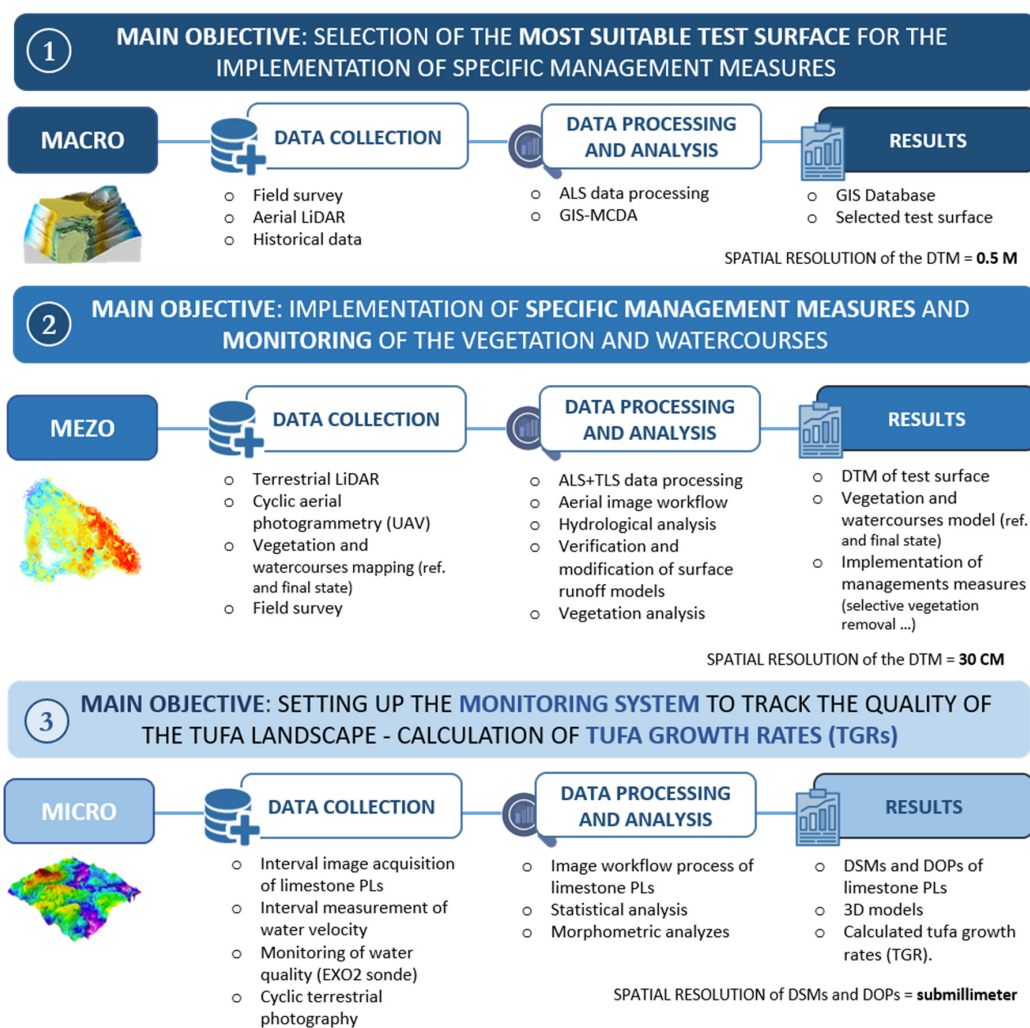
Figure 3. Multiscale methodological framework of tufa landscape degradation research at NPK (Croatia).

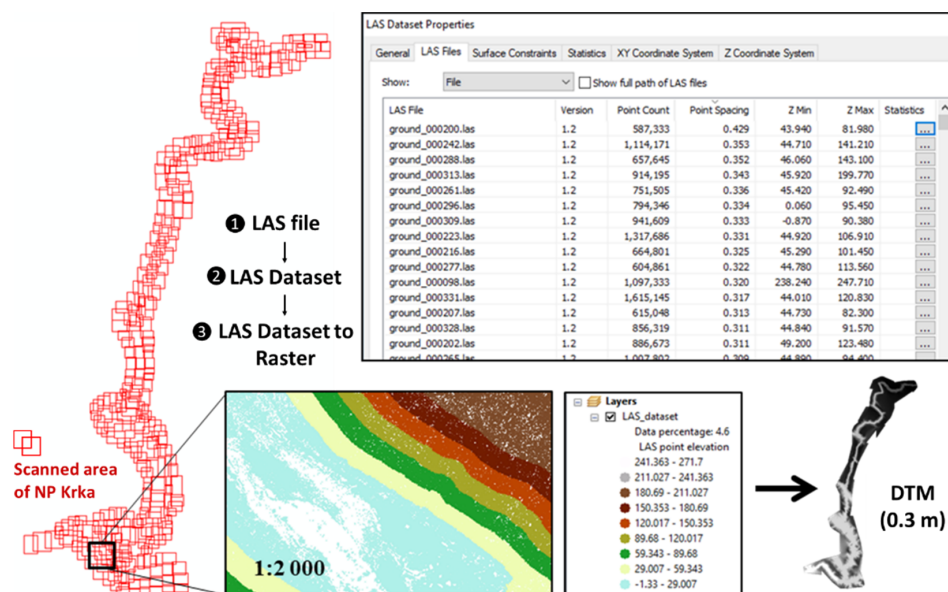
Aerial LiDAR scanning of the six waterfalls and both banks of the Krka River was performed for the purposes of generating the criteria for GIS-MCDA, production of referent digital surface model (DSM), mapping of high vegetation and other needs of the Park administration. Aerial LiDAR scanning was performed using a full-waveform laser measuring system Riegl LMS-Q780. The system was connected to a Eurocopter EC120B helicopter with an integrated Hasselblad H39 camera and a Novatel OEV/OEM4 internal GPS receiver. Data were collected in the NW-SE direction of flight. The laser beam stabilization or deviation accuracy was approximately 0.25 mrad, corresponding to a positional error of approximately 25 cm in the field at a relative flight altitude of 1000 m. The flight altitude was 500–600 m, while the flight speed was 112.12 km/h. The point density was 24.7 points/m² (precision 20 mm). Data processing was performed using the software packages Microstation (v2004) and Terrasolid, while Grafnav and IGI Aerooffice were used to process the GPS data. The process involved input and point classification, manual correction of automatic point classification (pulse time), data transformation and ultimately the creation of a digital terrain model (DTM). The entire scanned area contained a total of 350 dense point clouds with more than 781 million ground points (*last pulse*). Classified data were saved in *las format* (LAS format) and converted into the *LAS Dataset* structure from which detailed statistics of a classified point cloud were generated. After point classification, the average sampling density dropped to 10–15 points per m², depending on the density of the vegetation cover. A DTM was created using the *LAS Dataset to Raster* tool in *ArcMap* software (Figure 4).

Figure 4. Scanned area of NPK and schematic representation of digital terrain model (DTM) derivation from *LAS Dataset*.

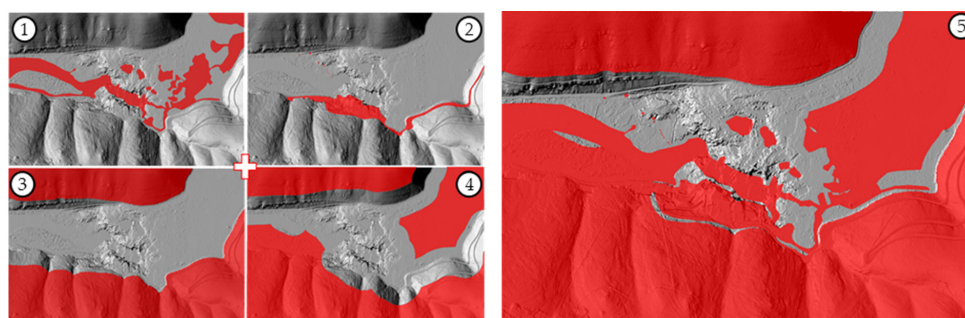
The GIS-MCDA was used for the selection of the most suitable test surface. Two concepts were used: Boolean and continuous values [47]. The Boolean approach, which serves to limit the alternatives under consideration, relies on the binary statement (true/false) of the criteria for a considered goal or decision [48]. Four exclusionary criteria were used (Figure 5):

Figure 5. (1–4) Exclusionary criteria in GIS-based multicriteria decision analysis (GIS-MCDA); (5) final excluded area.

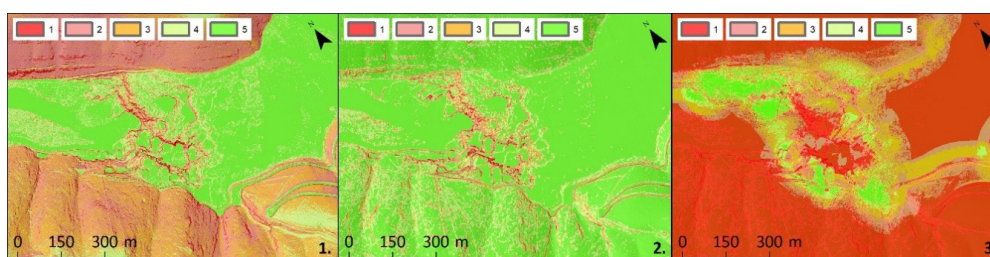
Then, the standardization process was performed. Each criterion was ranked into (1–5) classes using the Jenks classification method, where (5) represents very high convenience, (4) high, (3) medium, (2) low and (1) very low convenience (Figure 6).

Figure 6. (1–3) Criteria used in the GIS-MCDA continuous value approach.

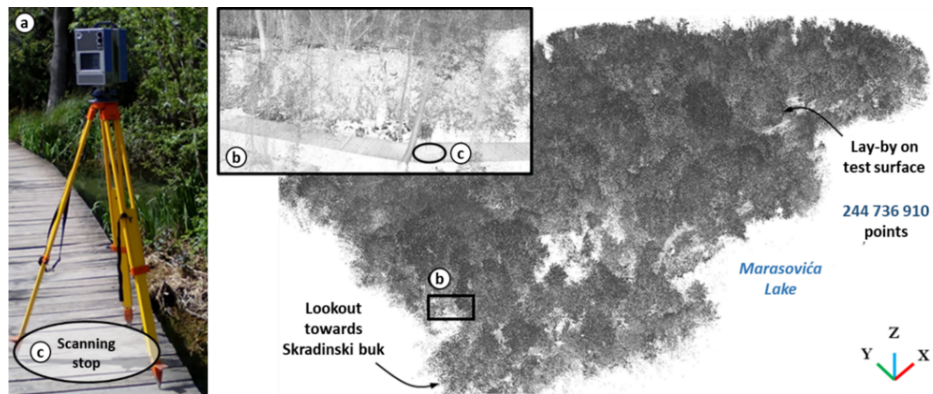
Terrestrial LiDAR scanning of the vegetation and tufa-forming watercourses referent state was performed on 5–7 April 2016. Scanning was performed with the Z+F Imager 5010 TLS (Figure 8a). The scanning resolution was set to *high*, while the quality was *normal*. A total of 244,736,910 points (Figure 8) were recorded at 156 stops (over 1.5 million points per stop). The distribution of scanning stops was the result of the test surface accessibility and its morphometric characteristics. In between two scans, at least two marks were left at the same locations. The marks were placed within the scanning range and moved through the scanning process. The coordinates of the six marks were collected by the RTK-GPS Stonex S10 receiver and used for dense cloud georeferencing.

Figure 8. (a) Z+F Imager 5010 on the test surface; (b) part of the dense point cloud of test surface (c) example of one from 156 scanning stops on the test surface.

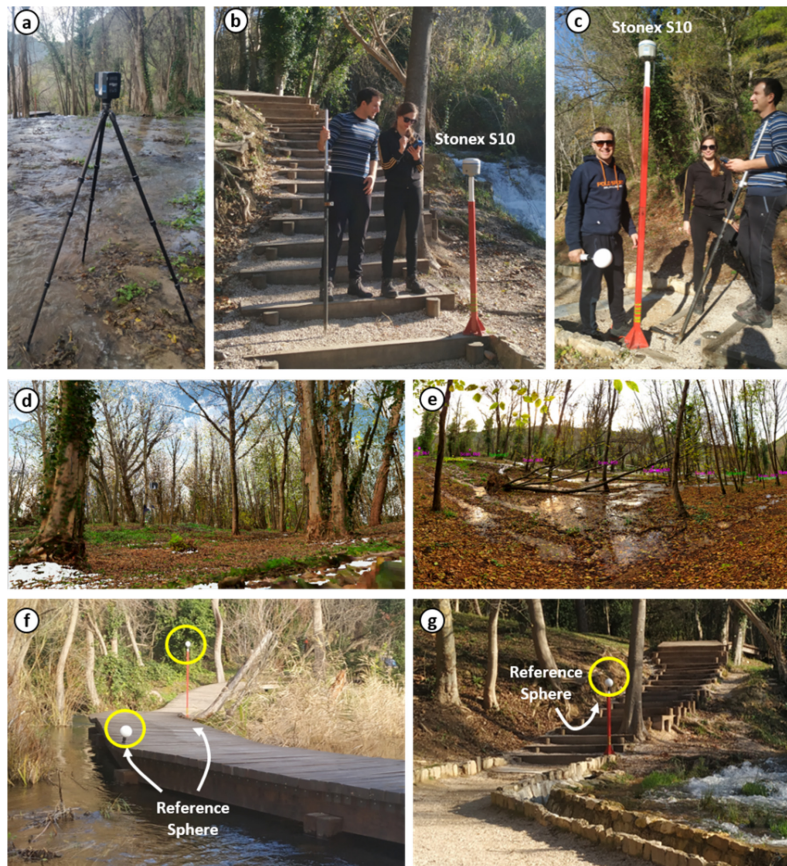
Terrestrial LiDAR scanning of the final state of vegetation and tufa-forming watercourses was performed two years after the implementation of management measures. It was performed on 19 December 2019. Scanning was performed with the Faro Focus M70 TLS (Figure 9). There were a total of 22 scanning stops in the final scan. The number of stops was lower than in the first scanning since the Faro Focus M70 TLS was more advanced than the Z+F Imager 5010 and since the vegetation density was lower after selective vegetation removal. In the scanning process, 1/4 resolution (with a point distance of approximately 6 mm at 10 m distance) and 2× quality was used. Additionally, the HDR texture parameter was set. The scanning per stop took 6–7 min.

Figure 9. (a) Faro Focus M70 results on the test surface; (b,c) coordinate collection of the reference spheres using Stonex S10 (d,e) examples of a dense point cloud from selected scanning points; (f,g) examples of set reference spheres for dense point cloud orientation.

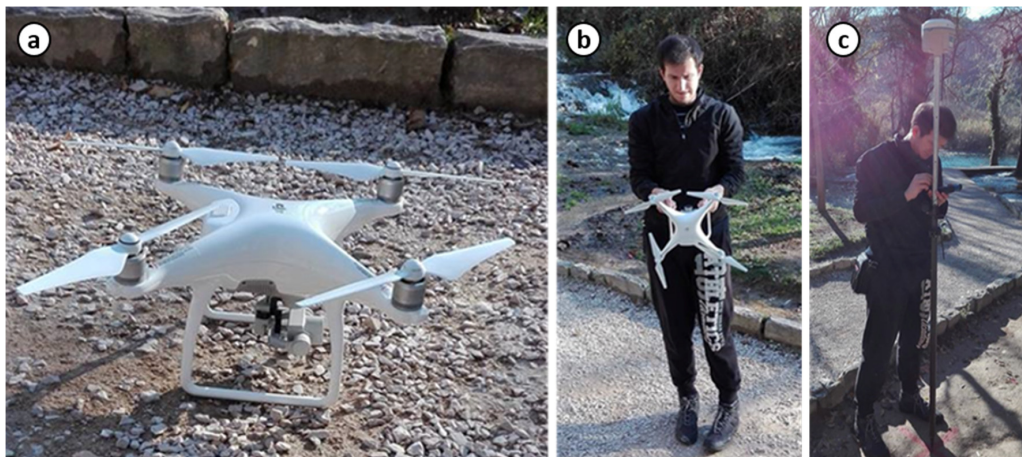
The objective of cyclic UAV photogrammetry was to create digital orthophotos (DoPs) on which changes in vegetation, watercourses and lakes before and after the conduction of specific management measures would be visible. Cyclic UAV photogrammetry was performed using a UAV Phantom 4 (Figure 10a). The first aerial recording was performed in March 2017. The second was done in March 2018, shortly after the selective removal of vegetation and placement of the artificial substrates in the reactivated watercourses. Before performing the flight, the IMU system and UAV compass were calibrated (Figure 10b). Ground control points (GCPs) were collected using the RTK-GPS Stonex S10 (Figure 10c). The test surface was recorded with several Double Grid missions at different heights using Pix4Dcapture software. The image workflow process was completed in Agisoft Metashape 1.5.1 software.

Figure 10. (a) Unmanned aerial vehicle (UAV) Phantom 4 used for cyclic UAV photogrammetry; (b) UAV compass calibration and (c) data acquisition of orientation points using the GPS Stonex S10.

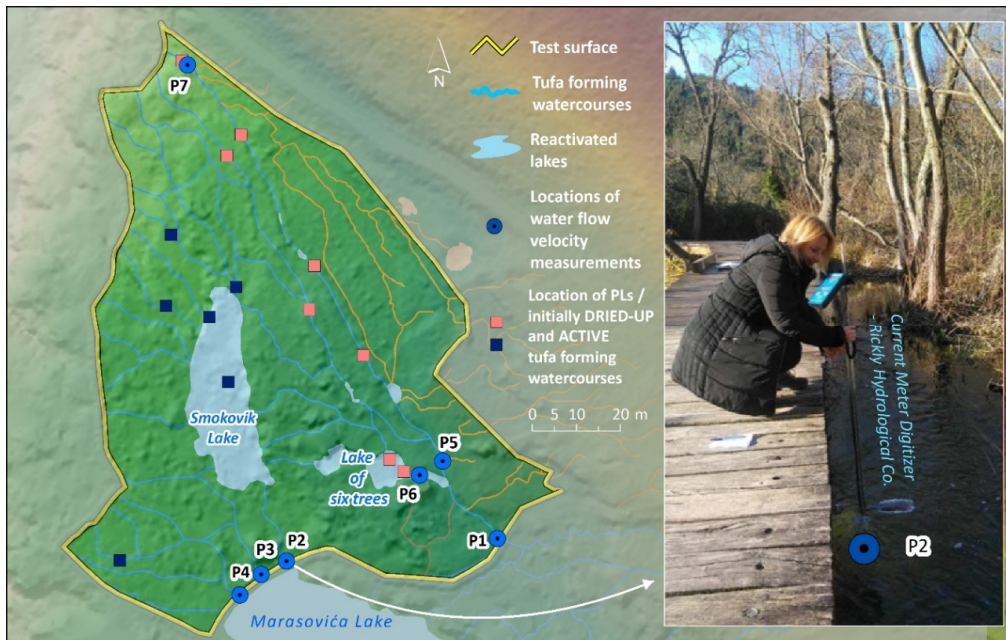
device logistical limitations precluded this operation. Before the implementation of management measures, there was no water at sites P1, P5, P6 and P7. These were dried-up tufa-forming watercourses. The water flow velocity was measured several times a month.

Figure 14. Locations of water flow velocity measurements on the test surface.

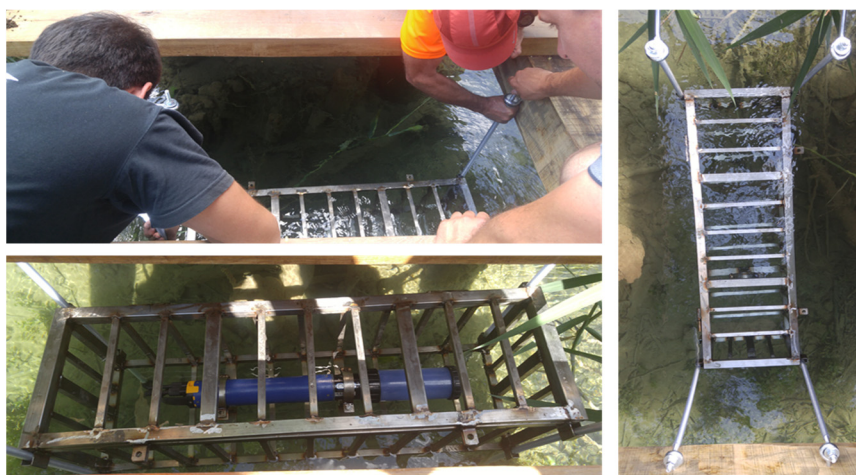
Systematic monitoring of water quality helps in identifying specific natural processes (e.g., natural eutrophication) and human impacts (e.g., the presence of pollutants or heavy metals) on this sensitive ecosystem. Near the P2 location, a multiparameter YSI EXO2 probe was installed on 18 May 2018. It is designed for water quality monitoring and characterized by high-precision sensors with built-in memory, wireless connectivity and easy integration into marine, freshwater and groundwater systems. The probe was positioned below the walkway and continuously measured the quality of the water coming to the test surface. To reduce the risk of theft, the probe was placed in a metal cage of non-oxidizing iron at a depth of approximately 40 cm at location P3 (Figure 15).

Figure 15. Placement of the probe in a metal non-oxidizing cage near the P3 location.

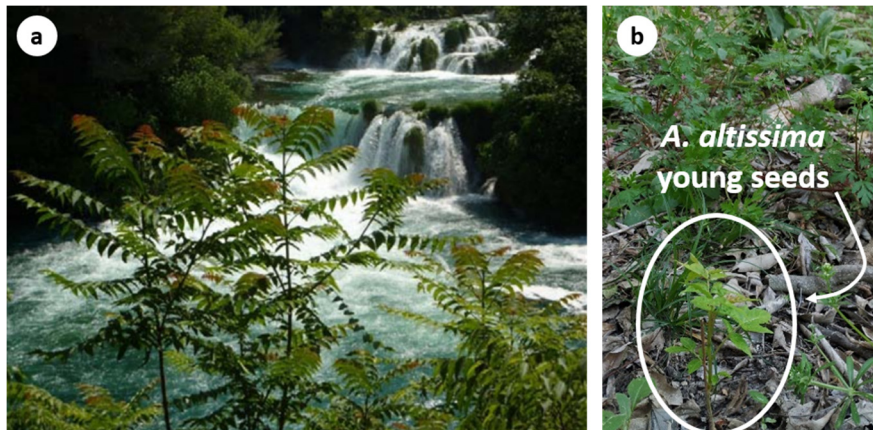
Field surveys conducted in the wider area of SB with the guidance of the official expert staff of NPK have found that invasive vegetation, more specifically, *A. altissima*, has spread over a large area of the NPK (Figure 18a,b). [57] were the first to mention this problem.

Figure 18. (a) *A. altissima* blocks the view on the largest tufa waterfall in Europe—SB and (b) young seeds of *A. altissima* in NPK; Source: (a) [57] (2014); (b) field survey.

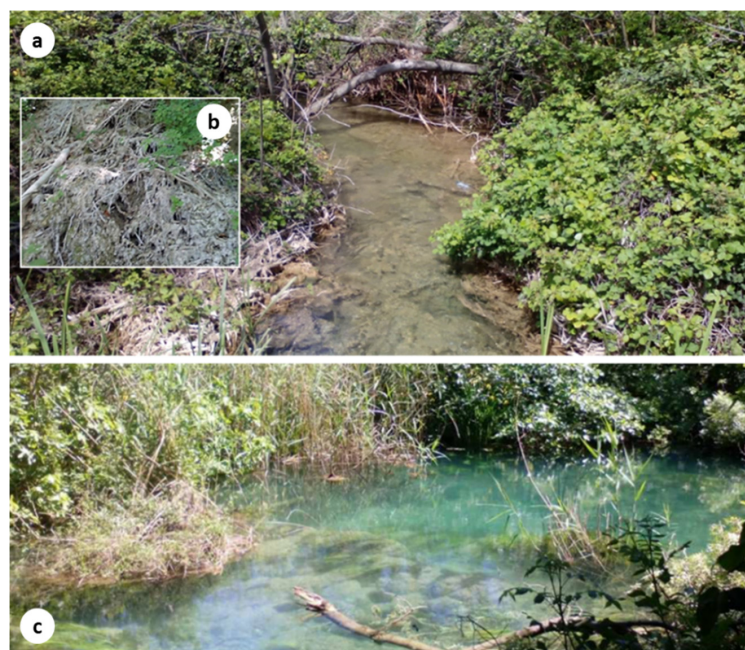
Furthermore, the locations where the tufa formation process was stopped (old/dead tufa) (Figure 19b) or its intensity was reduced, along with dried-up tufa-forming watercourses and waterfalls, were detected. Additionally, locations with a change in direction and a slowdown in the flow velocity were detected (Figure 19a).

Figure 19. (a) Example of a direction change and slowdown in the flow velocity in tufa-forming watercourses; (b) old (dead) tufa at a smaller waterfall in the wider area of SB; (c) potential natural eutrophication process at a smaller lake in the wider area of SB.

Additionally, many potential sites have been identified that may indicate a possible natural eutrophication process (Figure 19c). In addition, a smaller number of trees were detected that fell into the tufa-forming watercourses due to weather conditions (storms) partially blocking the water flow in these watercourses (Figure 20).

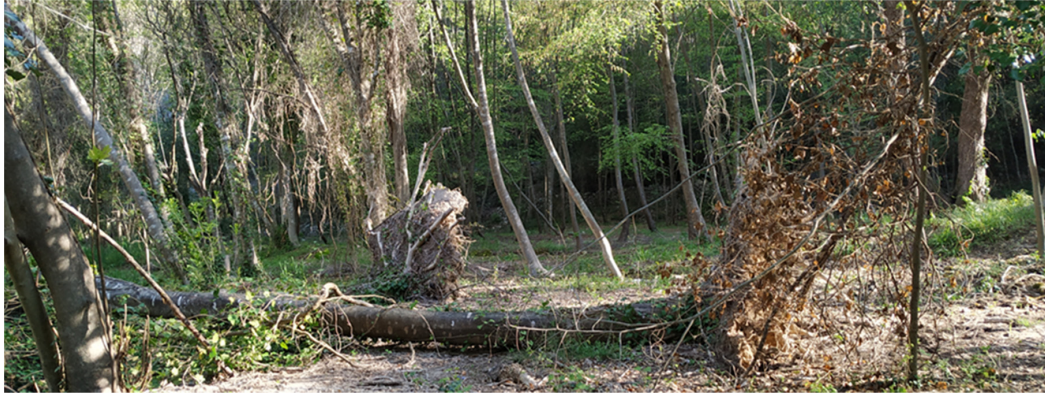
Figure 20. Example of fallen trees that blocked the water flow in tufa-forming watercourses.

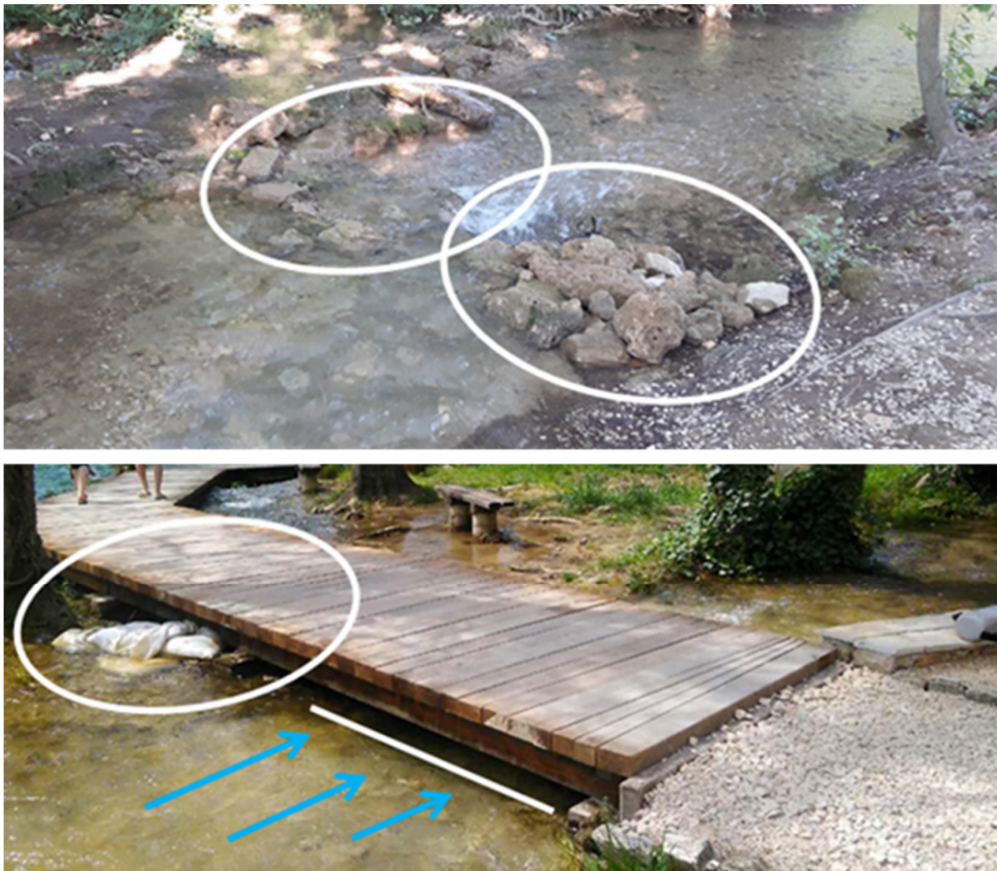
At some locations, negative hydrodynamic phenomena were also observed as a result of anthropogenic impact (trail and resort construction, tourist influence, gravel accumulation under trail/bridges) (Figure 21).

Figure 21. Examples of negative anthropogenic influences (path construction and gravel accumulation) on the hydrodynamics of travertine watercourses.

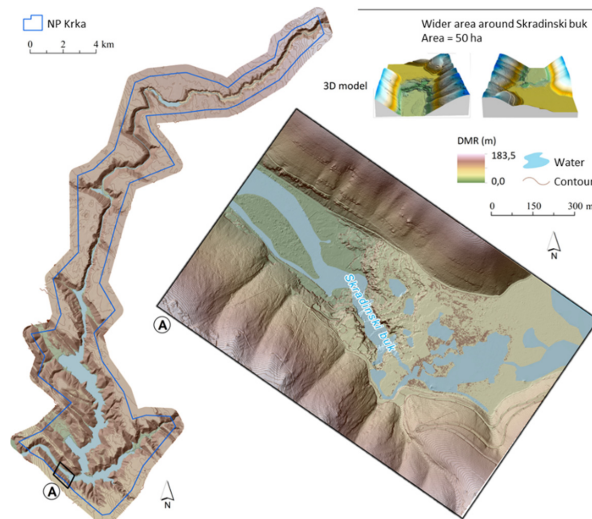
Aerial scanning was performed with the Riegl LMS-Q780 full-wave laser measuring system. The average point density was 24.7 points/m². The process of data classification was performed based on reflection time. The ground class included 350 dense point clouds for the entire NPK with a total of just over 781 million points. The spatial resolution of the created DTM was 30 cm. From the DTM of the whole NPK, a model of the wider SB area (approximately 50 ha) was extracted. The extracted DTM served (Figure 22) as the basis for deriving the morphometric criteria used in the GIS-MCDA.

Figure 22. (A) An extracted part of the NPK DTM, which represents a wider area of SB.

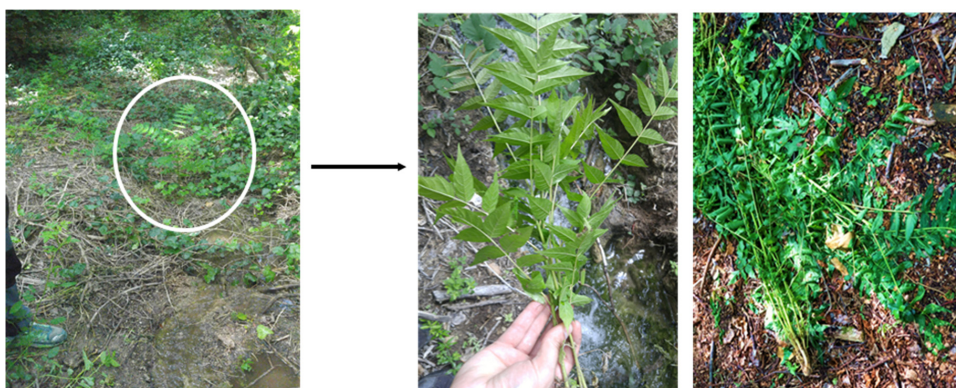
- (1) Hand-picking (young seeds); (Figure 26)
- (2) Manual cutting or twitching (young trees up to 1–1.5 m high);
- (3) Manual cutting (trees that are not in the seed stage and mature trees that are inseedinated)

Figure 26. An example of hand-picked young seeds of *A. altissima*.

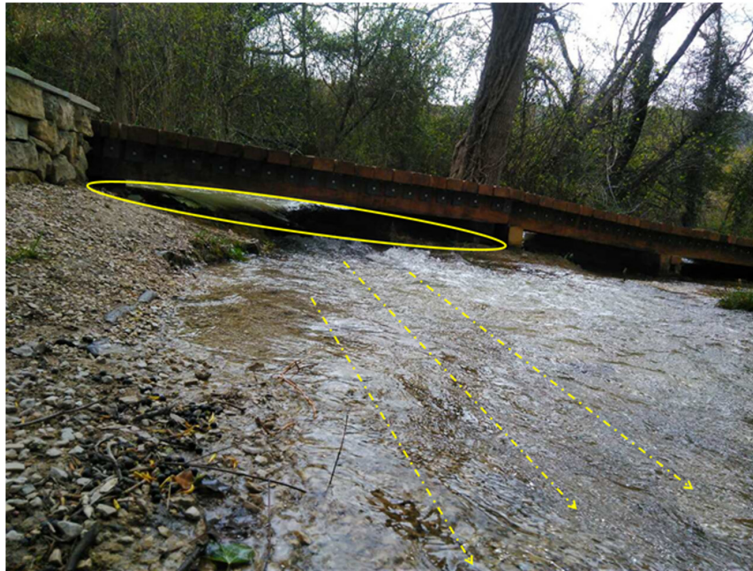
All young seeds and *A. altissima* trees were removed from the test surface. Specifically, 72 trees with a diameter larger than 15 cm were removed from the test surface. The removal of invasive vegetation and fallen accumulated plant fragments from the dried-up flows resulted in micromorphological changes on the test surface. Furthermore, the removal of artificially accumulated gravel was performed at those locations where its influence on the change in the flow outflow direction occurred (Figure 27).

Figure 27. Water runoff below the path after removal of accumulated gravel.

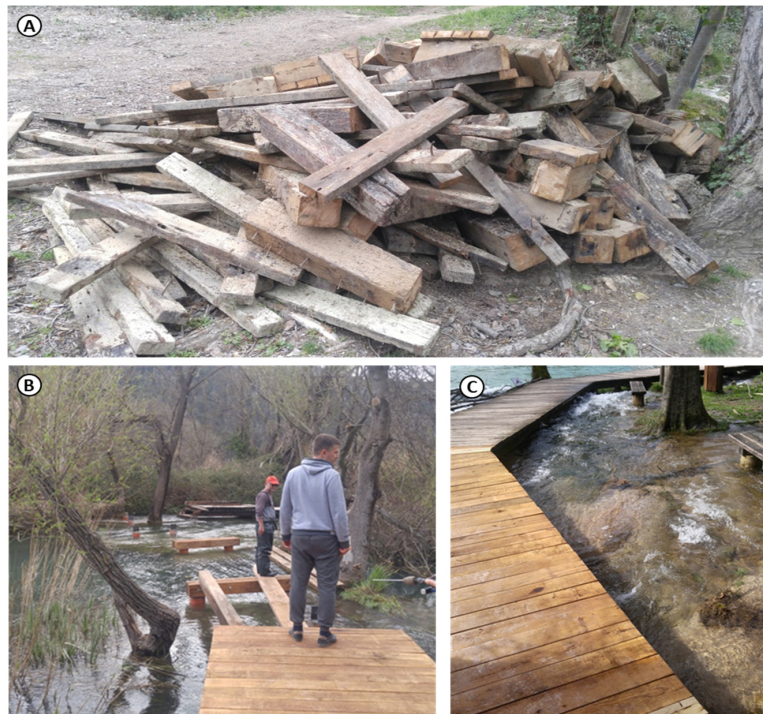
Additionally, the path was raised in those locations where it slowed down the flow and influenced the change in its direction (Figure 28). Given the small ruggedness of the terrain, these changes directly influenced the alteration of the hydrological network.

Figure 28. (A) Removed boards from the old path; (B) construction of the new path; (C) newly built path under which water runs unhindered.

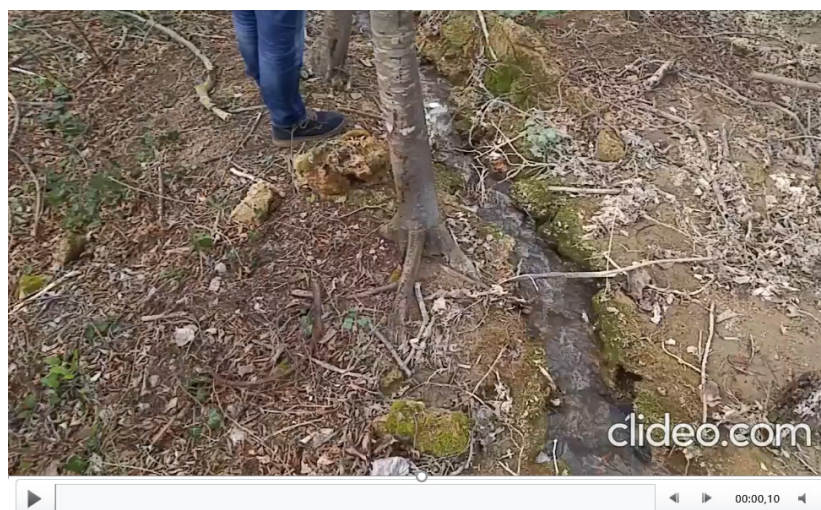
The combination of intense rainfall with increased water flow (gravel removed under the trail/bridge) caused the process of washing away plant fragments and reactivating the dried tufa, forming watercourses (Video S1) (Figure 29). These watercourses were initially mapped on the 19th-century Austro-Hungarian topographic map.

Figure 29. Screen shot from Video S1, which shows reactivation of tufa-forming watercourses.

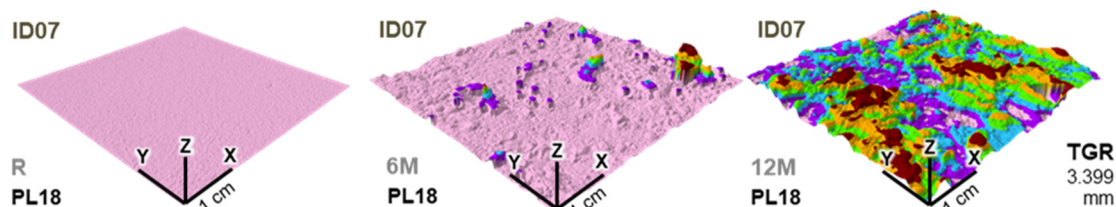
The production of digital submillimeter resolution (0.0236 mm) models of tufa surfaces is explained in Reference [56]. On all PLs installed in reactivated tufa-forming watercourses during a one-year period, the occurrence of tufa was measured (Figure 31).

Figure 31. Example of PL18; (R) initial digital submillimeter resolution model; (6M) tufa formed after six months and; (12M) after one-year period; the tufa growth rate (TGR) on PL18 was 3.399 mm a⁻¹.

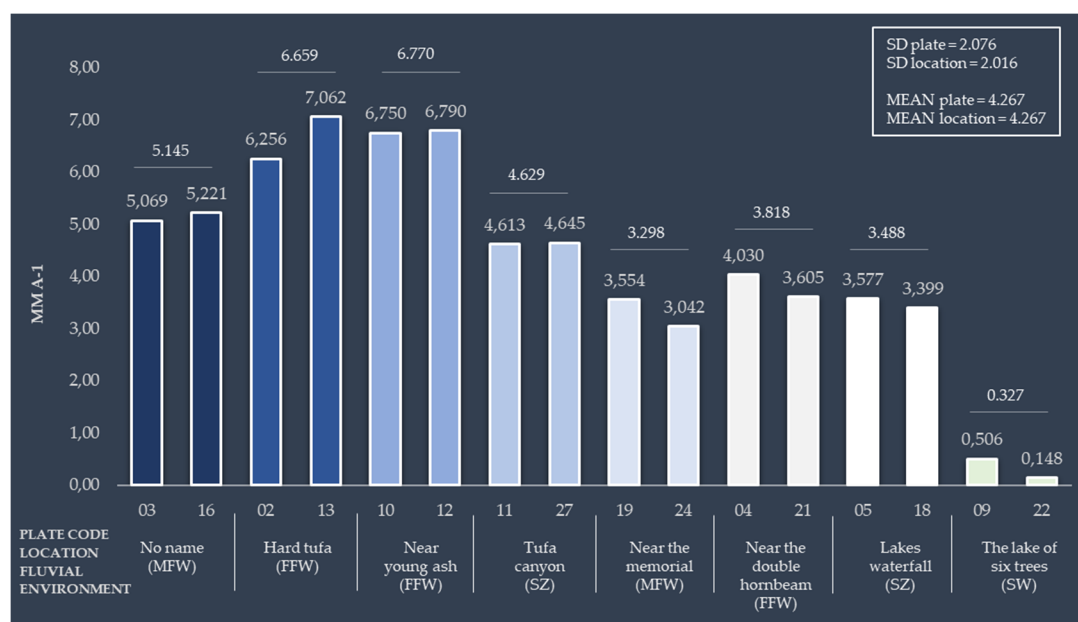
Figure 32. TGR per PL and location in reactivated tufa-forming watercourses.

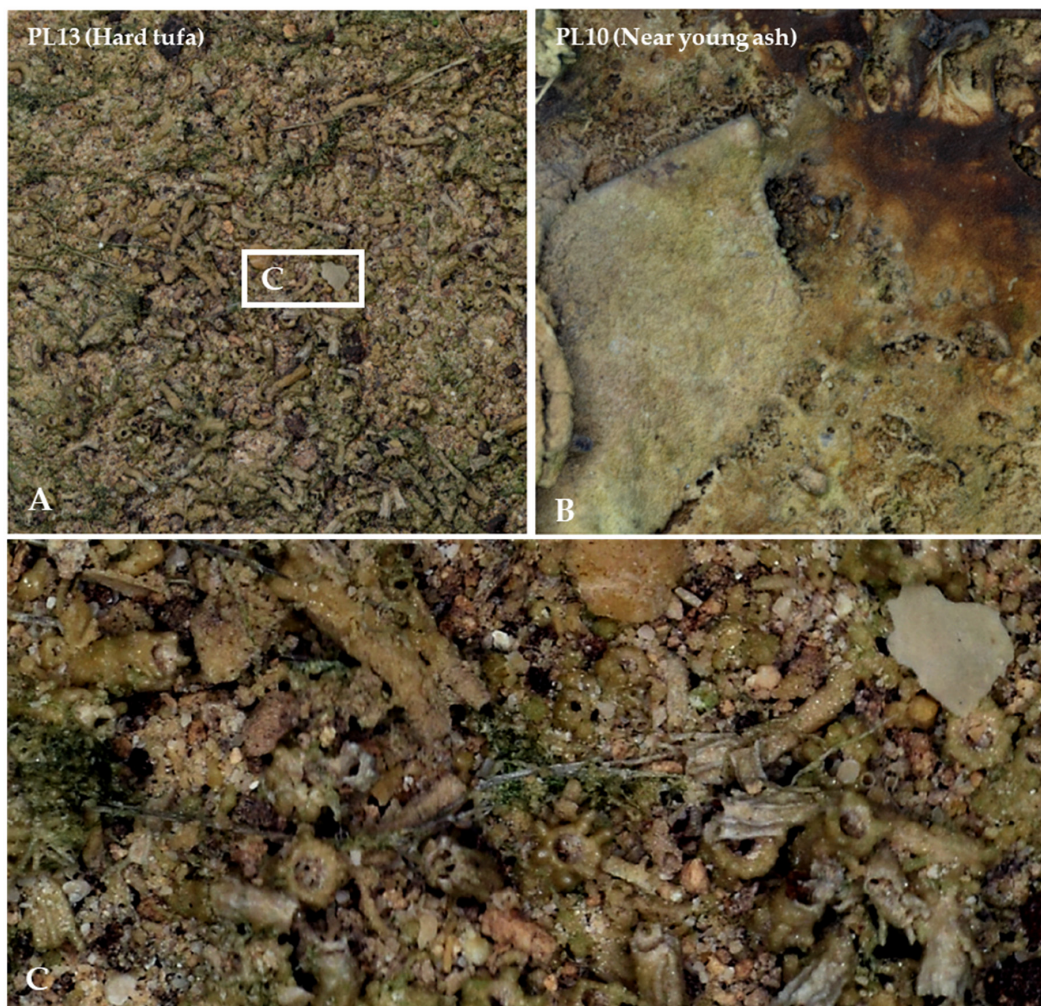
Figure 33. (A,C) Example of tufa-forming organisms and plant fragments on the PL13; (B) Incrustated leaf on the PL10.

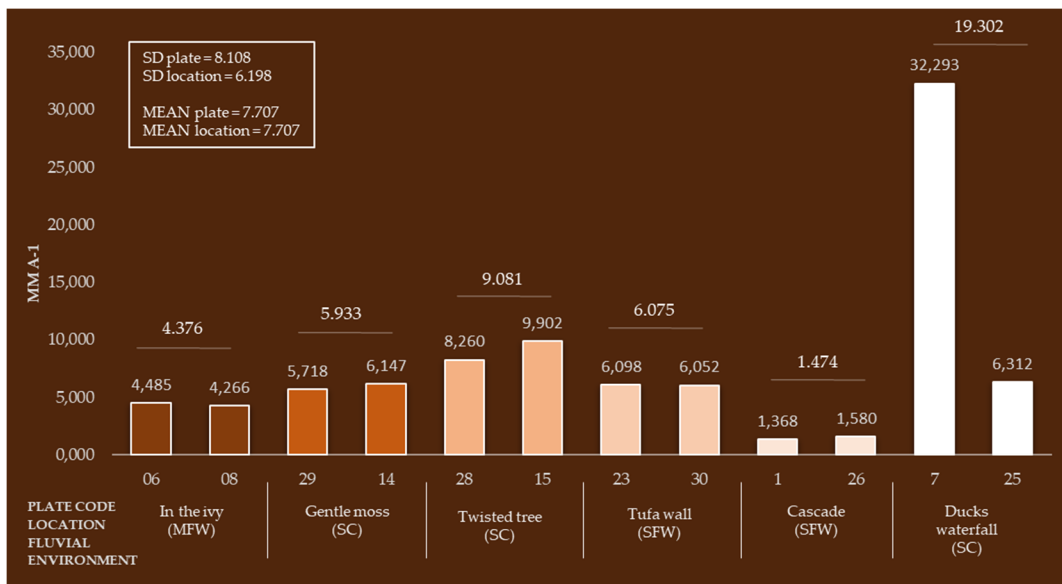
Figure 34. TGR per PL and location in previously active tufa-forming watercourses.

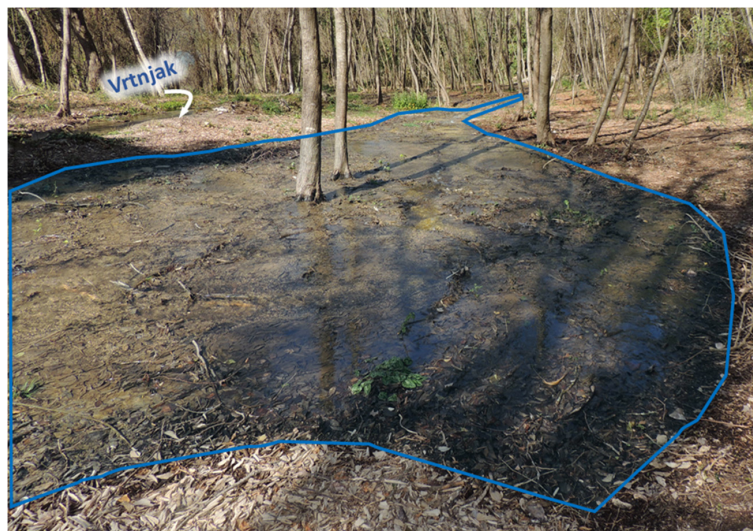
No regeneration of the invasive vegetation on the test surface was observed from the interval photographs collected during one-year recording with a 15 min interval. Furthermore, no regeneration was observed through regular monthly field surveys of the test surface. A likely reason for this is a reactivation of the tufa-forming watercourses with an intensified inflow of water beneath the raised path. This caused occasional flooding of larger areas within the test surface (Figure 35). Such a flooded environment did not favor the regeneration of invasive vegetation since *A. altissima*, does not tolerate long exposure to moist and flooded soils [54,55].

Figure 35. Example of test surface flooding.

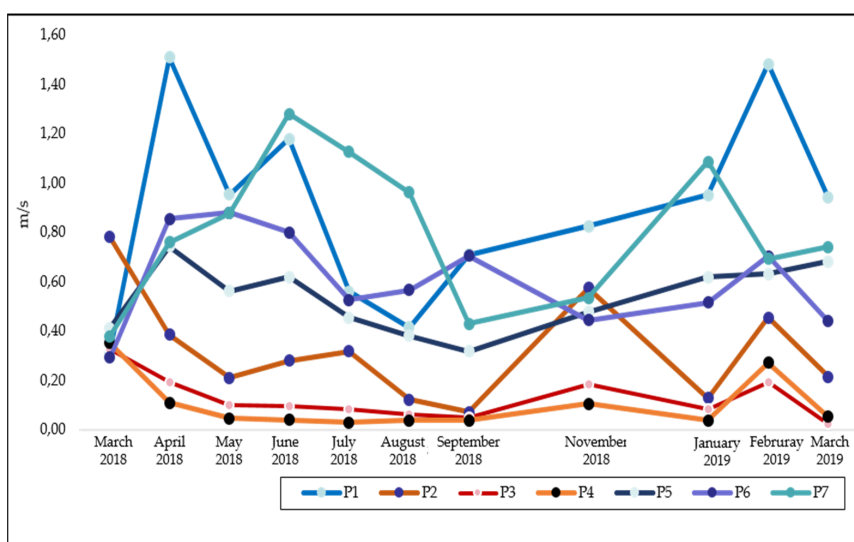
Figure 36. Water flow velocity over a one-year measurement period (March 2018–March 2019) at selected locations (P1–P7).

defined locations is in the range of values that are recognized as one of the basic conditions for tufa formation (0.5–3.5 m/s) [61,70]. Furthermore, reactivated tufa-forming watercourses do not have pronounced erosive properties, although minor erosive events have been measured [56], especially on tufa-forming organisms. Specifically, some authors state that a flow velocity faster than 1.5 m/s [71] or even 0.8 m/s can erode the tufa surface. However, flow velocities greater than 1.5 m/s were recorded only in April 2018 at the P1 location. Nevertheless, the values of the flow velocity at P1 (average value 0.897 m/s) and P7 (average value 0.808 m/s) indicate that the *Vrtnjak* tufa-forming watercourses at some locations had potential erosive properties. Although none of the sites of flow velocity measurement dried up, it is important to point out an example of how the non-removal of naturally fallen vegetation can influence the change in water runoff. Specifically, during the removal of the PLs in the colder part of the year, a change in the direction of water runoff within tufa-forming watercourses *Crni grab* was observed. This was the result of the fallen large tree and the accumulated plant material that created a natural dam (Figure 37). After the removal of the fallen tree, the watercourse was reactivated.

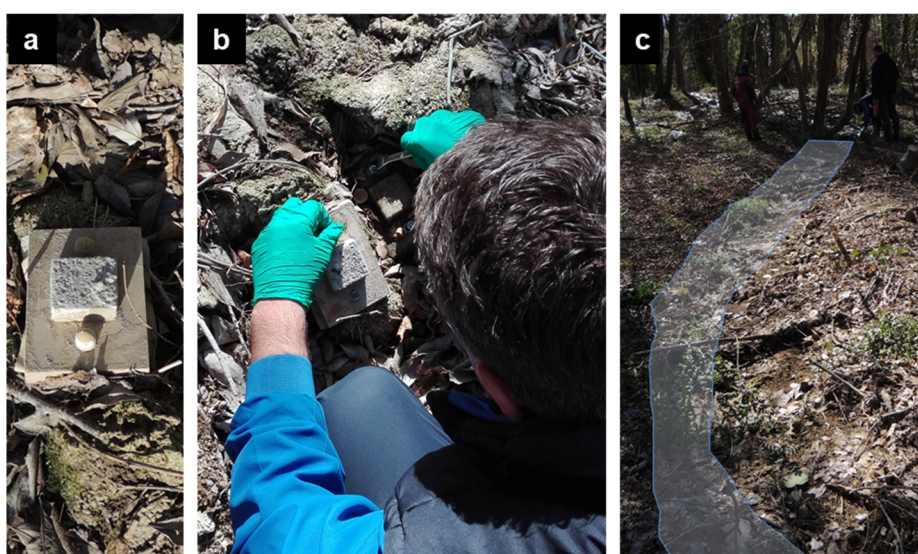
Figure 37. (a) Dried-up part of tufa-forming watercourses; (b) extraction of PL24; (c) location of natural dam.

Therefore, the downstream part of the stream dried out and the PLs at the location *Near the memorial* ran out of water. This resulted in a lower TGR (3.298 mm a^{-1}) than in other locations (*In the ivy* and *No name*) in the same fluvial environment (MFW) and a higher TGR in the warm period (2.832 mm a^{-1}) than in the cold period (0.209 mm a^{-1}). This and other examples (Figure 38) clearly demonstrate how non-maintenance of tufa-forming watercourses (removal of fallen and accumulated vegetation) can compromise sustainable sedimentation conditions at some micro-locations.

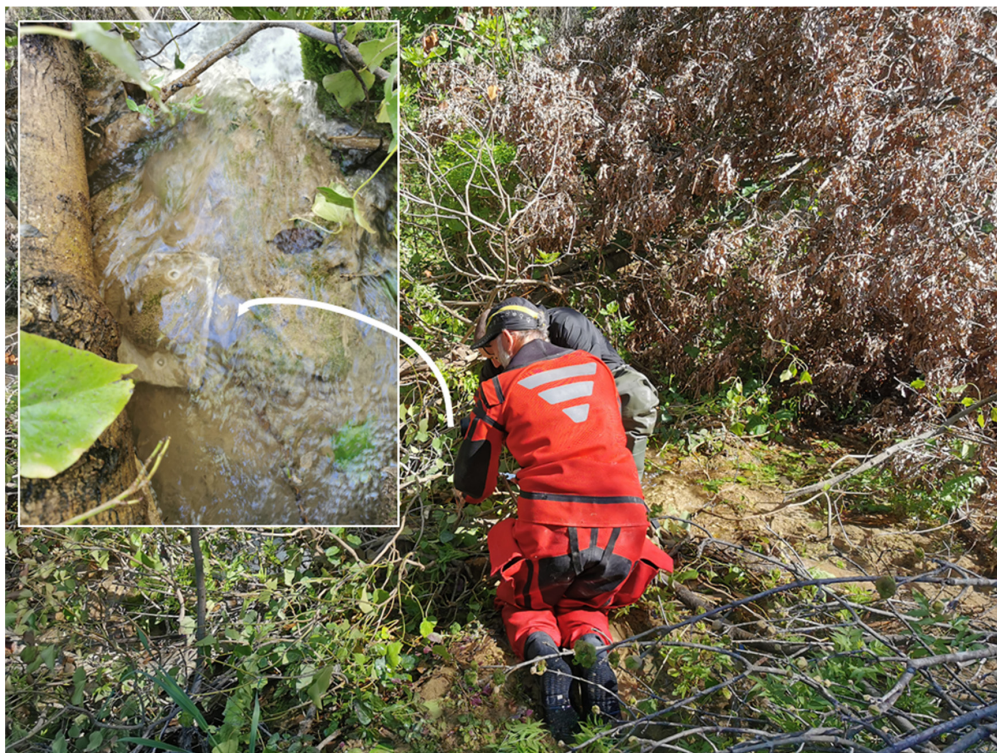
Figure 38. Example of how fallen trees can damage created tufa forms and change direction of tufa-forming watercourses.
