## HYDROMETRIC AND WATER QUALITY PROPERTIES OF THE MEDULIN POND (REPUBLIC OF CROATIA)

IVANA SUŠANJ ČULE<sup>1</sup>, GORAN VOLF<sup>1</sup>, NEVENKA OŽANIĆ<sup>1</sup>, IGOR RUŽIĆ<sup>1</sup>

### 1 Abstract

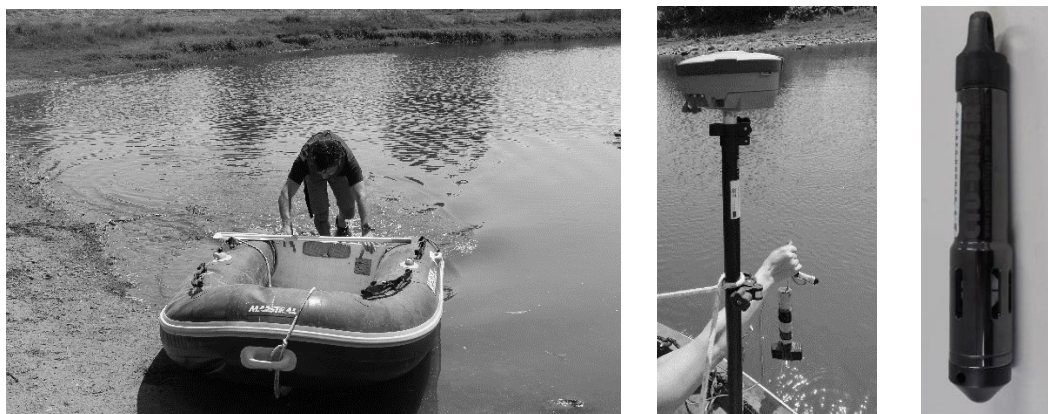
Hydrometric measurement under this research encompasses bathymetry and temperature stratification in the Medulin pond. Bathymetry is provided by usage of the CTD – diver (Van Essen Instruments B.V., Nederland), Topcon positioning system HiPer V for geodetic surveying, and a small inflatable boat. With an inflatable boat is possible to navigate on the surface of the pond, and with geodetic surveying equipment is possible to take precise georeferenced points on which the depth of the water is measured

by the CTD-diver [7]. CTD-diver also provides information about the temperature of the water and its conductivity. Used equipment in hydrometric measurement is shown in Figure 5.

**Figure 5.** Equipment used for the bathymetry measurement (from left to right): Inflatable boat, Topcon positioning system HiPer V and CTD – diver [7]

The bathymetry data was recorded on the 20. June 2022. on the same day when water quality sampling is done. The bathymetry was measured by usage of the small inflatable boat on which the Topcon positioning system HiPer V for geodetic surveying was attached. Also, the CTD diver was attached to

the aggravator and rope, and the depth measuring was conducted by constantly immersing the CTD diver in the water. Since the CTD diver is equipped with a temperature sensor, by moving all around the pond it was possible to take 122 depth and temperature points. In the area where water lilies have grown very densely, conduction of the measurement was not possible. The route of depth measurement points is shown in Figure 7.
