# 12<sup>th</sup> Annual Days of BHAAAS in B&H

## Application of 3D scanning for repairing the damage to the Zagreb mosque after the earthquake

Danko Markovinović/University North - Croatia

June 24<sup>th</sup> – 27<sup>th</sup>, 2021 - Mostar, Bosnia and Herzegovina

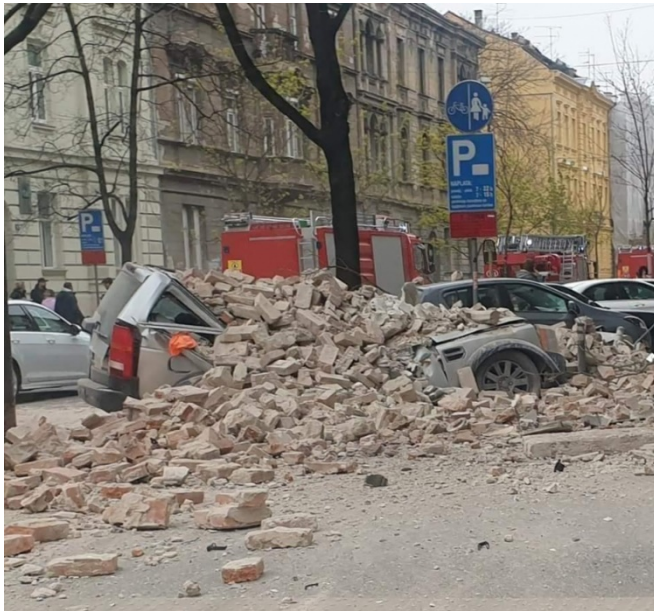
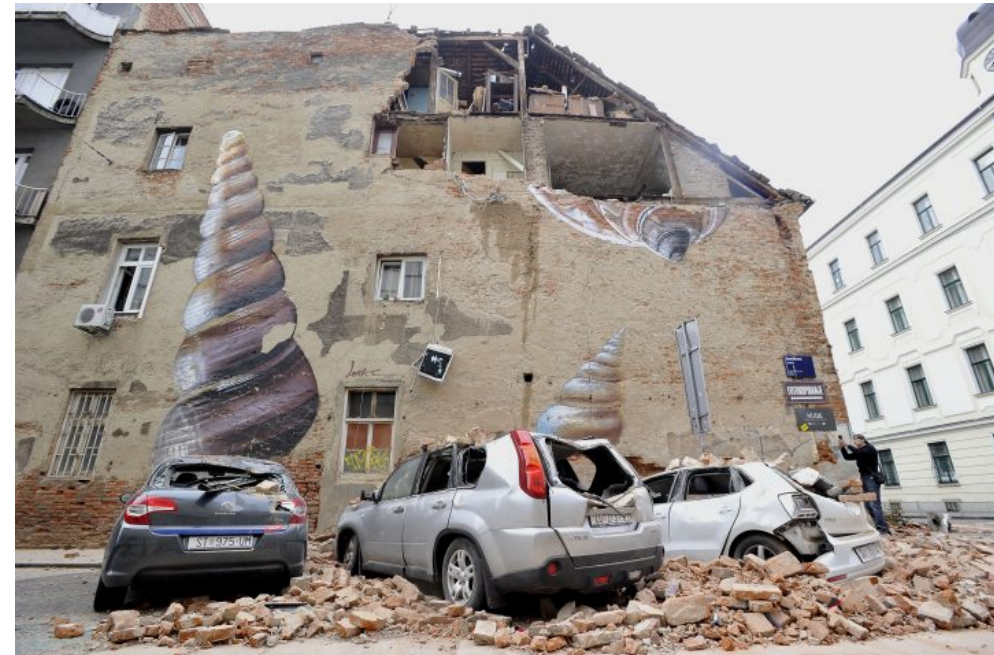
- unfortunately - one person died from his injuries
- total of 27 people were injured in the earthquakes in Zagreb
- a lot of destroyed bulidings

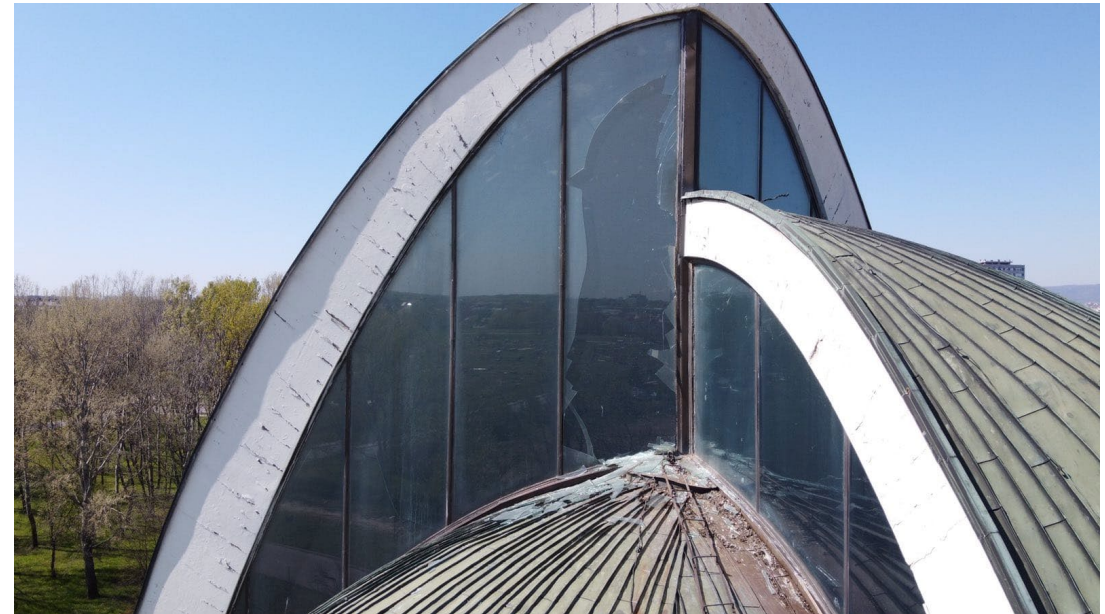
- one of the damaged buildings was Zagreb mosque
- after a preliminary inspection by construction experts, a couple of minor damages were found
- the main damage was found on the upper part of the dome
- the glass cracked and the frame was damaged

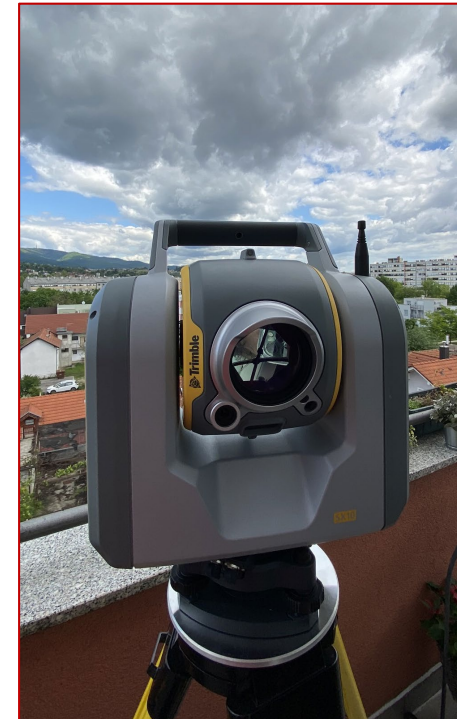
- total station Trimble SX-10
  - ✓ Angular Accuracy: 1"
  - ✓ EDM Technology: Lightning 3DM
  - ✓ EDM Accuracy: 1 mm + 1.5 ppm Prism / 2.0 mm + 1.5 DR
  - ✓ Servo: Robotic
  - ✓ Maximum Distance Range: 5 500 m
  - ✓ Additional Features: Scanning & enhanced VISION
  - ✓ Scanning Speed: 26 000 points per second
  - ✓ Scanning Range: 600 m
  - ✓ Laser Class and Ingress Protection: Laser Class 1M & IP55

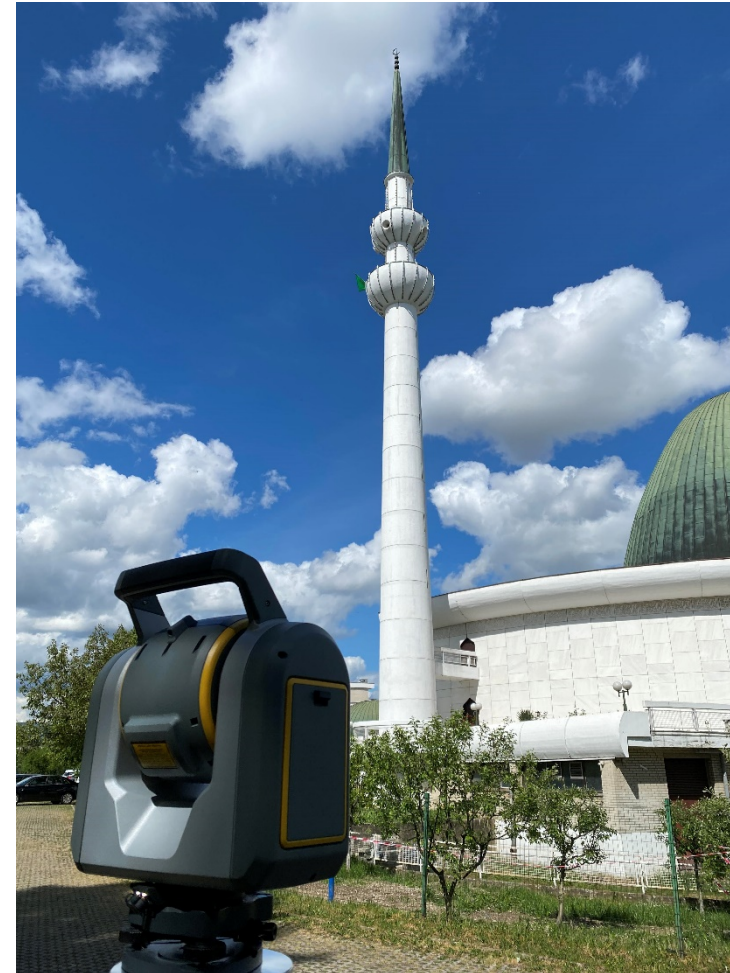
- method of forced centring
- orientation on the points with coordinates (directly overlapping of scans in software)
- standard mode of scanning - for whole surroundings
- super fine mode – for damage part of dome/rectangle
- the project consisted of two parts
  - laser scanning of the interior of the mosque  
(primarily referring to the upper part of the dome)
  - laser scanning of the exterior of the mosque

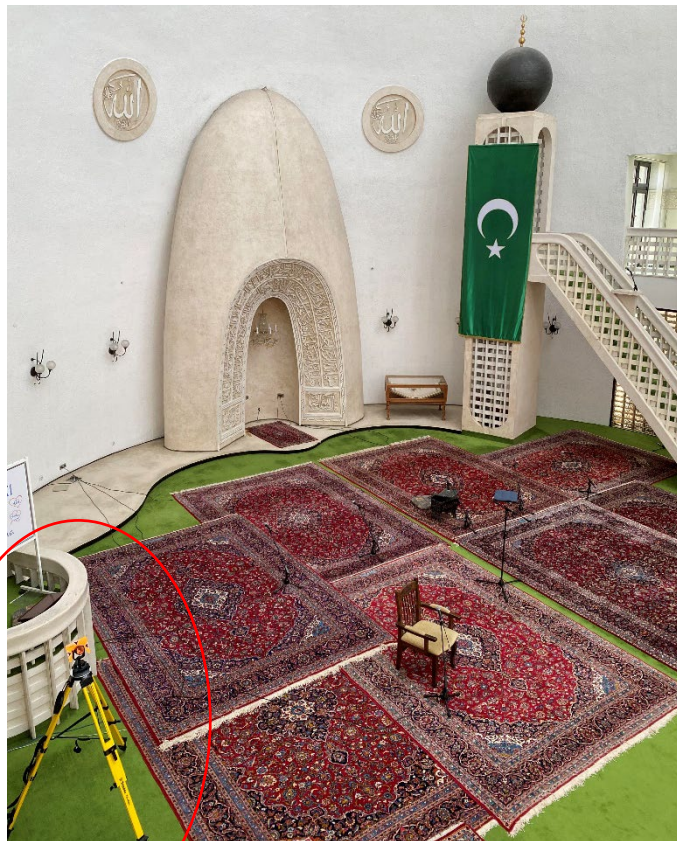
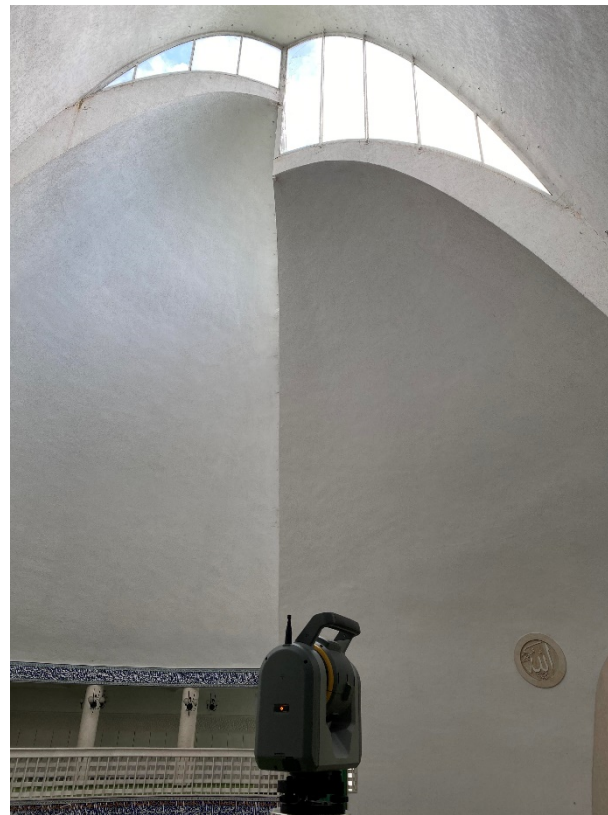
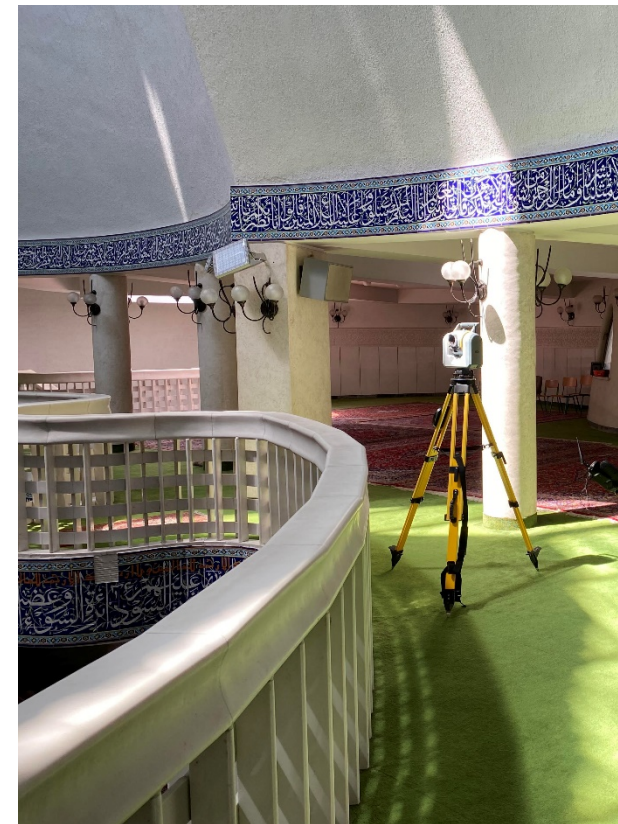
### ... Interior network

- network for scanning: inside 3 points & outside 4 points

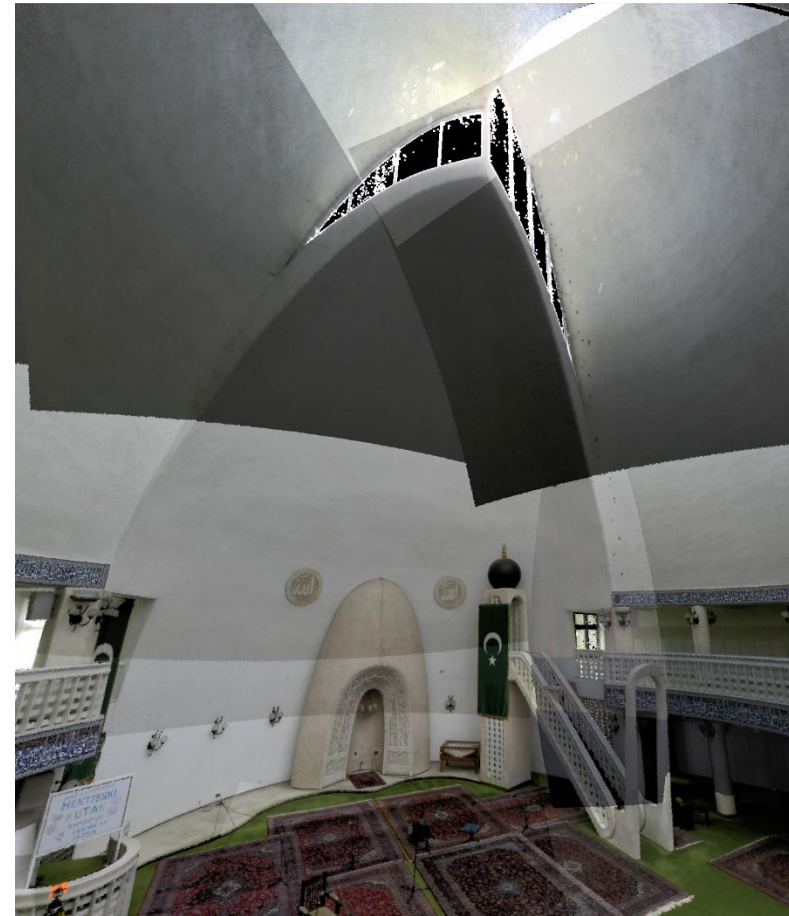
- the upper part of the dome was scanned separately
- during the measurement - strong light from the sun that illuminated the entire interior of the mosque
- we had interference when performing laser measurement but at the same time - we saw all the splendor of the design and architecture of the Zagreb mosque

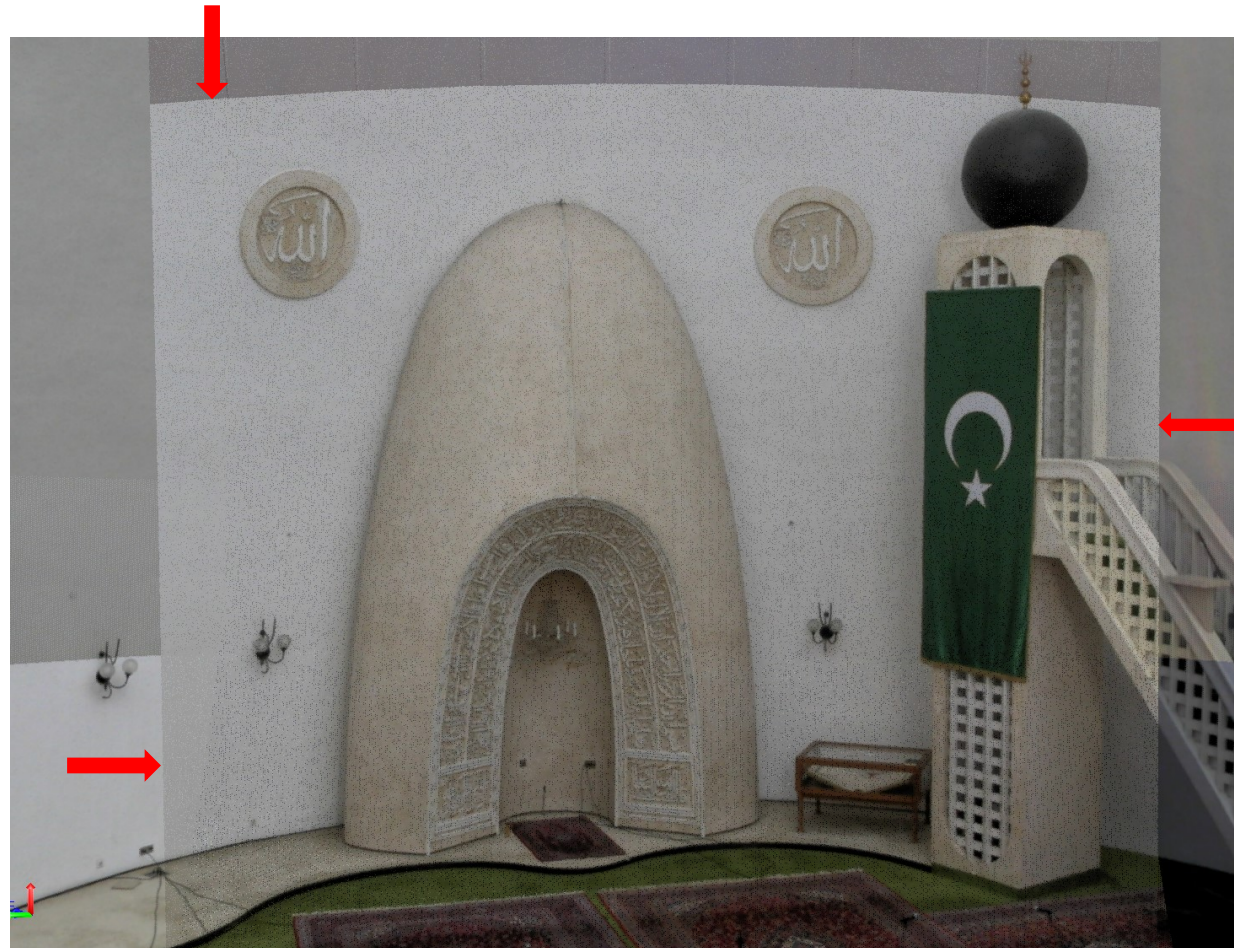
frame of scanning

- historical and cultural sights
- 3d view of the actual situation for:
  - ✓ future renovations
  - ✓ tourist promotions
  - ✓ cultural analysis
- ....
