SEISMIC PERFORMANCE OF EXISTING BRIDGES IN CROATIA:

*shortcomings, hidden reserves and seismic
assessment perspective*

Prof. Ana Mandić Ivanković
Chair for Bridges, Department of Structures, Faculty of Civil Engineering,
University of Zagreb

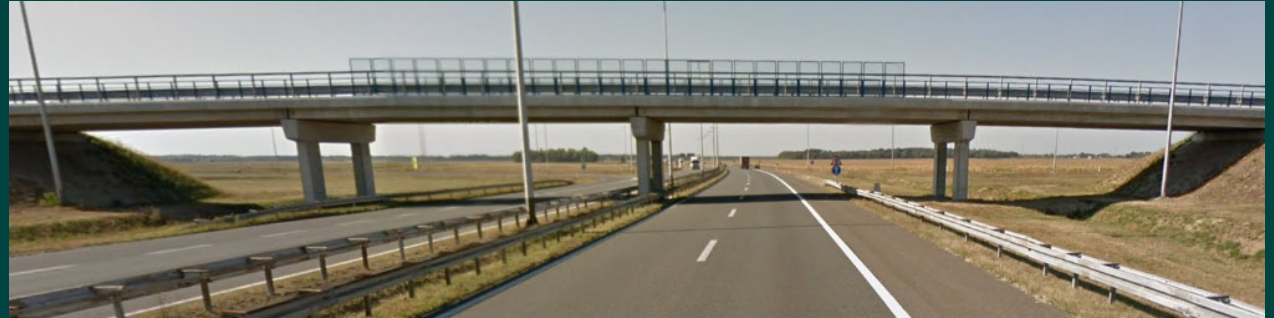
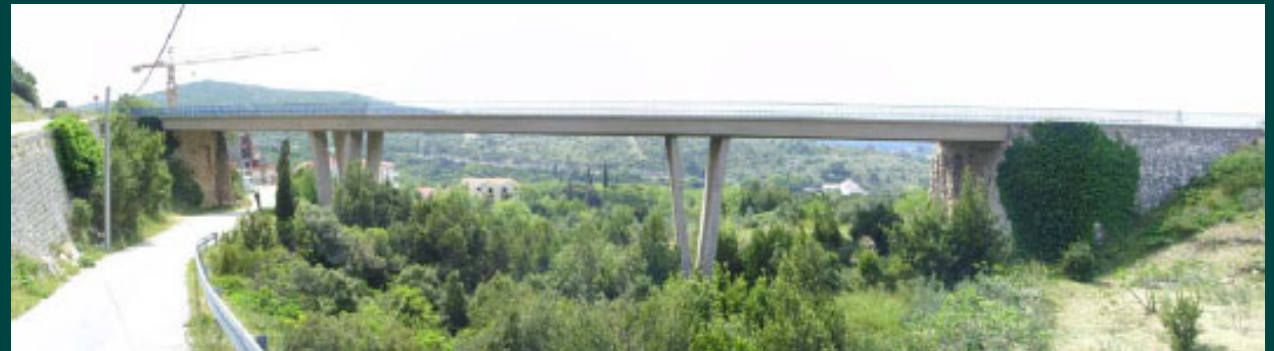
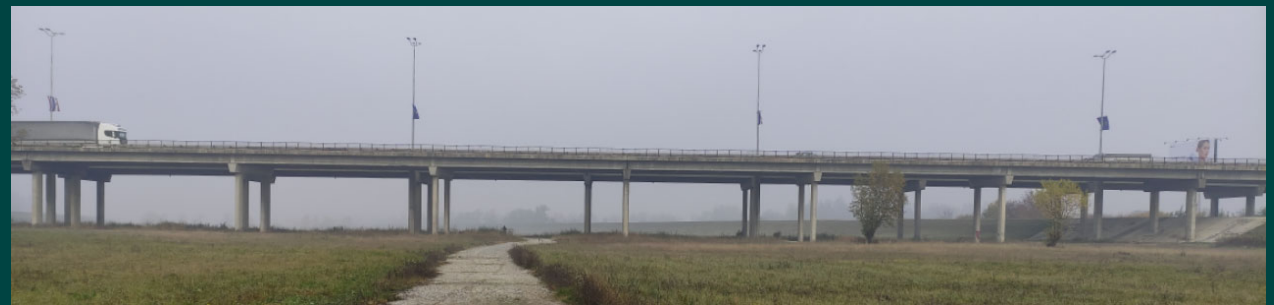
- Bridges in high seismicity area
 - peak ground acceleration
- Case study 1: Precast prestressed simply supported girder bridge
 - $a_g=0.3g$
 - built in 1980's
- Case study 2: Reinforced concrete frame bridge with V shaped piers
 - $a_g=0.29g$
 - built in 1963
- Case study 3: Set of six continuous grill type superstructures over three spans
 - $a_g=0.23g$
 - built in 1973

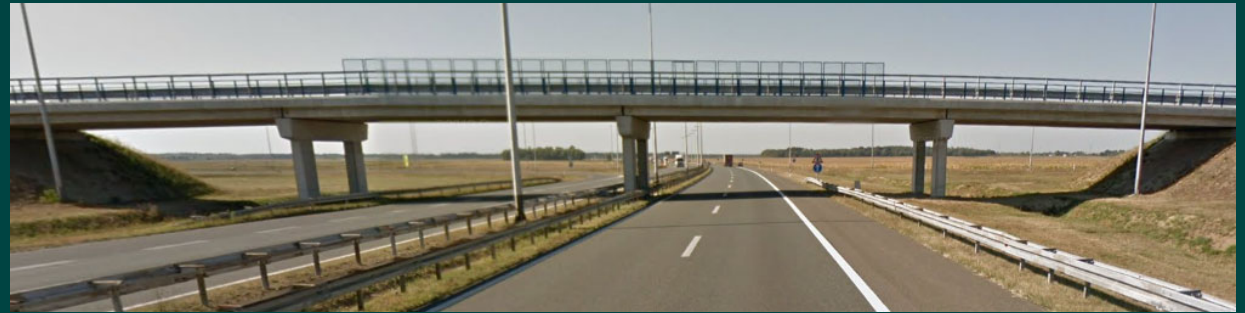
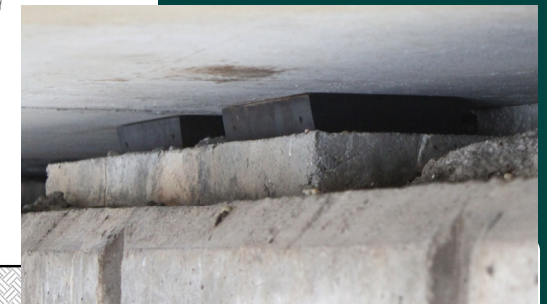
Case study 1: Precast prestressed simply supported girder bridge

- static system of each span is simply supported beam
- typical span of bridge is $L=19,9$ m
- cross-section of such bridges consisted only of precast girders, without in-situ concreted slab
- “SAN” type girders, utilized especially in overpasses and smaller bridges
- girders are supported by elastomeric bearings
 - 200*150*50 mm (type 1)
 - anchored neither to the superstructure nor to the substructure
 - maximum possible displacement due to earthquake - **70 mm** - reached at approx. $a_g = 0.25g$.
 - critical elements under seismic load

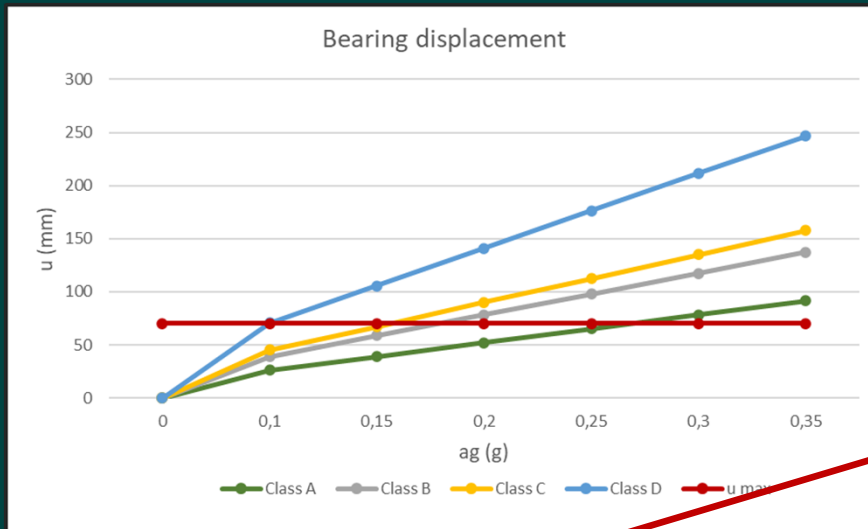
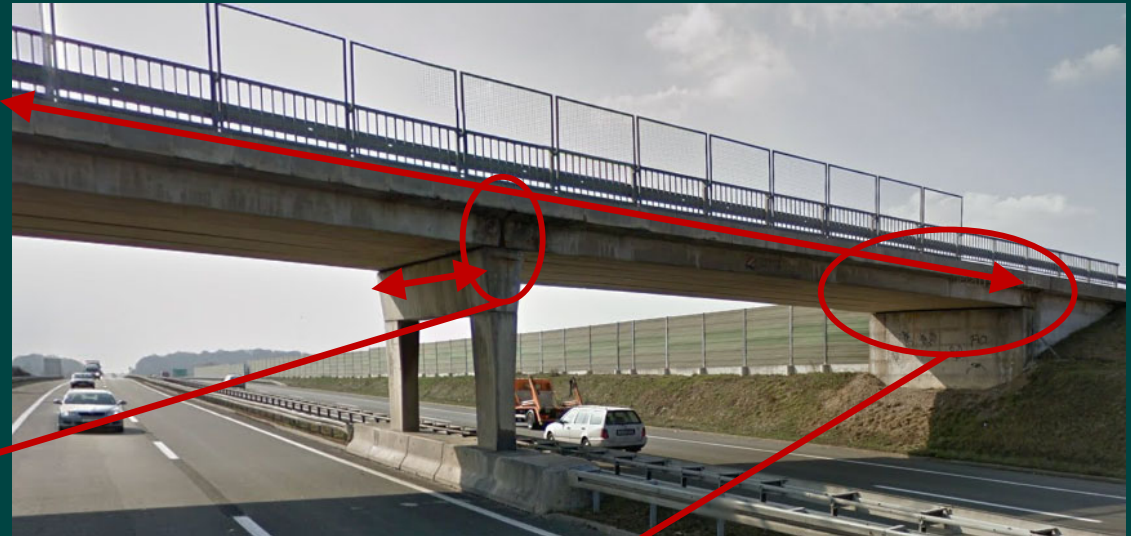
Case study 1: Precast prestressed simply supported girder bridge

- to gain insight into seismic response of such bridges, linear dynamic analysis – response spectrum method was performed
- analysis was made for different intensities of seismic action and for ground types A, B, C, D

in transverse direction, there are no elements limiting displacements of bridge deck, so that after breakage of bearings, large displacements may occur, depending on intensity of seismic action

in longitudinal direction - movement of superstructure is limited by abutment, and any displacement, larger than one allowed by the expansion joint, would result in bridge deck pounding into abutment wall, with probable damage to both, and with crushing of expansion joint device

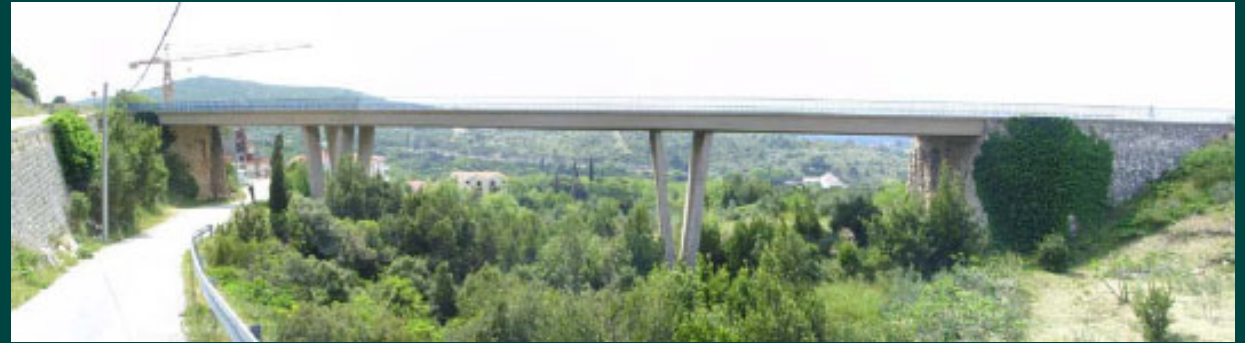
Case study 2: RC frame bridge with V shaped piers

- static system is a hinged strut frame bridge with longest span of 27 m

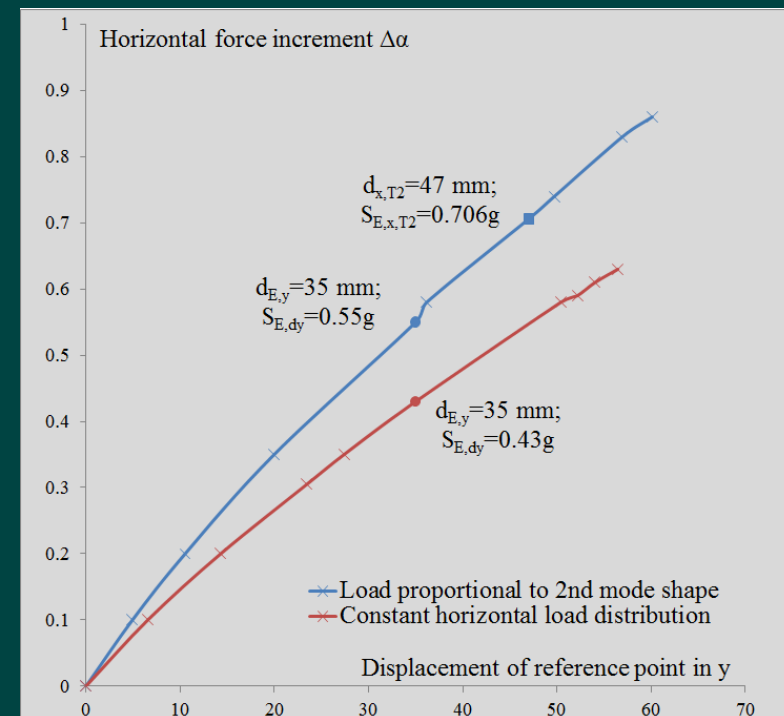
Case study 2: RC frame bridge with V shaped piers

- Nonlinear static pushover analysis - bridge structure was loaded with a horizontal load until target displacement of reference point was reached
 - target displacement - obtained from linear response spectrum analysis
 - pushover analysis was performed in both horizontal directions, longitudinal and transverse
 - force-displacement curve of the structure (“capacity curve”) - deformation requirements of the plastic hinges up to target displacement
- Displacements corresponding to the two dominant modal shapes T_1 and T_2 exceed the target displacements $d_{x,T1} > d_{Ex}$ and $d_{y,T1} > d_{Ey}$

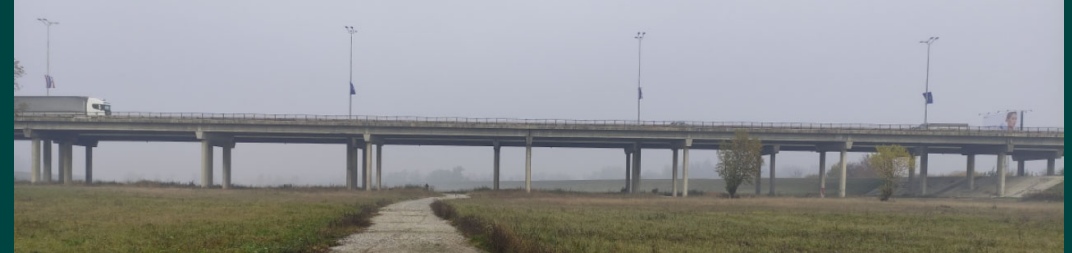
Case study 3: Set of 6 continuous superstructures over 3 spans

- $L_{tot} = 435,42 \text{ m}$
- Spans 24.5 m
- Expansion joints at 7 places

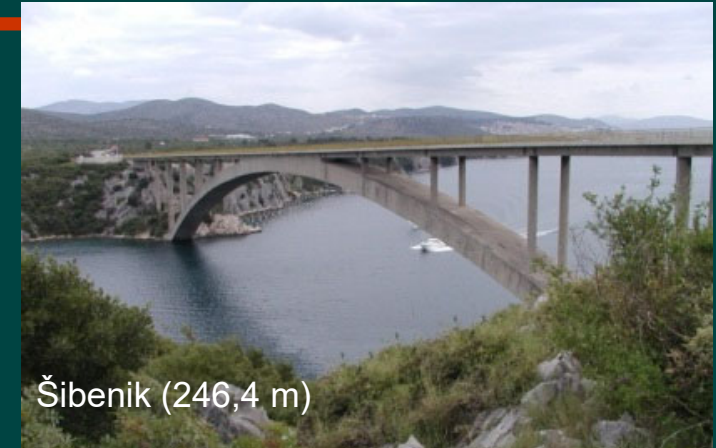
- RC arch bridges are particular owing to their robustness.
 - Performance of arches may be proved already at the 1st level
 - For spandrel columns (particularly short ones near the arch crown) it will be necessary to go through the 2nd level

- The dynamic specificity of arch bridges is the flexibility of an arch as support for spandrel columns, and the fact that a great amount of the bridge mass is generally located in the middle of the bridge.
- During inelastic response of arch bridge due to initial seismic stroke, the greatest deformation demands affect the shortest columns, which results in their excessive cracking and, finally, after a damage causing earthquake, in the need for their repair or retrofit.
- Upon the cracking of shortest columns and appurtenant stiffness reduction, deformation requirements are moved from the crown to coastal columns, which results in their degradation as well.
- That excessive cracking should be adequately taken into account with effective stiffness of column cross-sections using iterations procedure.

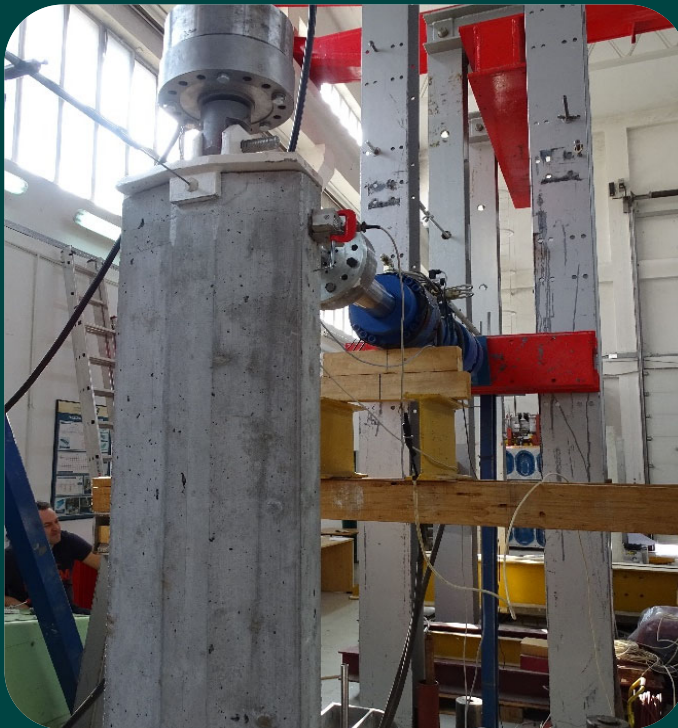
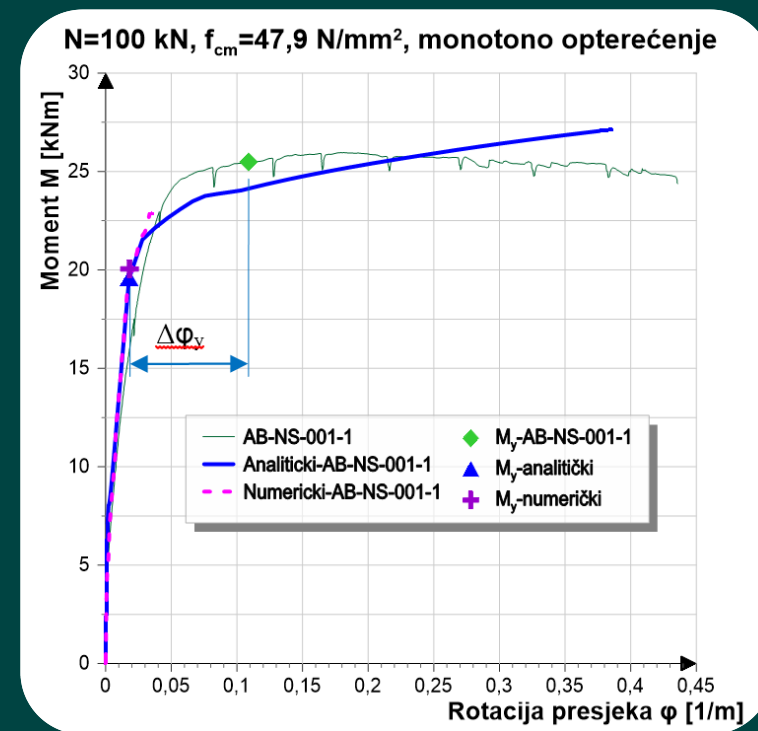
Revealing ductility levels

- ❑ Non standard sections, smooth reinforcement, no rules for ductile behaviour
- ❑ Seismic performance indicators:
 - M/ϕ diagrams - showing the rotational capability of plastic hinges
 - end section rotation and chord rotation capacity at the yielding point and at the ULS
 - plastic hinge length
- ❑ M/ϕ diagrams - analytical, experimental and numerical approach:
 - effect of the slippage of the smooth reinforcement causes larger section rotation up to the yield point but it gets smaller as we are approaching to the ULS
