## PETRINJA M6.2 EARTHQUAKE IN 2020 DAMAGED ALSO SOLID LINEAR INFRASTRUCTURE: ARE THERE SIMILAR ACTIVE FAULTS IN CROATIA?

Tvrtko Korbar<sup>1\*</sup>, Snježana Markušić<sup>2</sup>, Davor Stanko<sup>3</sup>, Davorin Penava<sup>4</sup>

### Abstract

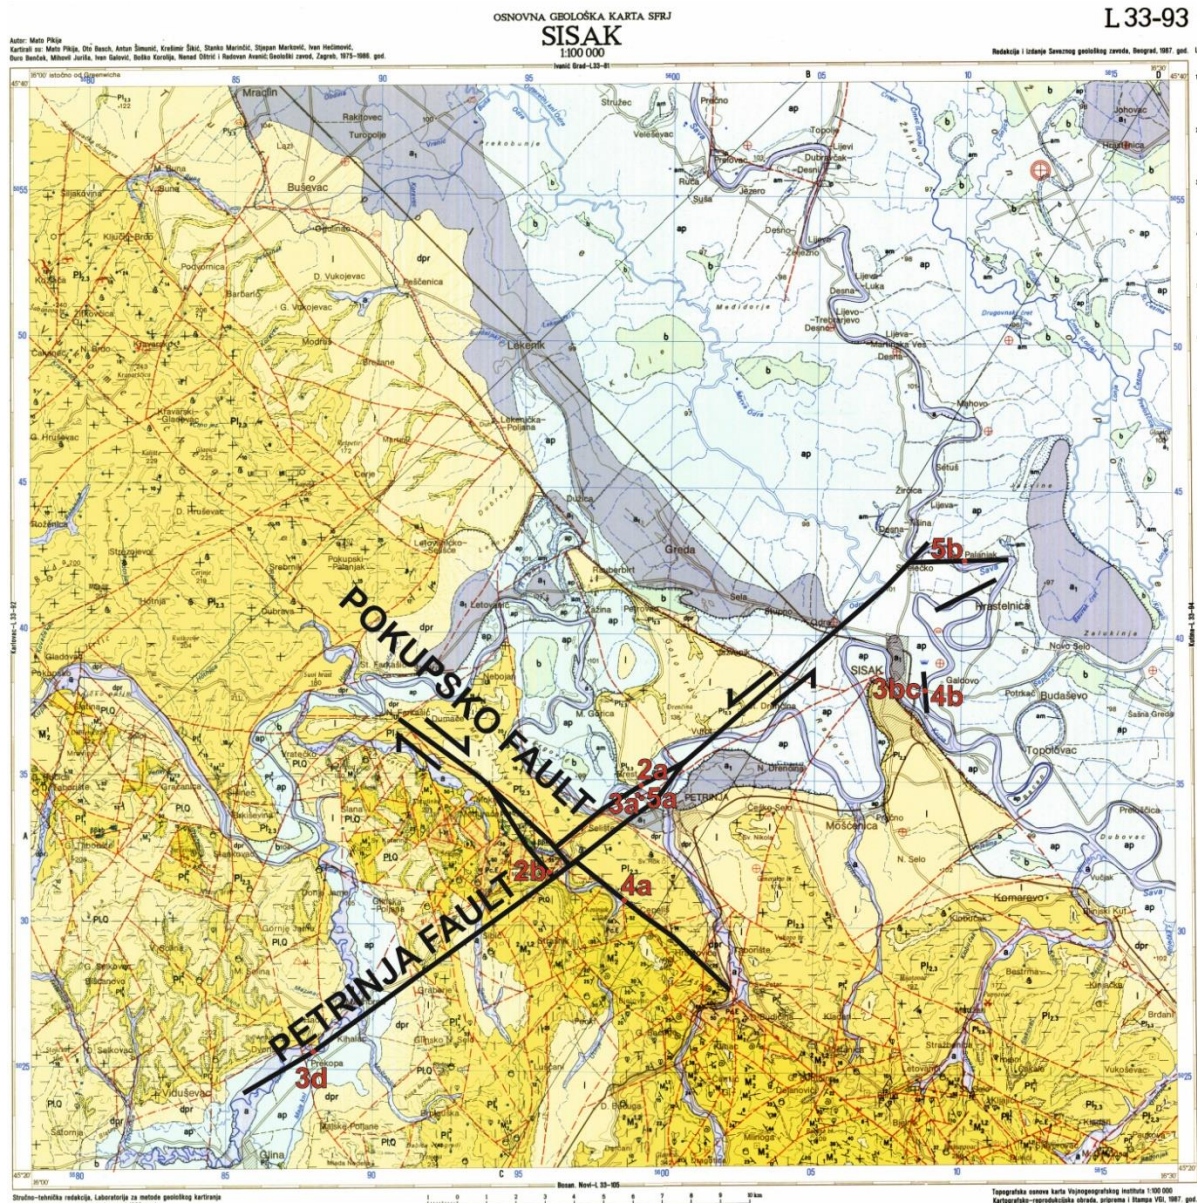
Based on the preliminary geological analyses, the M6.2 earthquake event was the result of the activation of complex fault systems; the intersection of two regional faults (longitudinal and transverse ones) to the strike of the Dinarides that were probably inherited since the formation of the fold-and-thrust belt [1, 2]. Both fault systems consist of multiple faults with horizontal (strike-slip) block movements. Beside the main activated faults (Figure 1), there were other conjugated faults that caused

Figure 1. a) Geological map [3] showing the main activated faults (thick black lines) during the Petrinja 2020 sequence [1]. Red dots and numbers mark locations of the other figures.
