Geotechnical Study of Raspadalica Cliff Rockfall, Croatia

Abstract: The Raspadalica Cliff is an almost vertical 100 m high limestone cliff with a railway line at its foot and is known for numerous rockfall occurrences in the past. This article presents the results of the geotechnical study of the cliff based on a traditional geological and geotechnical field survey and remote sensing analysis. Both the traditional geological and geotechnical field survey and remote sensing surveys and analyses enabled the establishment of the structural model of the Raspadalica Cliff and the determination of the discontinuity sets and discontinuity features, such as orientation, spacing, persistence, roughness, discontinuity wall strength, aperture, degree of weathering of discontinuity wall, seepage conditions, and the presence and hardness of discontinuity filling. Kinematic analyses were performed on five cliff zones with slightly different structural features, indicating a relatively low probability of typical failures in the cliff rock mass that precede the rockfall occurrences. Although rockfall phenomena from the cliff face are relatively frequent, the kinematic analyses did not indicate a

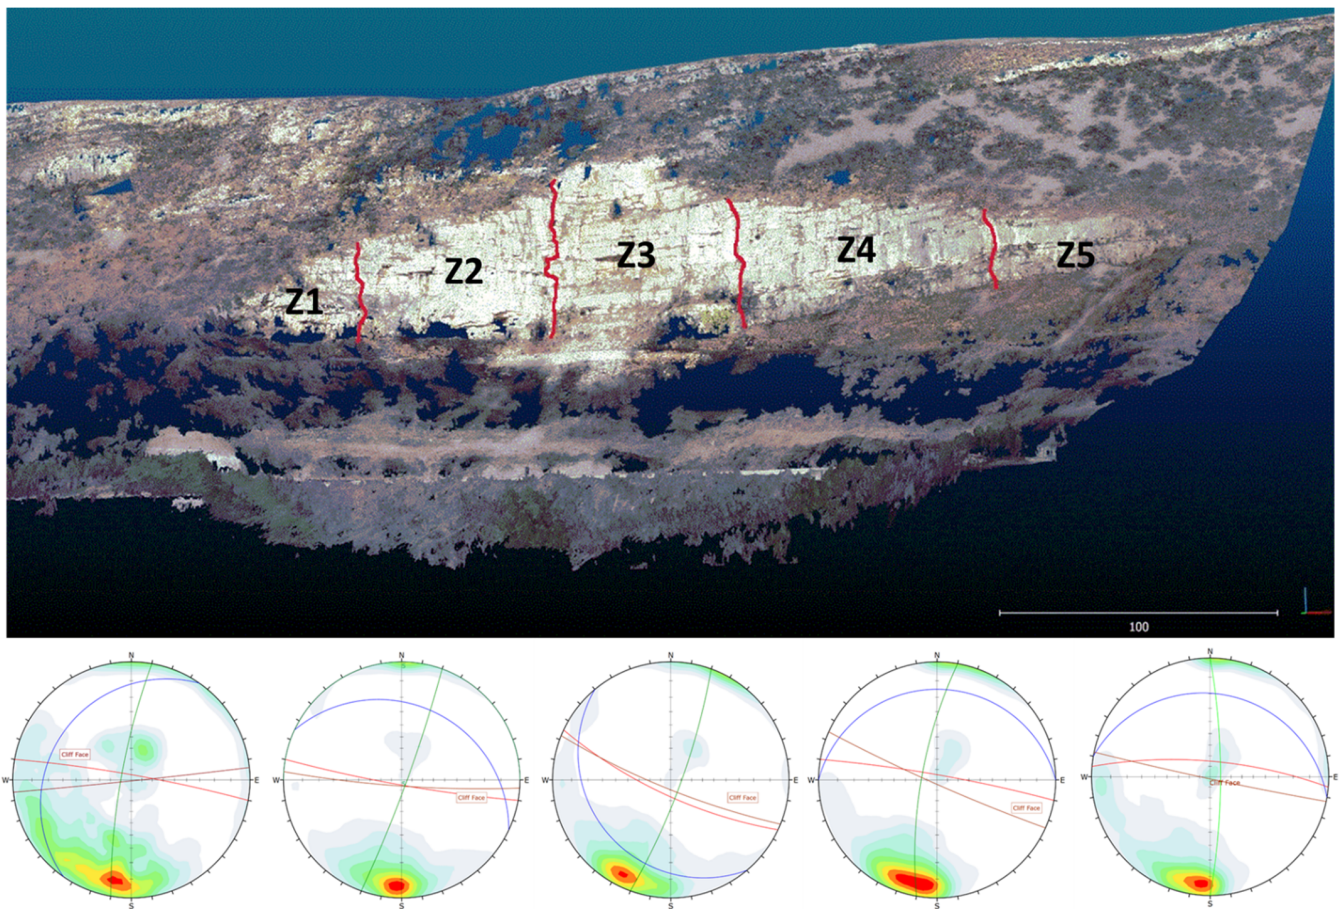
The *Cloud Compare* software [92] was employed to identify discontinuity sets and their dips and dip orientations. The cliff face was divided into five zones (Figure 7), and for each segmented zone extraction of joint planes and bedding using the *Cloud Compare Facet* plugin [45,63] (Fast Marching procedure) was completed to identify their orientations (dip directions and dips). An equal area projection was used in the presentations of the joint data. Since most of the discontinuity planes belong to the joint set that is quasi-parallel to the cliff face (Joint Set 1), and the other two are nearly perpendicular and rarely exposed the joint sets (Joint Set 2 and bedding) could not be clearly recognized using the *Facet* plugin, the *Cloud Compare Compass* plugin [92] was employed to measure the joint surface orientations of the main joint sets (Figure 9).

Figure 7. The 3D HR Point Cloud of the Raspadalica Cliff divided into five zones. For each zone the stereograph presentation of the main discontinuity sets (mean value) and orientation of the average cliff slope is presented. The concentration of plane poles quasi-parallel to cliff face is visible on each stereogram (from white (cold) with no or several poles to (hot) with high concentration of poles). Red is transversal of the average cliff face, other represent transversals of joint sets.

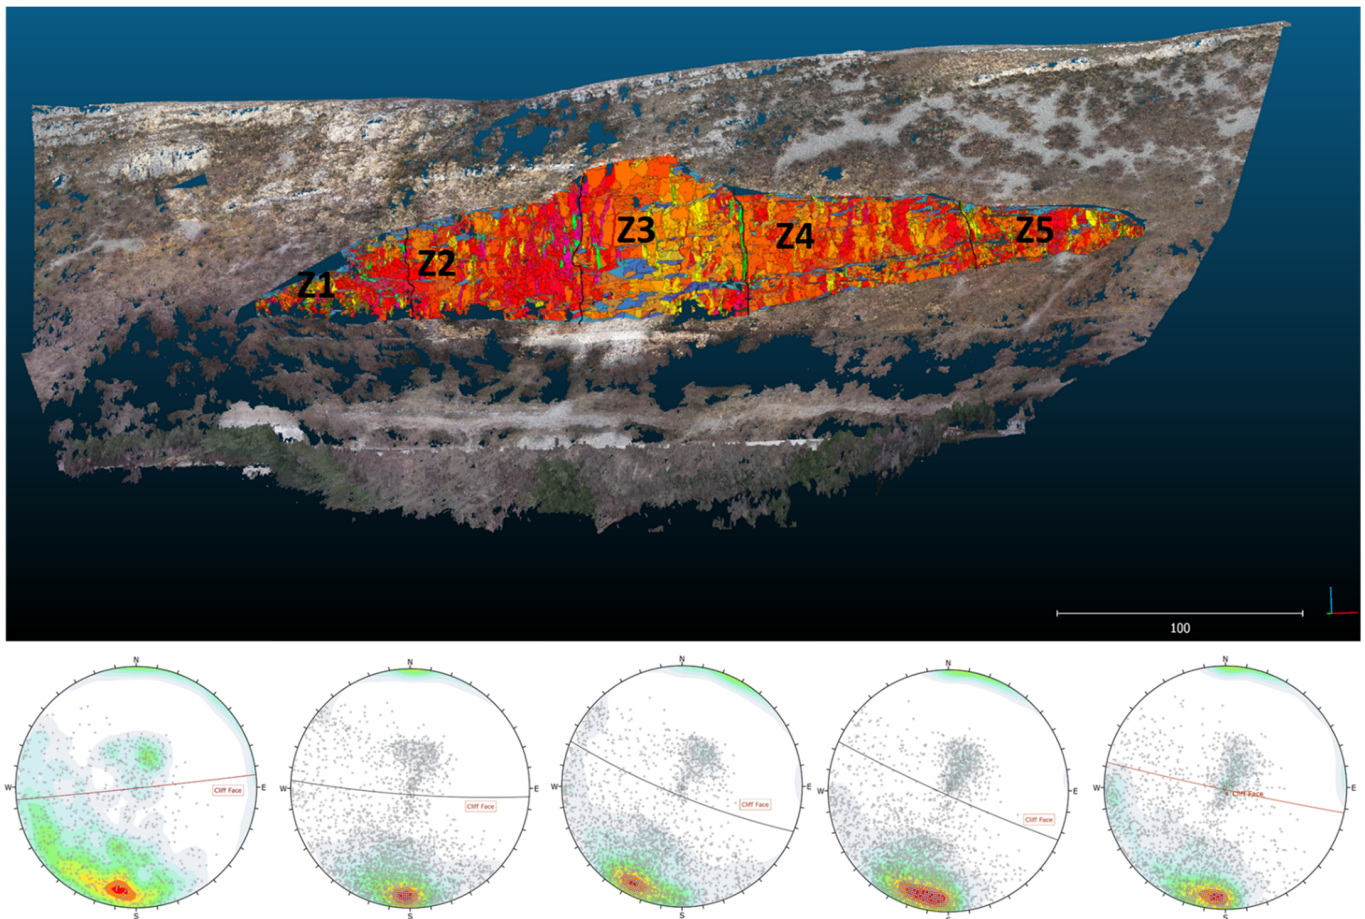
Figure 9. Three-dimensional HR Point Cloud of the Raspadalica Cliff with extracted facets using the *Cloud Compare Facet* plugin [43,61] (Fast Marching procedure). Orange and red to cyan facets represent Joint Set 1, parallel with the cliff face; green to yellow facets represent Joint Set 2, almost orthogonal to Joint Set 1; and blue facets represent Joint Set 3 (bedding).
