Rockfall analyses and rockfall protection at the Raspadalica Rockfall, Croatia

Željko Arbanas

ABSTRACT: The Raspadalica rockfall is well known location with numerous rockfall occurrences from 100 m high limestone cliff in the past that caused significant damages and victims at the railway Buzet - Pula in Istria, Croatia. Structural and kinematic analysis of possible future rockfall were carried out following the modern approaches and recent techniques in rockfall hazard analysis. Modern approaches include application of remote-sensing techniques enabled to ensure digital terrain models (DTM) from three-dimensional high-resolution point cloud (3D HRPC) of the cliff surface; engineering geological mapping using combination of remote-sensing techniques and field mapping. In this paper the methods and results of field and remote sensing investigation of the cliff structural and kinematic analysis results, identification of rockfall sources, as well as analysis of necessary protection measures and their positions at the slope above the railway route.

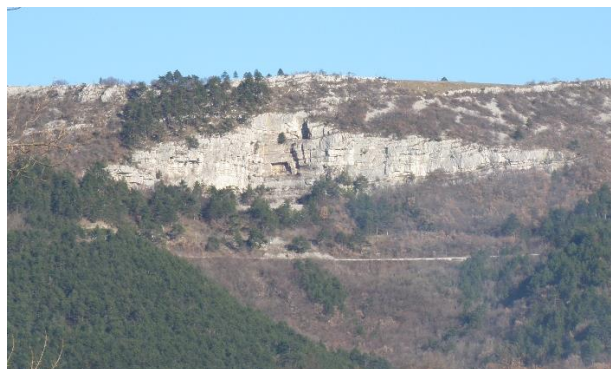
The Raspadalica Cliff is an almost vertical 100 m high limestone slope (Figure 1) situated at the contact of two geomorphological units, namely the hilly Paleogene Flysch Basin and the elevated Čičarija Mountain Range in the northern part of the Istrian Peninsula, Croatia (Arbanas et al., 2006). The Raspadalica wider location is well known by numerous instabilities occurred as rockfalls from the Raspadalica Cliff and landslides (Dugonjić Jovančević and Arbanas, 2012) already caused significant damage at the railway route situated at the flysch slope in the foot of the cliff.

Figure 1. A view at the Raspadalica Cliff, Istria Peninsula, Croatia.

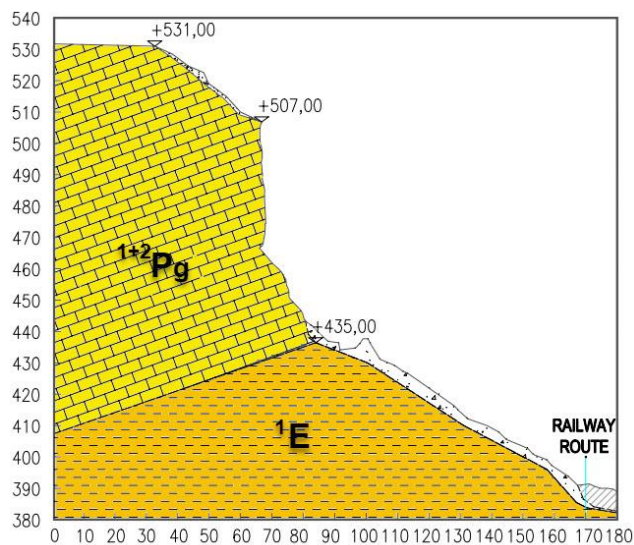
Raspadalica Cliff is a part of the Čičarija Mountain Range built of Paleogene limestone and the contact of the limestone rock mass of the cliff and the flysch complex in the lower part of the slope is characterized by reverse fault at the dip of approximately 23 degrees (Figure 3). The limestone mass is homogeneous, fine-grained and well stratified. The thickness of beds ranges from 10 centimeter to 2 meters with several interlayers of coal several centimeter thick. The general dip of the bedding planes is relatively favorable and inclined into the slope with minor variations along the cliff. Detailed description of the structural model of the cliff is described in the following chapters.

Figure 3. Schematic engineering geological cross-section of Raspadalica Cliff (Udovič et al., 2021). Overthrust limestone Paleogene rock mass ($1+2Pg$) lies on Eocene flysch deposits ($1E$). The flysch deposits are covered with talus material originated from limestone cliff.

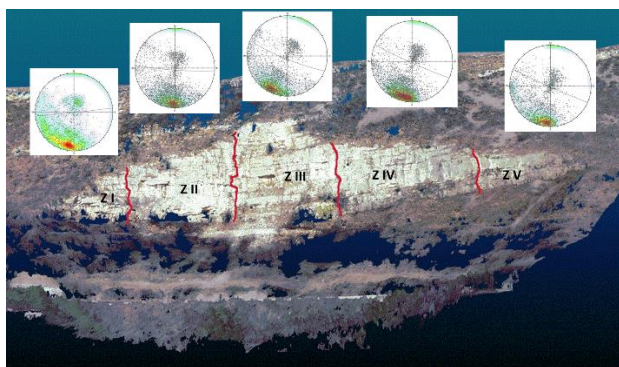
The structural model of the Raspadalica Cliff is established based on both traditional geological and geotechnical field survey and remote sensing analysis. Detailed analyses of field survey and remote sensing data pointed to five slightly different zones, but because of their properties and rock block standings according to the general orientation and dip of cliff face. These zones (Zone I to V) are presented at the 3D HRPC (Figure 5) while the borders that separate zones are determined analyzing changes in orientation and dips of the main joint sets as well as changes in rock block volumes (Udovič et al., 2021).

Figure 4. Point cloud of the Raspadalica Cliff with different zones and stereonet plots for each zone.
