Characterization of materials used for earth architecture in Eastern Croatia

A Perić¹

¹ Teaching and research assistant, Department of Materials and Structures, Faculty of Civil Engineering and Architecture Osijek, Vladimira Preloga 3, 31 000 Osijek, Croatia

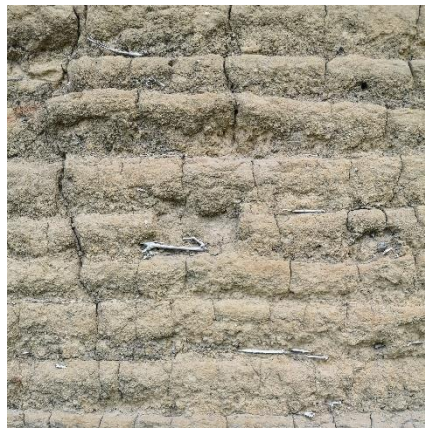
Earth buildings can be built using different techniques, such as adobe, rammed earth, cob and more. Authors conducted field research and found numerous rammed earth constructions and their high occurrence in Eastern Croatia was also confirmed by Lončar-Vicković and Stober [1] and Živković [2]. For that reason, scope of this research are constructions built using rammed earth technique. Traditionally, rammed earth wall is built by pouring earth mixture between formwork and ramming it using wooden rammer [1]. However, today wooden rammers are usually replaced by pneumatic rammers [12]. After ramming, thickness of a layer usually decreases from about 15 cm to about 10 cm [12]. Process is repeated until desired height of the wall is reached. Layers are distinguished on face of the finished wall, as shown in Figure 1.

Figure 1. Visible layers on face of the RE wall (author's archive).

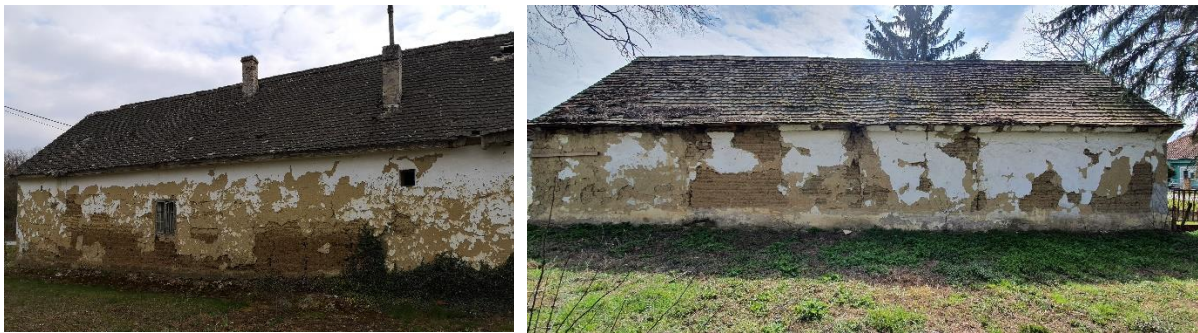
The aim of this research is to learn more about the behaviour of earthen material in construction. For that purpose, authors conducted field research and visited still existing rammed earth houses and outbuildings in Eastern Croatia (Figure 2). Several buildings have been measured in detail, examined, and photographed, and material samples were collected from walls of houses for characterization.

Figure 2. Rammed earth houses in Eastern Croatia (author's archive).

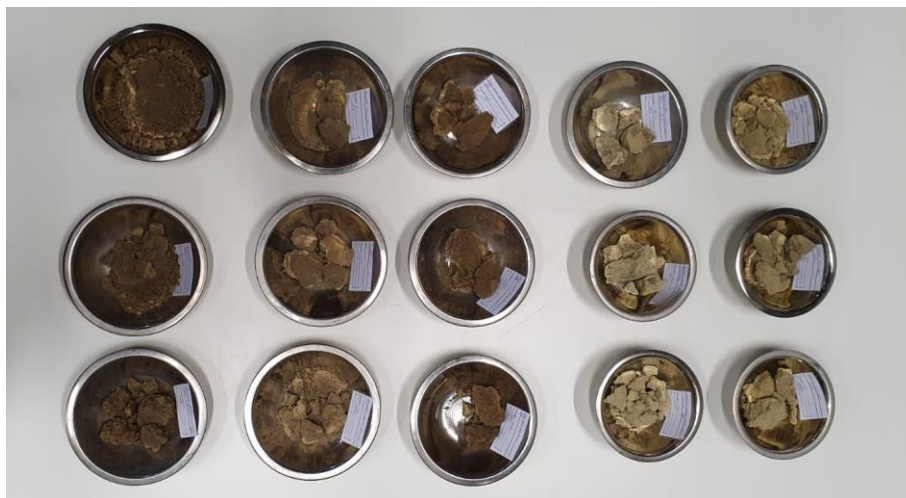
Immediately after collecting material, moisture content of in-situ material was tested according to BS 1377: Part 2 : 1990 (Figure 3). Moisture (Table 1) ranged from 2.43 to 6,65 %, with average value of 4.38 %. Differences in moisture content between the five specimens can be explained by taking material from different locations in Eastern Croatia area. Furthermore, the specimens were taken from different heights on the wall, varying from 0.3 m to about 1.5 m from the ground. It should also be noted that some walls were exposed to direct sunlight, while others were shaded by vegetation.

Figure 3. Samples for determining moisture content.

Since compressive strength testing was performed approximately one month after collection of samples, moisture content decreased for about 20 %, as seen in Table 1. In time of compressive strength testing, moisture content ranged from 1.95 to 5.59 %, with average value 3.48 %. In Table XY, w_0 refers to moisture determined on the same day when the samples were collected from the field, while w_f refers to moisture determined on the day when the compressive strength was determined.

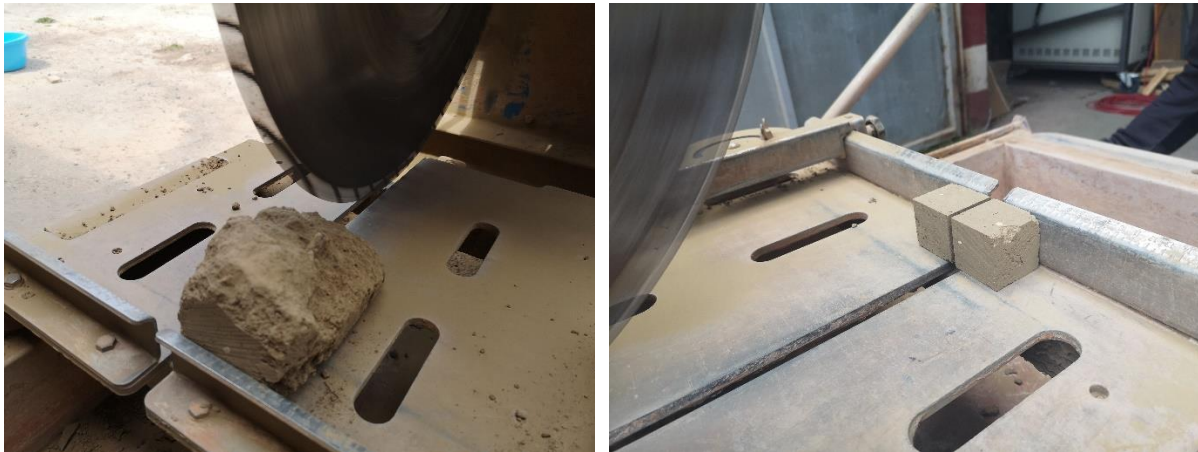
Big chunks of earthen material were cut into cubes with side length of approximately 4 cm, using circular saw (Figure 4). From every sample, between two and six cubes were cut, depending on size and shape of the chunk. Compressive test (Figure 5) was conducted using Shimatzu AG-X plus 50 kN testing machine, with stress control 0.01 MPa/s. Values ranged from 1.22 to 3.32 MPa, with average value of 2 MPa.

Figure 4. Cutting earth chunks into cubes for testing compressive strength.

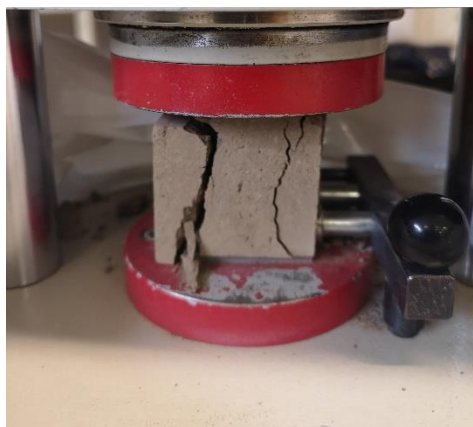
Figure 5. Testing compressive strength.

Specimen	Number of specimens tested	f_c (MPa)
A2	2	1.37
B4	2	2.22
B5	3	1.22
A7	6	3.32
A8	5	1.88
