UNIVERSITY OF RIJEKA  
FACULTY OF MARITIME STUDIES

**DURABILITY MODELING AND ANALYSIS  
OF COMPOSITE STRUCTURES EXPOSED  
TO THE MARINE ENVIRONMENT**

DOCTORAL DISSERTATION

Rijeka, 2022.

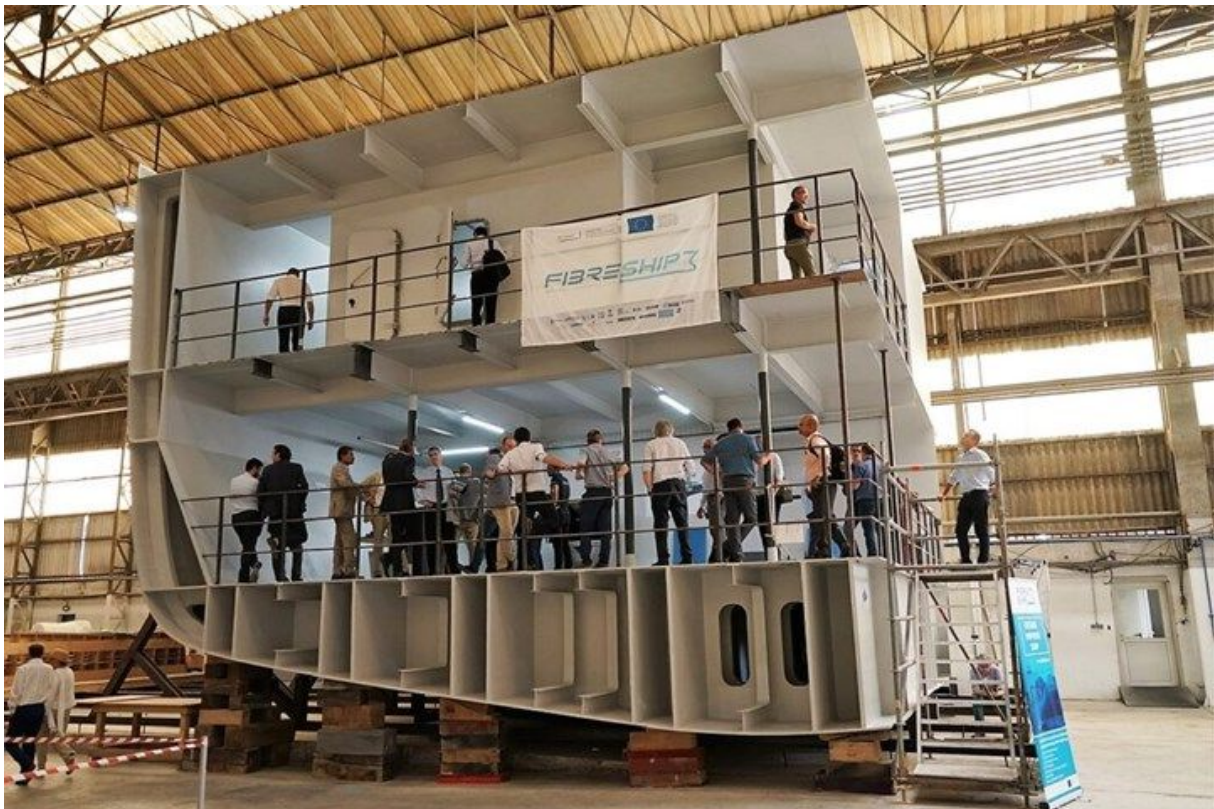
Figure I.1 Composite ship hull section (source: <http://www.fibreship.eu/fibreship-2nd-public-workshop/>)

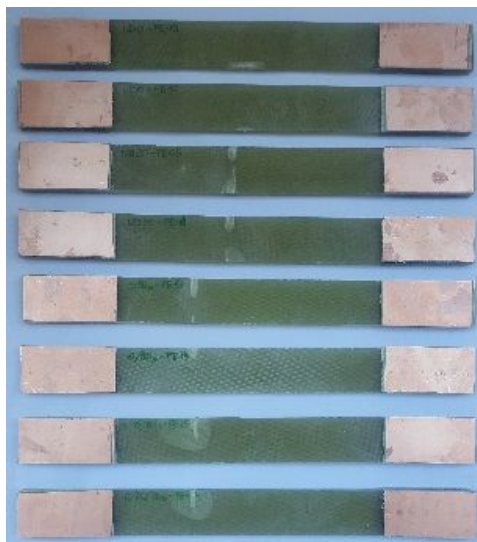
Vacuum assisted infusion process was used for the epoxy/glass coupons and hand layup process was used for the polyester/glass coupons. Reinforcement tabs, made of printed circuit board cutouts and glued at the coupon ends before the tensile test minimized the influence of the tensile test machine's grips pressure on the test results (Belingardi et al., 2011). The size of the tabs was chosen based on ISO 527-4 recommendations.

Figure I.4 Coupons with tabs before submersion

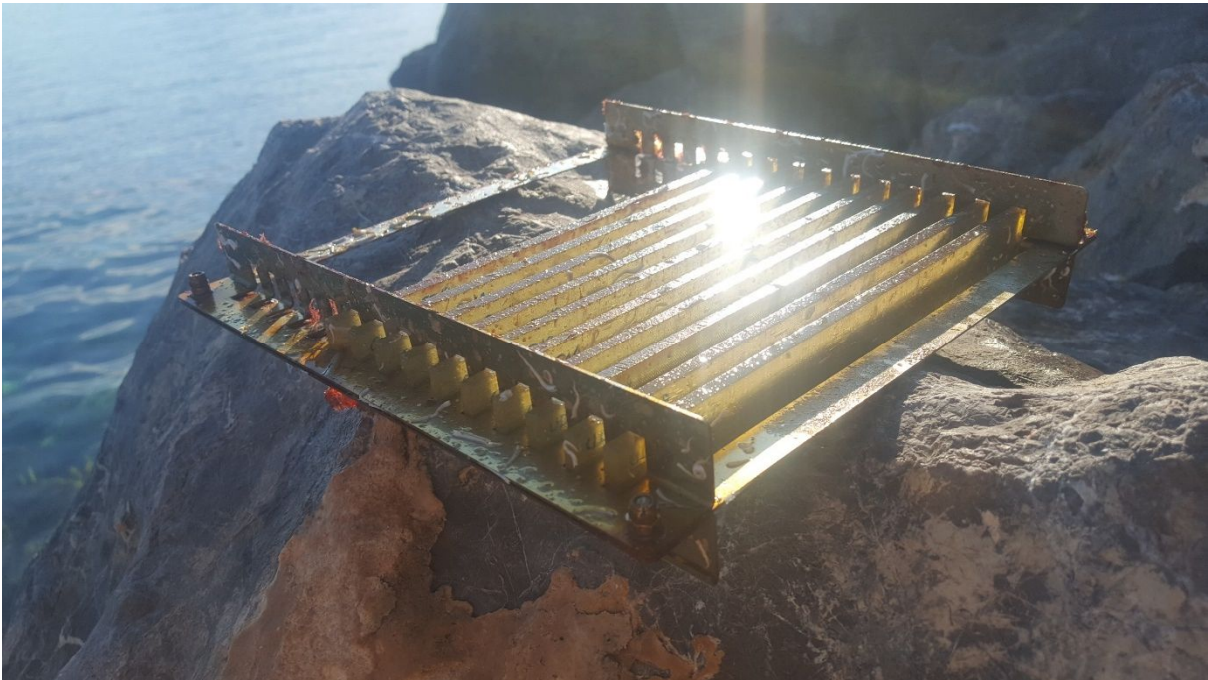
Figure I.6 Coupons in frame after 6 months of submersion

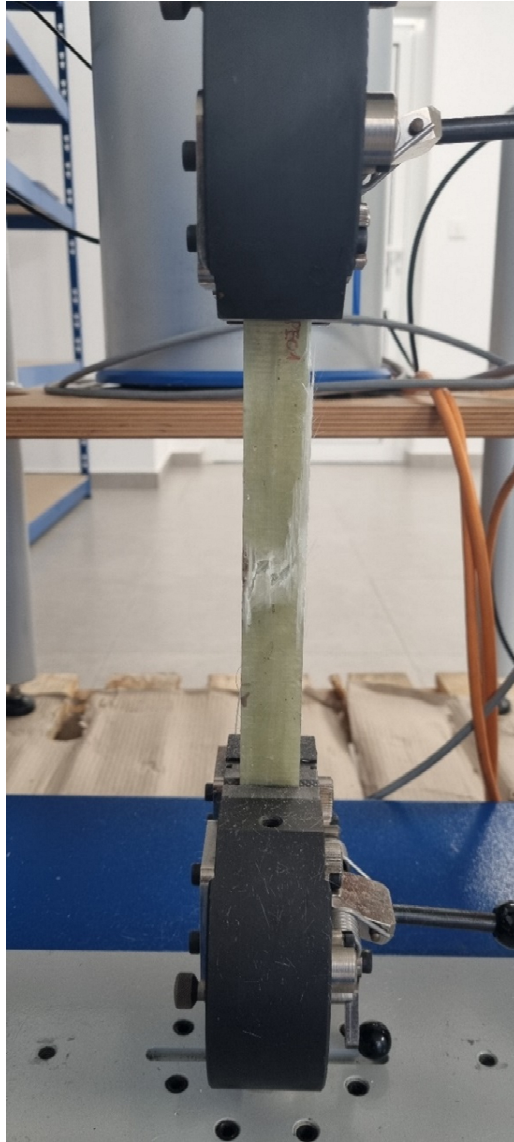
Tensile tests done on all coupons on the same testing machine (Zwick 400 kN universal testing machine coupled with a BTS Exmacro-H02 macro extensometer, Figure I.7) are instrumental in the determination of changes in the ultimate tensile strength (UTS) for the coupons exposed to the sea environment compared to the reference values of the dry coupons.

Figure I.7 Coupon on completion of the tensile test

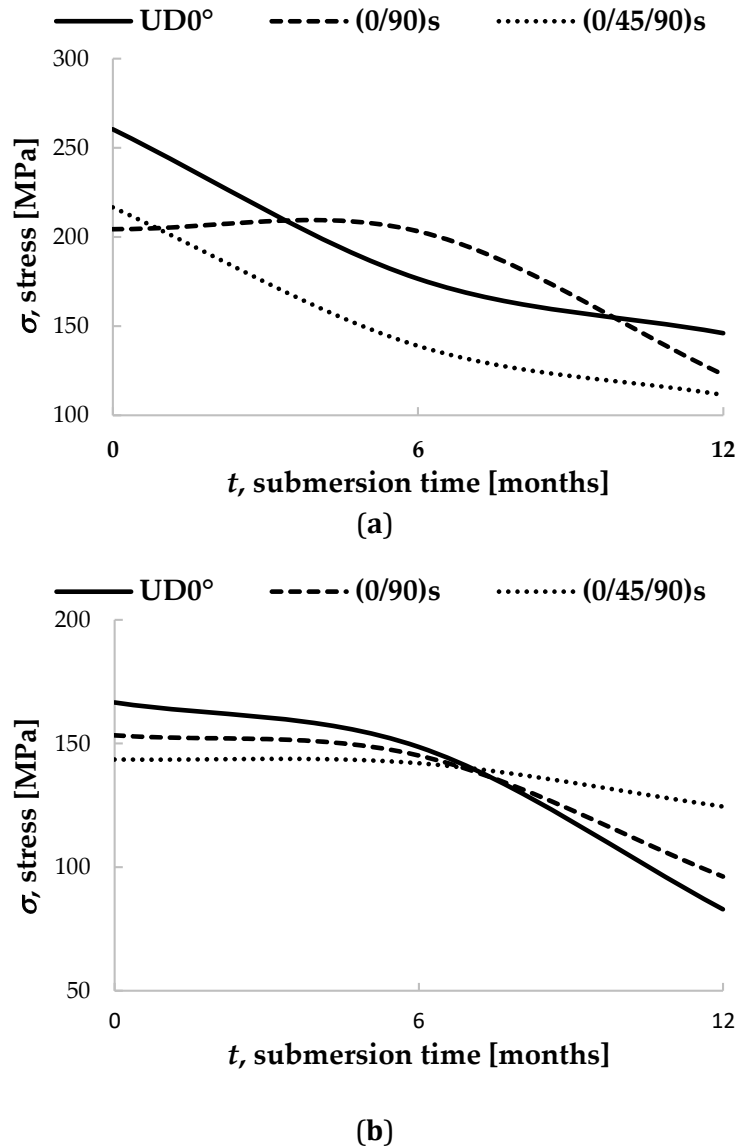
The change in tensile strength due to the prolonged submersion in seawater is shown, Figures 13 and 14.

**Figure 13.** Average tensile strength degradation: (a) epoxy resin coupons; (b) polyester resin coupons

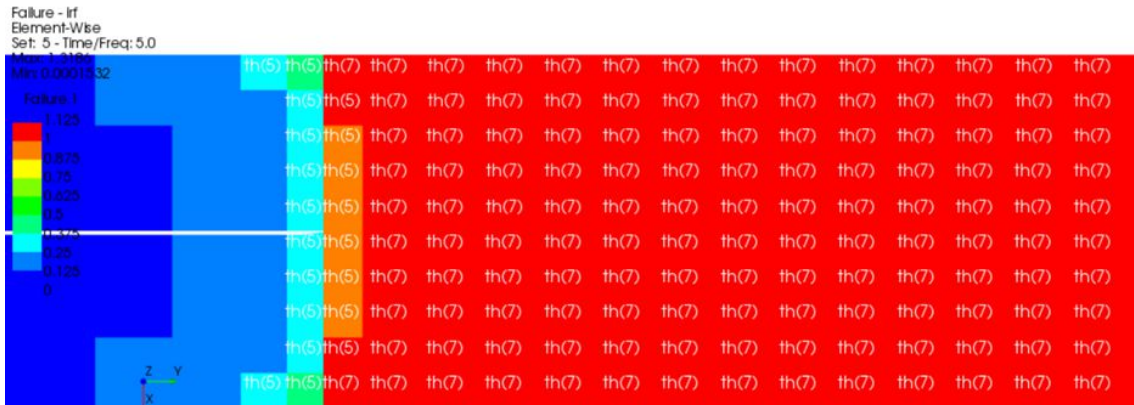
Figure 10 shows the stress distribution through the coupon for the (0/45/90)s fiber layout configuration.

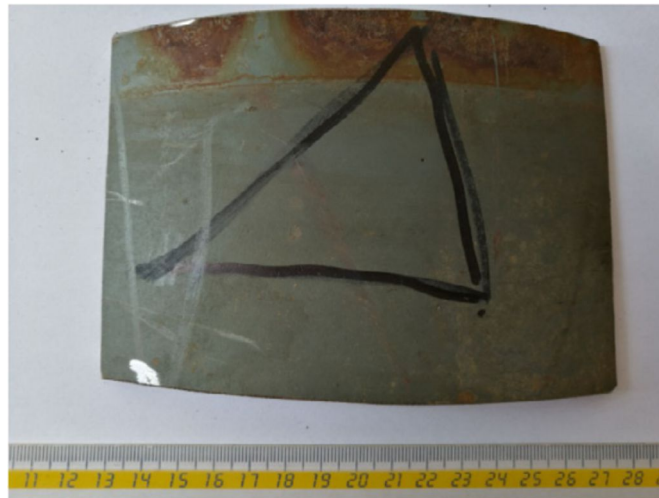
Fig. 4. Cut-out specimen containing crack used to perform microscopic examination.

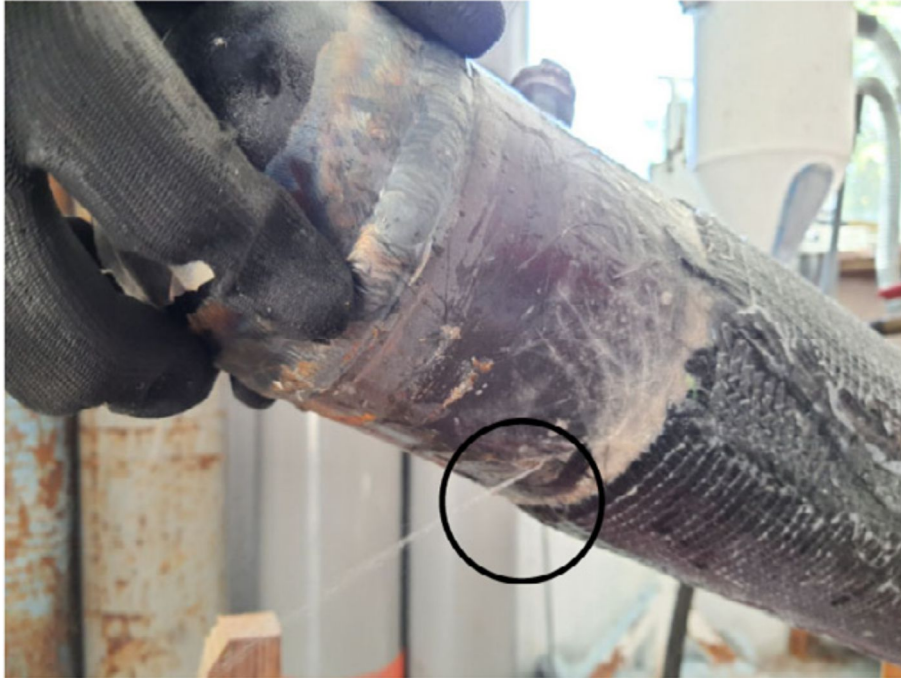
Fig. 21. Detail of the test fluid bursting on the edge of the composite patch.
