Article

Modelling Cover-Collapse Sinkholes That Appeared after the M6.2 Petrinja Earthquake in Croatia Using Electrical Resistivity Tomography Data

Citation: Šumanovac, F.; Pekaš, Z. Modelling Cover-Collapse Sinkholes that Appeared after the M6.2 Petrinja Earthquake in Croatia Using Electrical Resistivity Tomography Data. *Sustainability* **2023**, *15*, 1124. <https://doi.org/10.3390/su15021124>

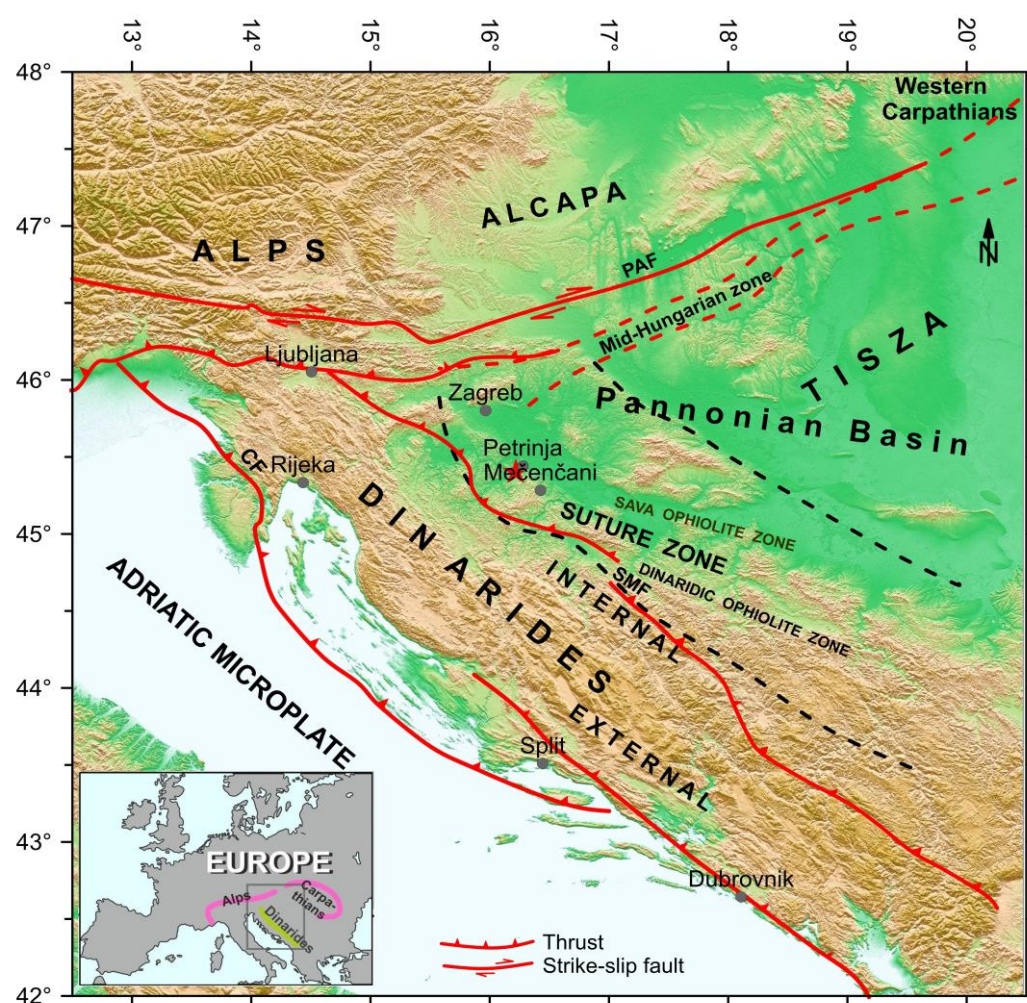
Figure 1. Topographic and tectonic map of the Pannonian-Dinaridic region with the border area of the Alcapa (Alpine-Carpathian tectonic unit). The epicenter of the Petrinja earthquake is shown as a red star, and the survey area is the villages of Mečenčani and Borojevići. The main tectonic units and faults are superimposed on the topographic map (PAF: Periadriatic fault; CF: Ćićarija fault; SMF: South marginal fault of the Pannonian basin). The borders of the suture zone (dashed black line) after [4].

The area under investigation is located on a plain and slightly hilly area in the valley of the Sunja River, surrounded by smaller hills (Figure 1). It is located 25 km southeast of Petrinja and 85 km southeast of Zagreb. The epicentre of the main earthquake is located 3 km southeast of Petrinja (45.4002° N and 16.2187° E). The survey area, the villages of Mečenčani and Borojevići, are located approximately 20 km southeast of the epicentre region.

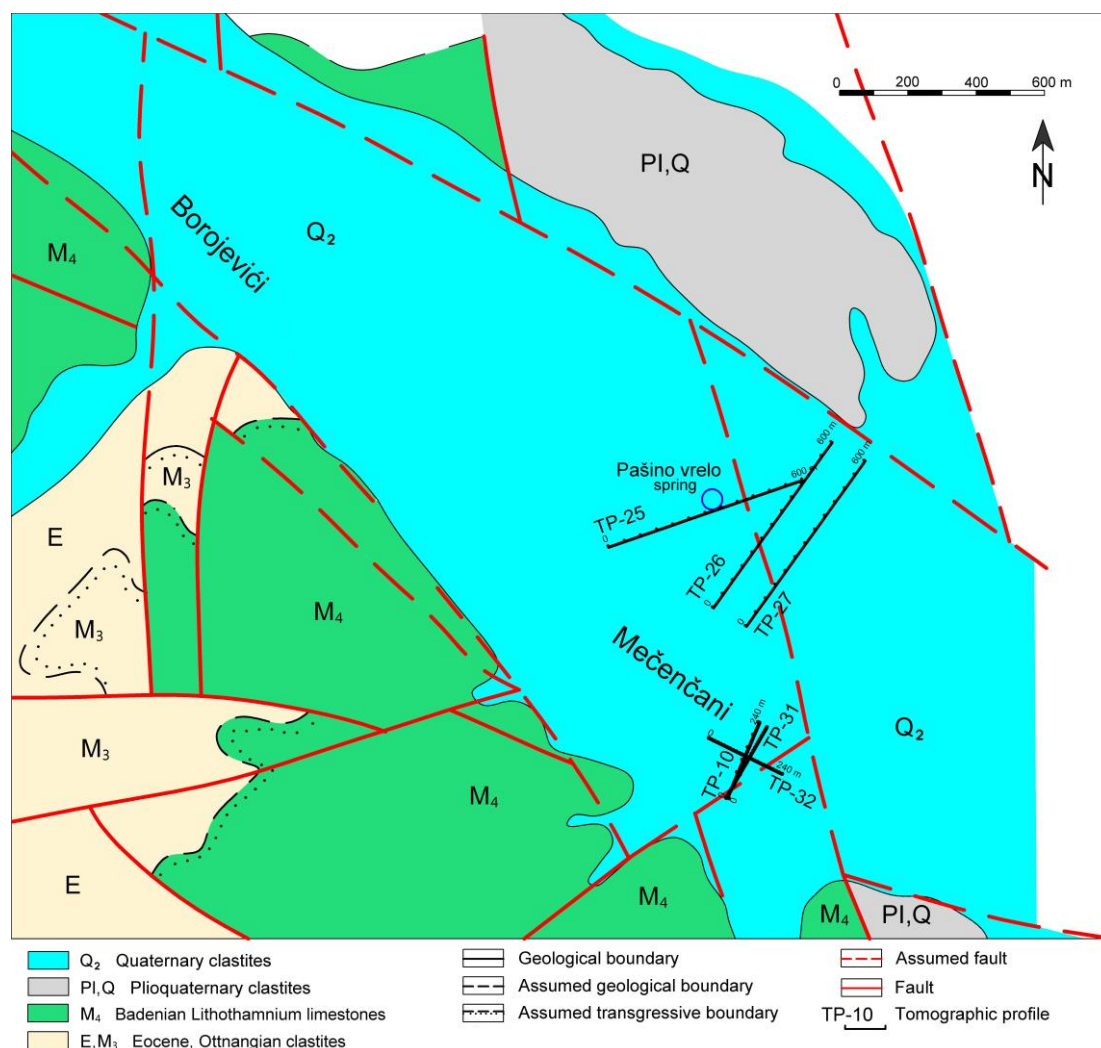
Figure 2. Geological map of the survey area adapted with permission from Ref. [36]. Measured tomographic profiles discussed in the paper are shown as black lines.

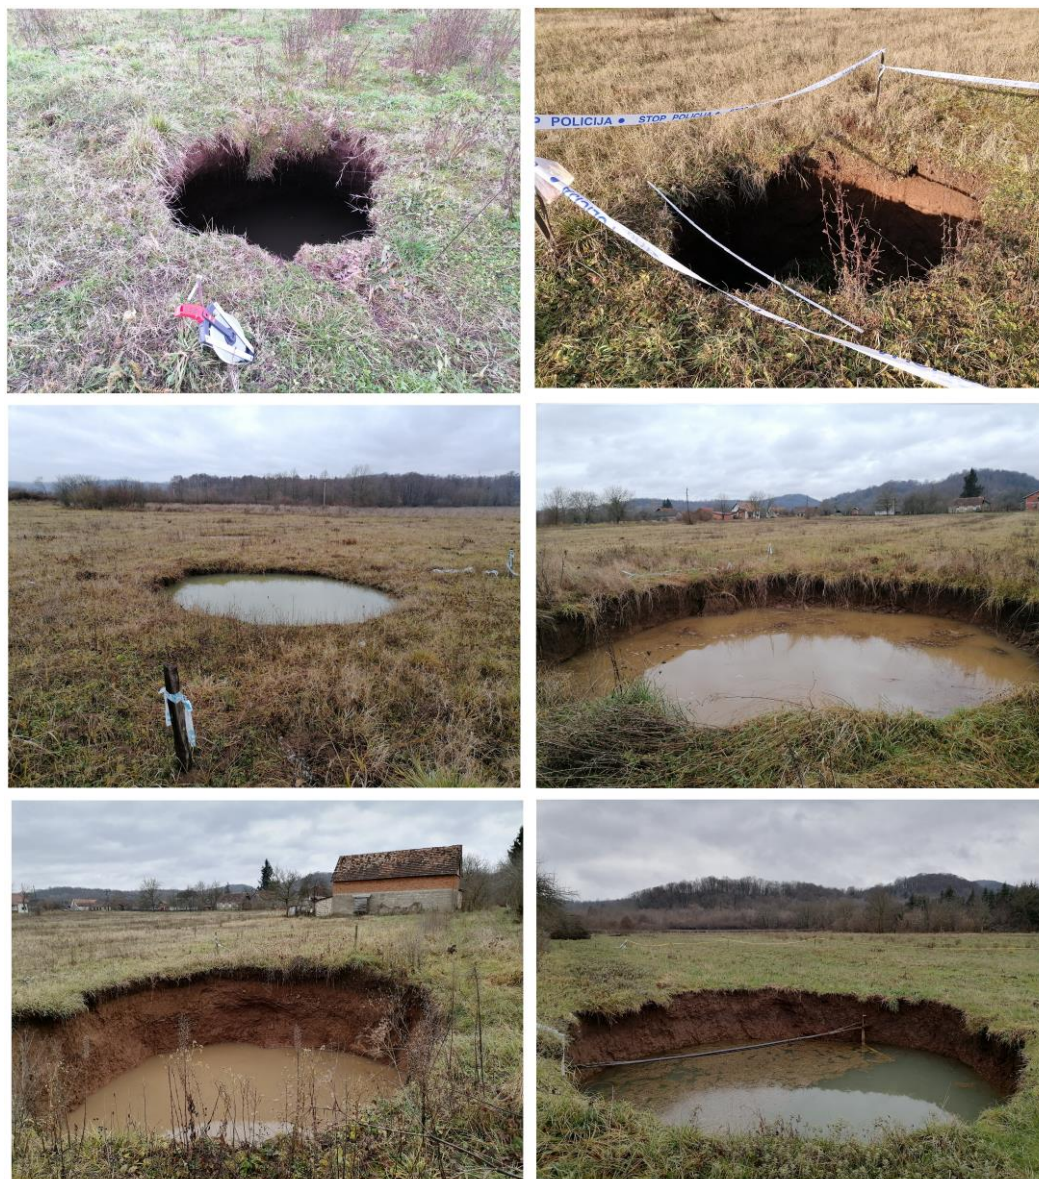
Figure 3. Photographs of several cover-collapse sinkholes that appeared after the Petrinja earthquake. The diameters of the sinkholes range from 1 to 10 m, with the exception of the main one (Figure 4).

by the sudden collapse of the clastic covering above the carbonate basement and are called “cover-collapse sinkholes” (Figures 3 and 4).

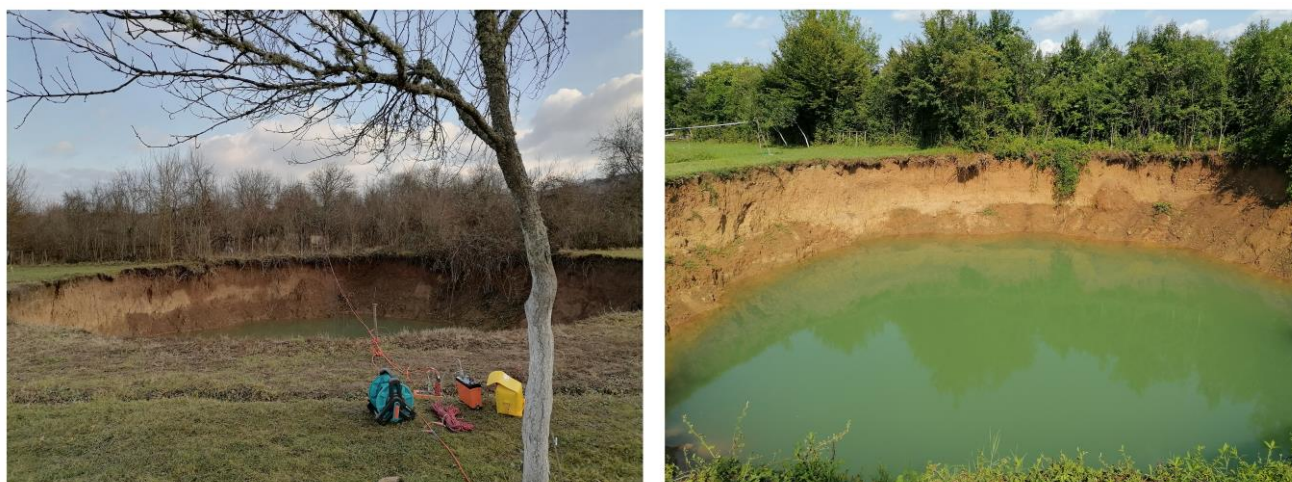
Figure 4. The largest cover-collapse sinkhole differs in dimensions from all others and has a diameter of about 25 m. It served as a polygon for tomographic measurements to determine the mechanism of cover-collapse sinkholes. Groundwater level is 4.5 m below the surface.

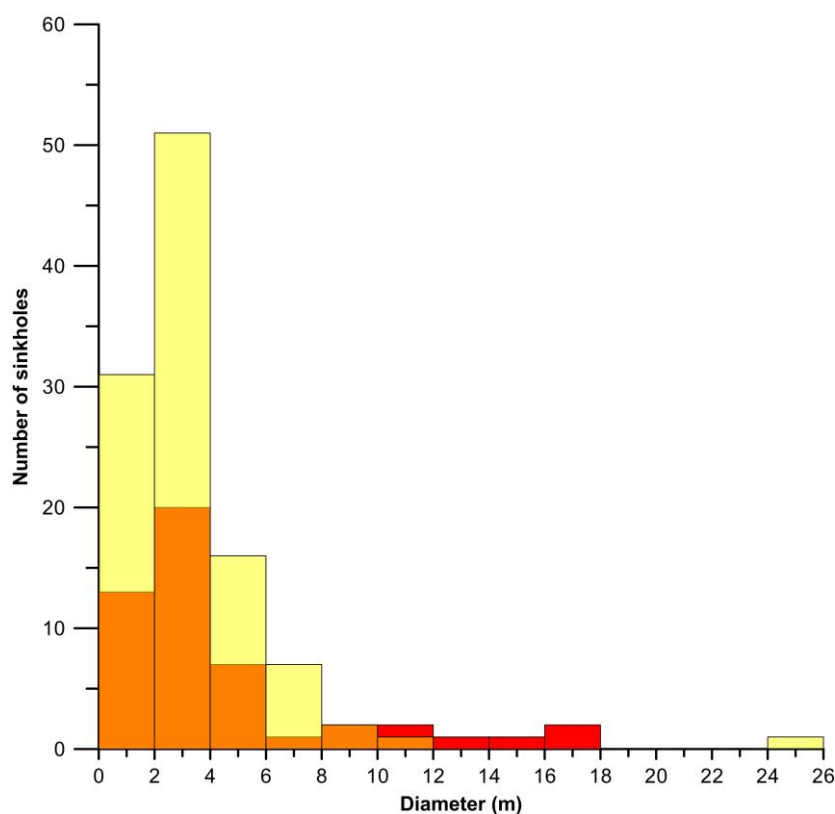
Figure 5. Statistical analysis of the development of cover-collapse sinkholes in the survey area. Fossil sinkholes are shown in red, and new sinkholes in yellow.

Underground water plays a major role in the development of underground cavities. The water level can range from the surface to 5 m, depending on the season and rainfall, and in some parts of the investigated area there may be artesian water. The cover-collapse sinkholes appeared even before the earthquake, although in much smaller numbers, but they were not systematically explored and mapped. Due to the threat caused by their rapid spreading after the earthquake, there has been increasing interest in the mentioned phenomenon and hence greater systematic research into the topic. The dimensions of the cover-collapse sinkholes vary in size from less than one to tens of meters (Figure 5). The largest number of new sinkholes has dimensions up to 4 m (78%), and only four are greater than 8 m. However, one of them stands out in terms of size, with dimensions exceeding 25 m (Figure 4), and serves as a polygon for more detailed geophysical measurements in order to identify the underlying mechanism of the phenomenon. The largest number of fossil sinkholes are up to 4 m in size, [5] but a great number of sinkholes with dimensions greater than 8 m can be observed (Figure 5). However, it should be noted that fossil sinkholes are regularly buried, so their dimensions are mostly determined based on the testimony of local residents. That is why the precision of determining their dimensions is significantly lower than new sinkholes.

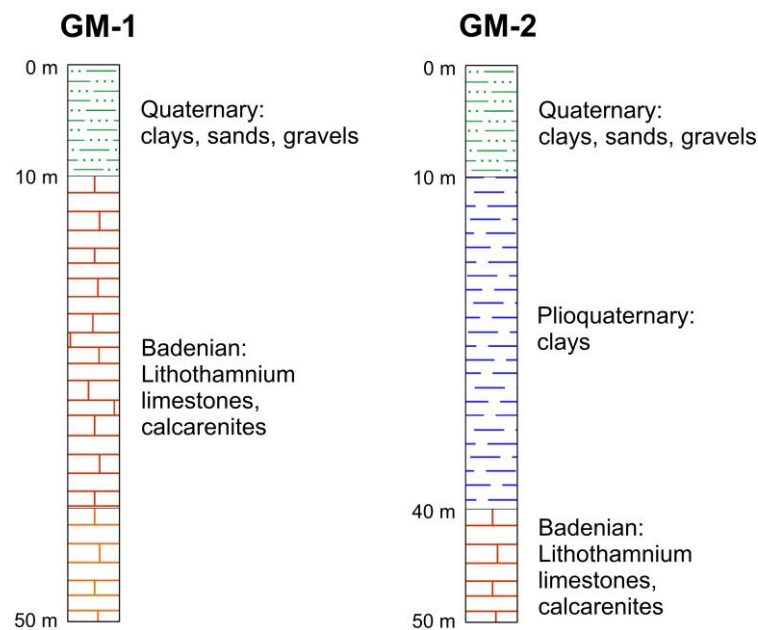
Figure 6. Geological models in the survey area. In the GM-1 model, underground cavities and cover-collapse sinkholes are formed, while in the GM-2 model, they do not appear.

We differentiated two eventual causes of the karst hazards located in the area under investigation, which are interpreted on the basis of previous geological and other data [36,37]. These two geological cases can generally be called basic geological models in the investigated area, which is addressed in the following text. Both models show a surface with Quaternary clastic deposits (Alluvium, Diluvium and Proluvium): gravels, sands and clays as well as their transitional forms (Figure 6). The first geological model (GM-1) shows the presence of weathered and fractured Lithothamnium limestone and calcarenites (Badenian, M₄), in the basement in which the action of water forms underground cavities. The action of water again means that clastites from the surface layer fill the cavity; however, an underground cavity appears in the clastites. In time it spreads, along with the thinning of the surface clastic layer, and at a certain moment, due to reduced load-bearing capabilities, it suddenly collapses (Figure 7). This is then followed by the formation of circular and elliptical sinkholes with steep walls (Figures 3 and 4). This explanation of the origins of cover-collapse sinkholes is most encountered in the geological literature [41], but the issue surrounding the effects of water and earthquakes in this case implies the need to consider a more precise model of their origin based on gathered geophysical data from the investigated region.

In the second geological model (GM-2), Quaternary deposits again are found on the surface, but the base has deposits with very small resistivity, stemming from the Plio-Quaternary clay [37]; see Figure 6. Badenian carbonate rocks can again appear under them at shallower or deeper depths, but Plio-Quaternary clays act as a buffer zone and prevent the creation of cover-collapse sinkholes. Specifically, underground cavities do not develop in such deposits as in carbonates, whereas the area where the lithological column forms is considered safe against the onset of cover-collapse sinkholes.

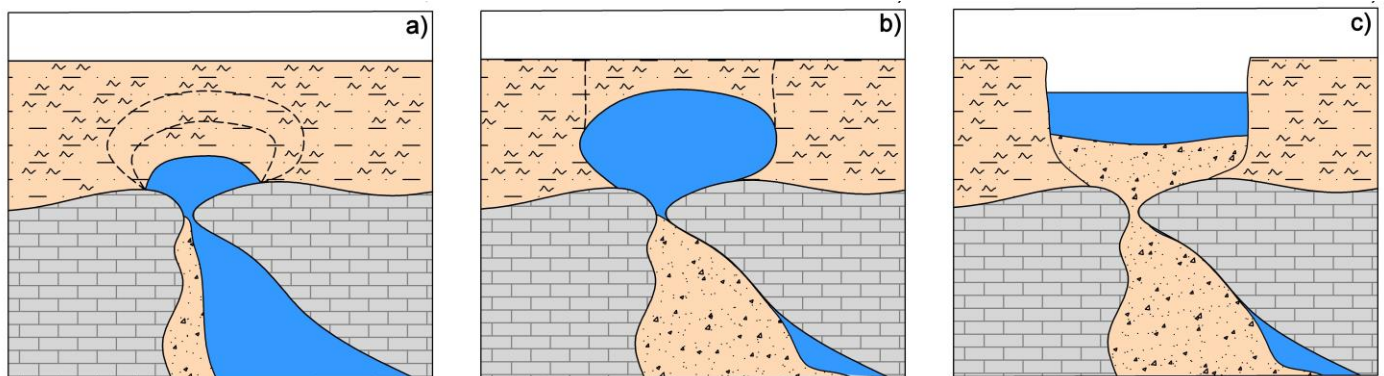
Figure 7. Sketch of the formation of a cover-collapse sinkhole. Carbonates in the basement are karstified with underground cavities, and due to the action of underground water, a cavity develops in the clastic cover (a), which increases and approaches the surface (b), and the thinned surface layer suddenly collapses (c).

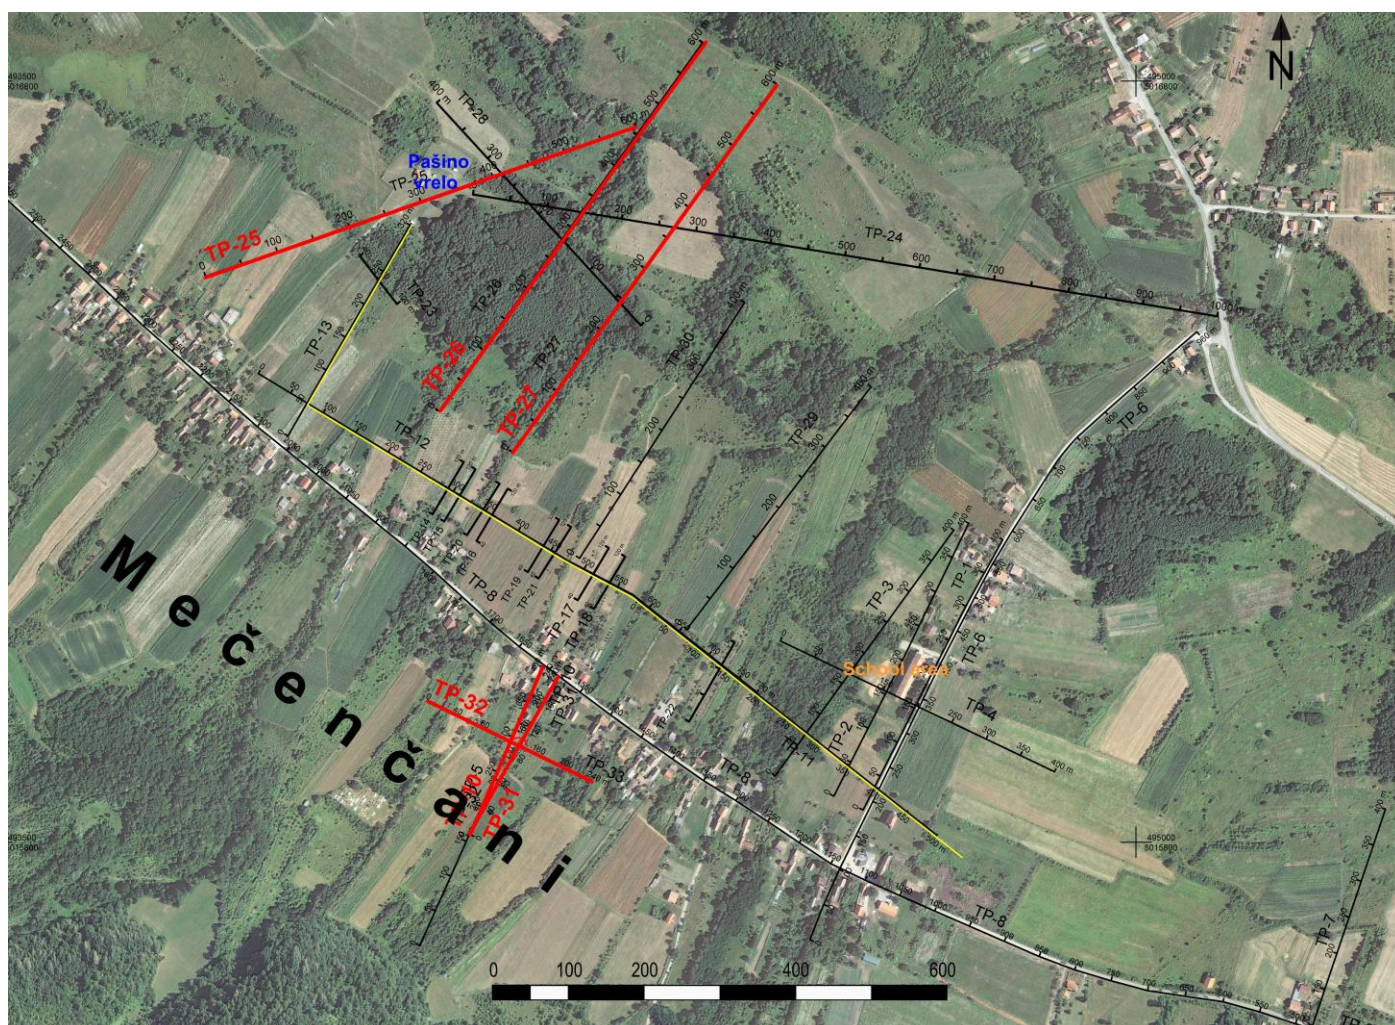
Figure 8. Extensive measurements using electrical tomography were performed in the area of the rural settlement of Mečenčani and in a section of the rural settlement of Borojevići. The research was conducted in four phases. All measured tomographic profiles are shown in black, and the profiles shown and discussed in the paper are marked in red; the red profile titles are at the beginning of the profile. Water supply pipeline is shown in yellow.

Comprehensive tomographic measuring of the area under investigation was conducted in four phases (Figure 8). The first phase of measurements was performed in the area of the school building and along the road in order to determine the potential threat to infrastructural facilities, in other words, to determine which geological model (GM-1 or GM-2; Figure 6) is present in that area. The school area was also defined as a potential location for accommodating housing containers for the population in the event of new earthquakes and expectations of new cover-collapse sinkholes. The measurements were

conducted using a Wenner electrode array with a unit electrode spacing of 5 m, which enabled a depth coverage up to 50 m for the reliable determination of geological cases.

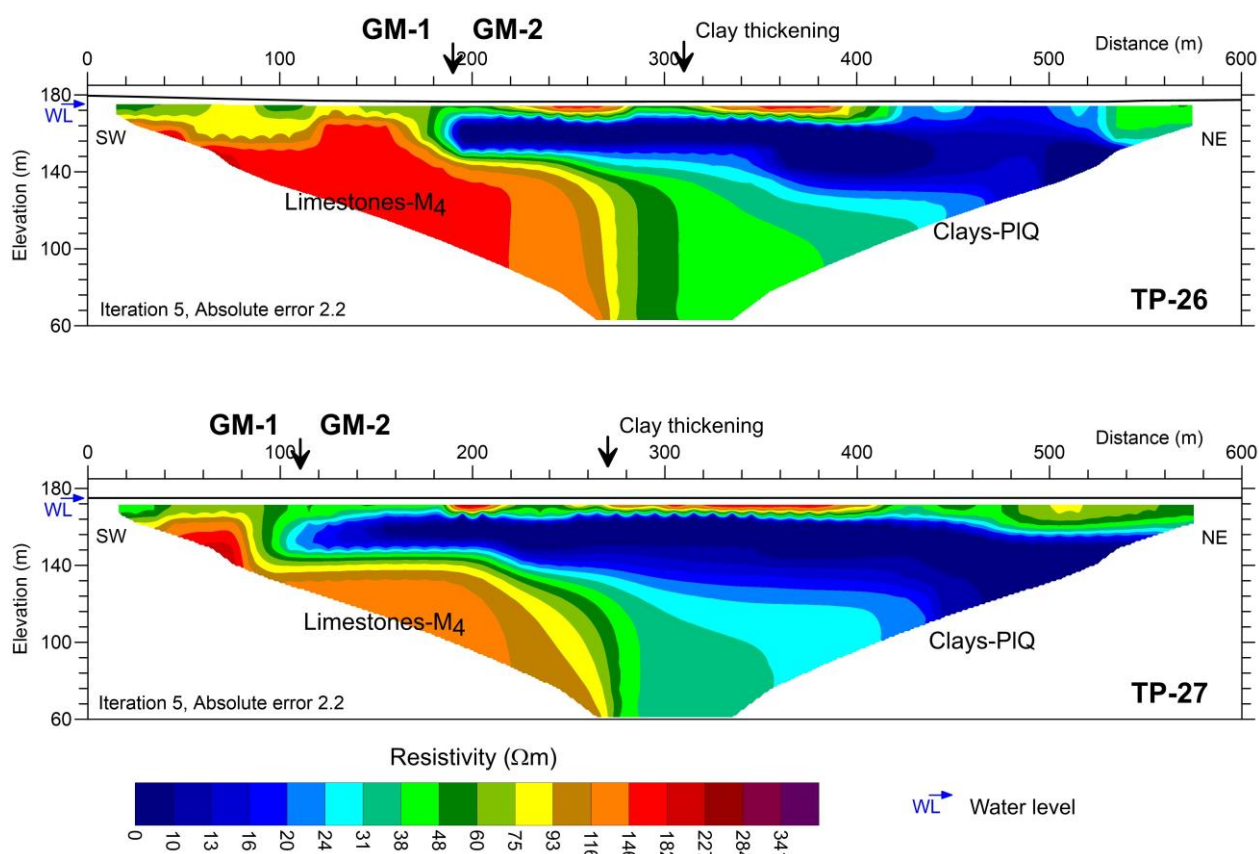
Figure 9. Inverse resistivity models of tomographic profiles set up to precisely determine the boundary of two geological models: GM-1 and GM-2. The basis of the clastic strata or cover in the GM-1 model are limestones and calcarenites, while in the GM-2 model it is clay deposits. The GM-2 does not have cover-collapse sinkholes.

The formation of underground cavities should be viewed as a continual process; hence, the area of the GM-1 model can be considered a region facing continual risk. The first goal of the investigation is to determine the boundary of the GM-1 models, along with the carbonate strata, and GM-2 with the clay strata, in which the formation of underground cavities and subsequently cover-collapse sinkholes is not expected. Electrical tomography effectively differentiates these models based on the characteristic distribution of resistivity, which can be demonstrated using two separate cross-sections in the area under investigation, i.e., TP-26 and TP-27 (Figure 9).

The first half of profile TP-26 shows predominantly higher resistivities caused by gravel-clay deposits on the surface and Lithothamnium limestones in the base strata. Up to 190 m along the surface, there are gravel-clay deposits varying in thickness from a few meters to ten or so meters. In the second half of the cross-section, lower resistivities are typical and are caused by clay deposits, except at positions located at approx. 250 m and 350 m, where thin surface zones exhibited higher resistivities, probably due to gravel deposits. The boundary between the GM-1 and GM-2 models is defined at the 190-metre position, where the thickness of the contacting clay is approx. 20 m, and under this there is again limestone. The thickness of clay gradually increases towards the end of the profile in the northeast, and at the 310-metre position, the thickness increases considerably. A similar resistivity relationship exists on the neighbouring TP-27 profile, but the boundaries are shifted towards the start of the profile. The boundary of the GM-1 and GM-2 models is located at 110 m, and a greater thickness of the clay is seen at 270 m. Young clay deposits on an uneven carbonate strata are noticeable on both profiles along with sudden changes in depth. The resistivity in the carbonate strata is proportionally less and generally does not exceed 200 Ωm , which indicates the level of fragmentation and weathering, given that such resistivity is typical for saturated gravel deposits, whereas carbonate rocks can have a very high resistivity (a few thousand Ωm) if not very fractured.

The boundary indicating the presence of underground cavities correlates well with the boundary of the GM-1 and GM-2 models, which was precisely determined using tomographic investigations (Figures 9 and 10), i.e., the largest concentration of cover-collapse sinkholes is found along the boundary of the two models (Figure 14). Therefore, the boundary of the geological models across the wider region, where tomographic measurements were not performed, can be determined by following the boundary indicating the presence of cover-collapse sinkholes.

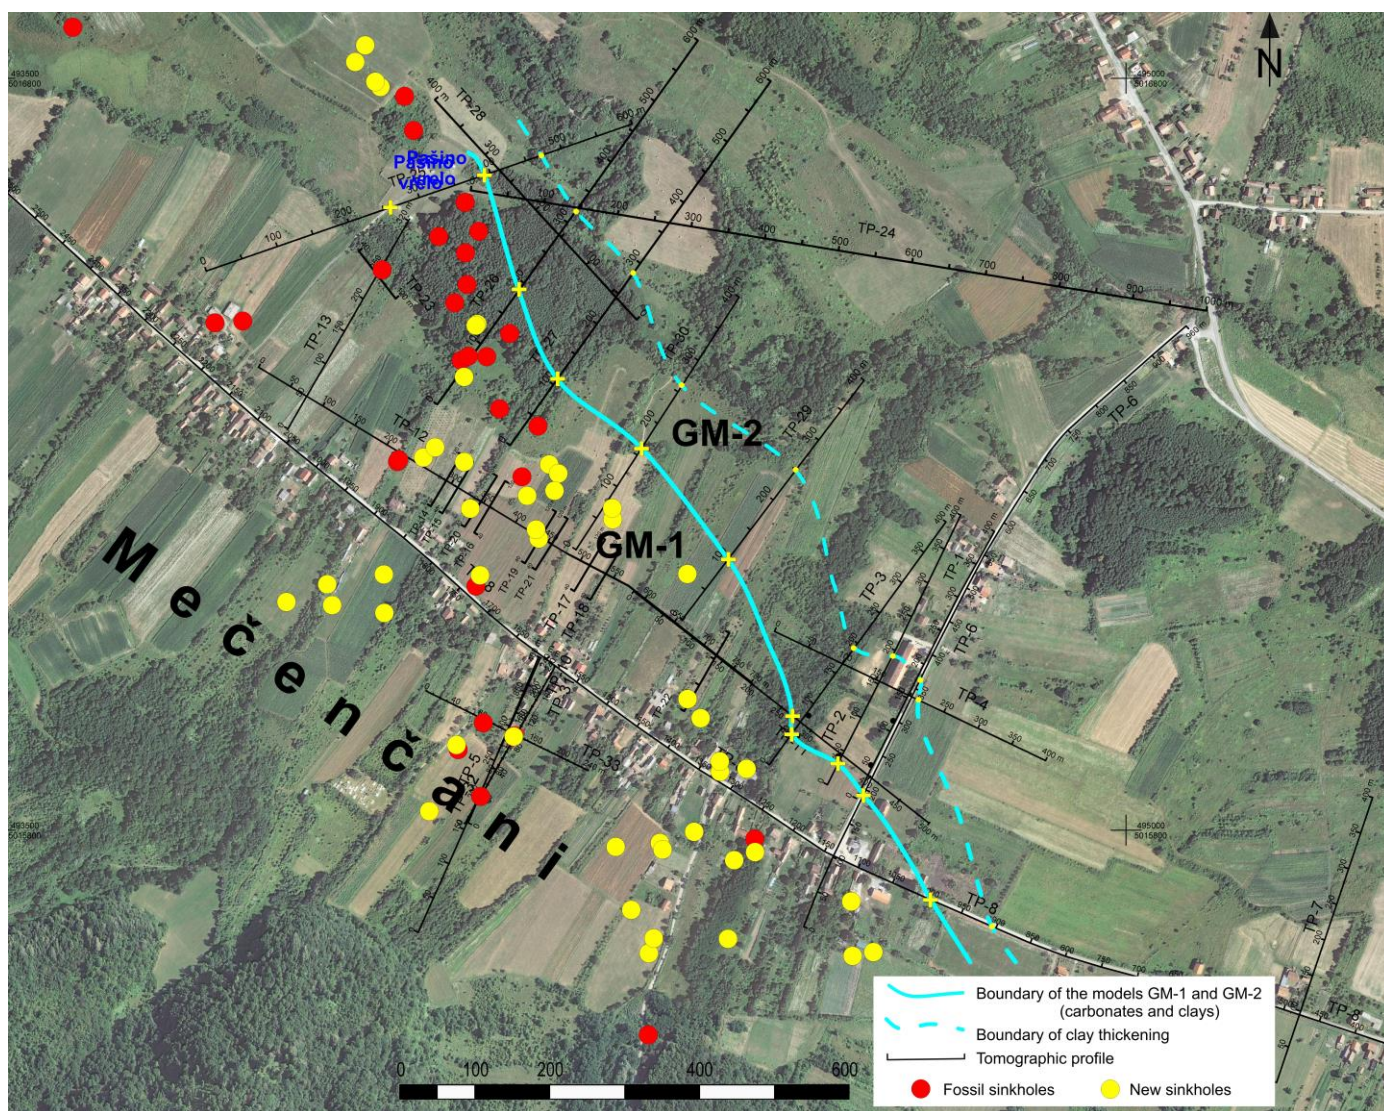
Figure 10. The boundary of the two geological models GM-1 and GM-2 and the boundary of greater thickening of clay deposits in the GM-2 model were determined on tomographic profiles and interpolated in the area of Mečenčani. The boundaries generally extend in the NW-SE direction.

The boundaries of the tomographic profiles have been marked on position maps, and the two boundaries have been drawn, i.e., the boundary of the GM-1 and GM-2 geological models as well as the boundary demarcating the greater thickness of the clay Plio-Quaternary (PIQ) packet in the GM-2 model (Figure 10). The boundaries extend in a north-west-southeast direction, with the boundary demarcating the presence of cover-collapse sinkholes generally following the boundary of the GM-1 and GM-2 models, indicating the

significant role of water, especially its mechanical effect on forming underground cavities in the clastic strata as the basis for the formation of cover-collapse sinkholes.

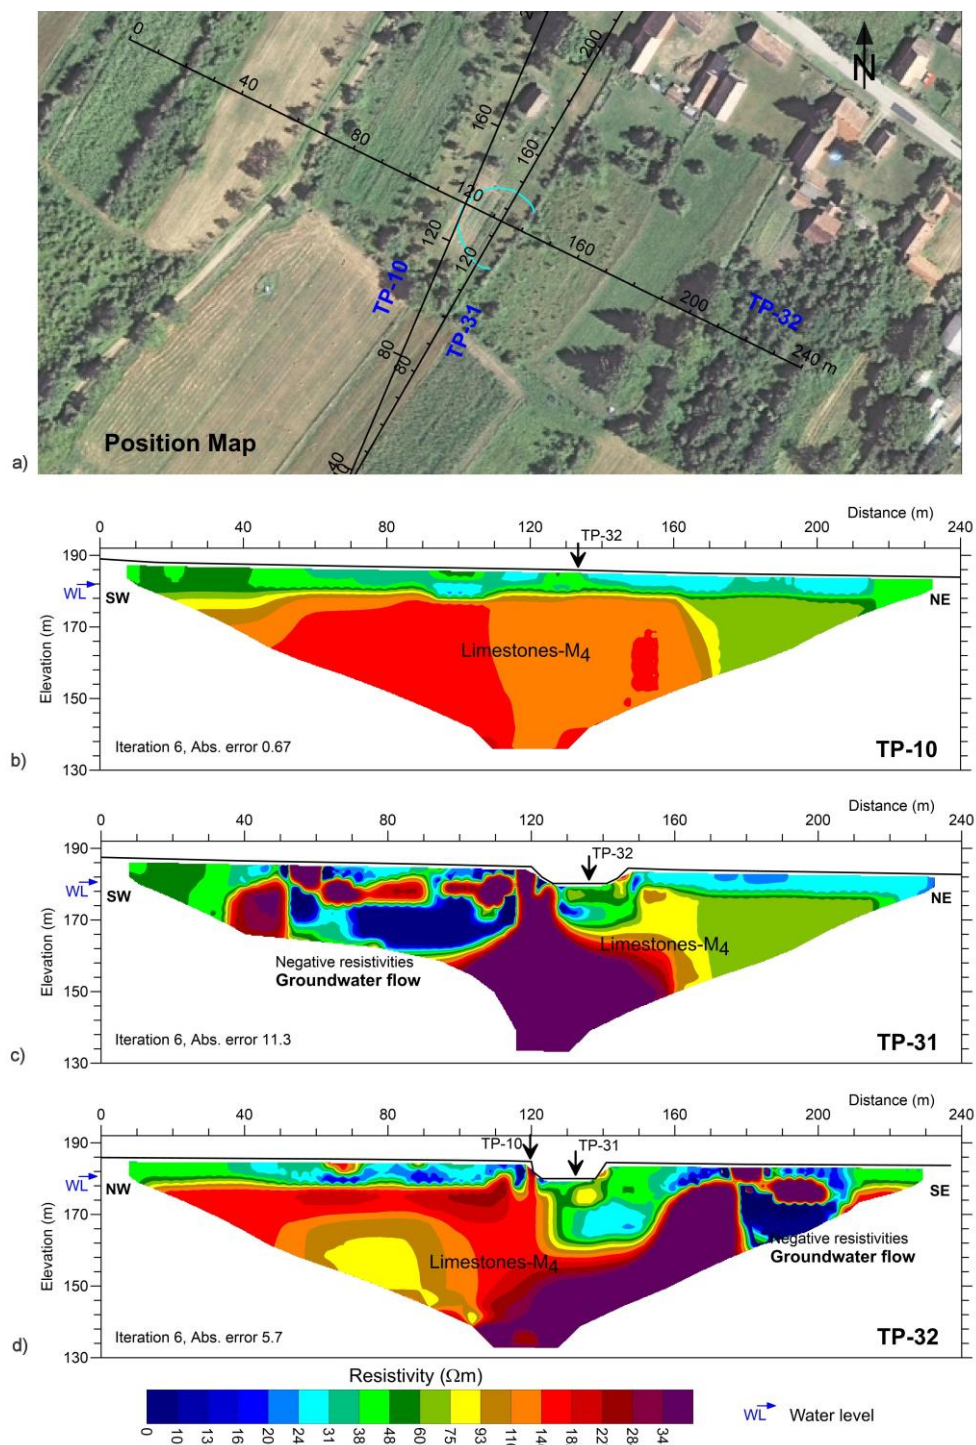
Figure 11. Tomographic measurements carried out over the largest sinkhole enabled a more detailed definition of the mechanism of cover-collapse sinkholes. The position map is shown in the upper part (a) of the image, and located below are the inverse resistivity models of the tomographic profiles (b,c,d). A dramatic change in the resistivity models is observed between the TP-10 and TP-31 profiles laid in a similar direction at a very short distance. A complex lithological structure is also seen below the cover-collapse sinkhole.

Detailed tomographic measurements over the largest cover-collapse sinkhole facilitated reliable devising of the entire model for the formation of cover-collapse sinkholes (Figure 11); three tomographic profiles with a length of 240 m are shown. At profile TP-10, extending from the edge of the cover-collapse sinkhole, carbonate strata exhibiting higher resistivity is located at a depth of 6–10 m, and above are clastic, clay-gravel deposits providing lower resistivity (max. 60 Ω m). The boundary is generally levelled, but the resistivities in the Lithothamnium limestones are uniform; hence, zones with greater fragmentation are not expected. However, the resistivity model changes dramatically on the TP-31 profile, which extends through the middle of the sinkhole (Figure 11). Resistivity distribution is much more complex and indicates very complex lithological relationships. Noticeable under the cover-collapse sinkhole is a lower-resistivity zone in the shape of an undulating depression in the carbonate strata. Higher resistivities were identified at the southern edge of the sinkhole, indicating a less fractured block, while at the northern edge, lower resistivities indicated larger fractured carbonate blocks. Located on the transversal TP-32 profile is a more compact block to the west, whereas an anomaly of lower

resistivities is fully directed towards the east (Figure 11). Accordingly, located on the southwest is a significantly compact carbonate block, while significantly fractured and weathered carbonate rocks are found on the northeast edge. The depth of the anomaly indicating low resistivities is estimated to be at 15 or so meters on the TP-31 profile, and 20 or so m on the TP-32 profile, indicating an exceptional anisotropic environment.

Located on both profiles immediately under the sinkholes is a zone with somewhat higher resistivities (40–100 Ωm), followed by a zone of lower resistivities (10–40 Ωm). Higher resistivities in the first zone are probably caused by the remaining smaller carbonate blocks and gravel deposits that have filled underground cavities in carbonates, whereas lower resistivities in the second zone indicate larger underground cavities containing water and clay. The resistivity of clay is approx. 20 Ωm , and water is approx. 40 Ωm , making it difficult to differentiate the content of underground cavities in tomographic resistivity models.

Located at positions 51–117 m on the TP-31 profile is an extensive anomaly of very low resistivity that extends to a depth of 25 m, and within it, close to the surface, there are smaller high-resistivity blocks, which probably stem from tightly compacted carbonate blocks (Figure 11). The resistivities are a maximum of about 20 Ωm , i.e., at the clay level. However, we can see that the vertical projection of that profile section is essentially reduced, given that the measurements contain negative resistivity values, which were rejected in the inversion process. This kind of phenomenon causes a sudden flow of water in the underground and, subsequently, large natural potentials; this, in turn, causes large amounts of noise during measurements and is attributed to water escaping from tectonic, fractured zones. Rejecting the negative resistivity values reduced the vertical projection; hence, a less fractured carbonate strata, indicating a fault zone, was not included.

Accordingly, the zone probably contains large underground cavities through which groundwater flows and is probably partially filled with clay deposits. The distribution of resistivity in the respective zone, along with the high-resistivity blocks, indicates a grid-like structure of the underground environment, where carbonate rocks are the basis of the grid-like structure, and where numerous underground cavities are located between them through which groundwater flows. This kind of anomaly and structure is noticeable at the end of the TP-32 profile in the positions at 180–213 m and may be linked to the anomaly on the TP-31 profile. This all indicates the significant role of water, especially its mechanical effects at high levels in the formation of underground cavities and, subsequently, cover-collapse sinkholes.

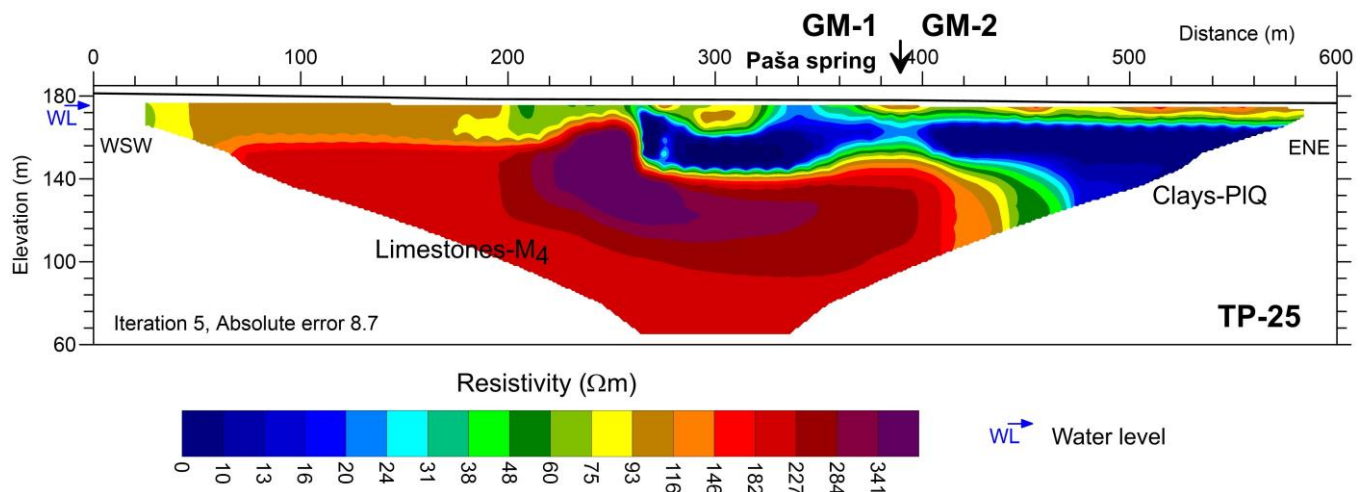
Figure 12. The inverse resistivity model of a tomographic profile placed over Pašino vrelo (Pasha Spring). The boundary of the geological models is at 390 m, and the area below the captured spring (260–390 m) correlates exceptionally well with the low resistivity anomaly of the TP-31 profile (51–117 m, Figure 11).

The argument concerning the strong mechanical effects of water is further supported in profile TP-25, which was measured over the main water source at Pašino vrelo (Figure 12). There is a large correlation between the low resistivity anomaly under Pašino vrelo and profile TP-31 (51–117 m, length 66 m). Profile TP-25 mostly features high resistivities caused by the limestones. Low resistivities, stemming from the clay in the base, are located after the 390-metre position, where model GM-2 begins. The thickness of the clay increases towards the end of the profile. At the positions extending to 260–390 m, a relatively large section of low resistivities (140 m in length) was noticed, extending to a depth of approx. 40 m, whereas resistivities are at the clay level, similar to the anomaly on profile TP-31. However, this section is found in the area of the Pašino vrelo source; hence, it is improbable to conceive that these low resistivities are due to clay. Again, the likelihood is that the zone has underground cavities, partially filled with water and partially with clay. Moreover, wells are used in the zone to pump up water, which causes significant electrical noise and causes distortion of the measured resistivities. This is supported by the large absolute error (8.1%) in the inverse resistivity model with respect to other surrounding profiles.

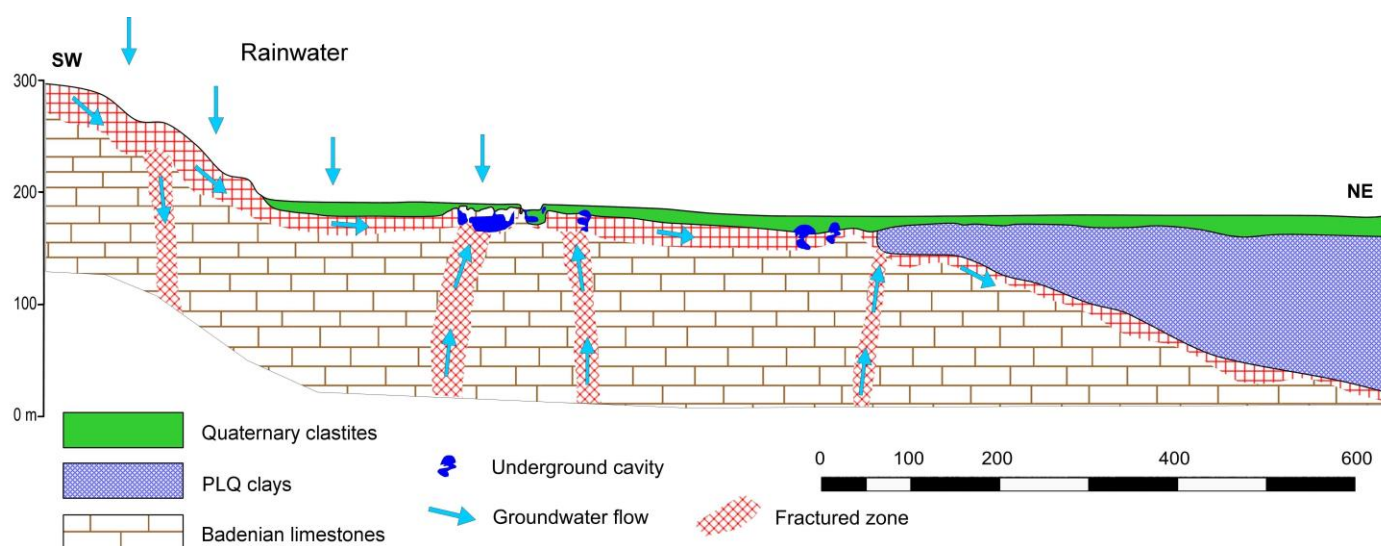
Figure 13. General sketch of the hydrogeological model in the investigated area. The surface zone of the carbonate aquifer has mostly sub-horizontal groundwater flows, whereas subvertical flows are dominant in the fault zones. Underground cavities in the clastites occurred due to the action of underground water, mostly mechanical, which increases the size of the cavities. The earthquake caused the breaking of numerous fragile grid-like structures in the top part of the aquifer and breakage of the thinned clastic covering, which led to an explosion in the number of cover-collapse sinkholes.

A general drawing of the entire hydrogeological model of the underground is shown in Figure 13. Stormwater feeds the peripheral parts of the aquifer, including the Lithothamnium limestones located on the surface of surrounding hills. The water enters the aquifer and flows through its more permeable sections, surface weathered zone, upper zone, as well as faults and fractured zones, that is, through underground cracks and

cavities [47]. These zones contain systems of underground cavities typical for carbonate rocks. The expectation is that the surface zone of the aquifer has mostly sub-horizontal groundwater flows, whereas subvertical flows are dominant in the fault zones. Water continually washes the clay out from the clastic deposits of the covering, whereas sand and gravel components undergo sedimentation in the underground cavities in limestones, creating and forming shallow underground cavities in the clastic covering. During intense rainfall and high groundwater levels, in addition to a sudden increase in water yield, severe water turbidity was observed at springs and wells. This washes the clay component out of the system, which means that the cavities in the deposits increase. Intense pressure from underground waters at high water levels, which are artesian in nature, especially along the permeable fault zones containing subvertical flows, also cause strong mechanical action from groundwater and increase the size of underground cavities in the clastic covering. As the cavities approach the surface, there is a sudden collapse followed by the formation of circular and elliptical sinkholes with steep walls.

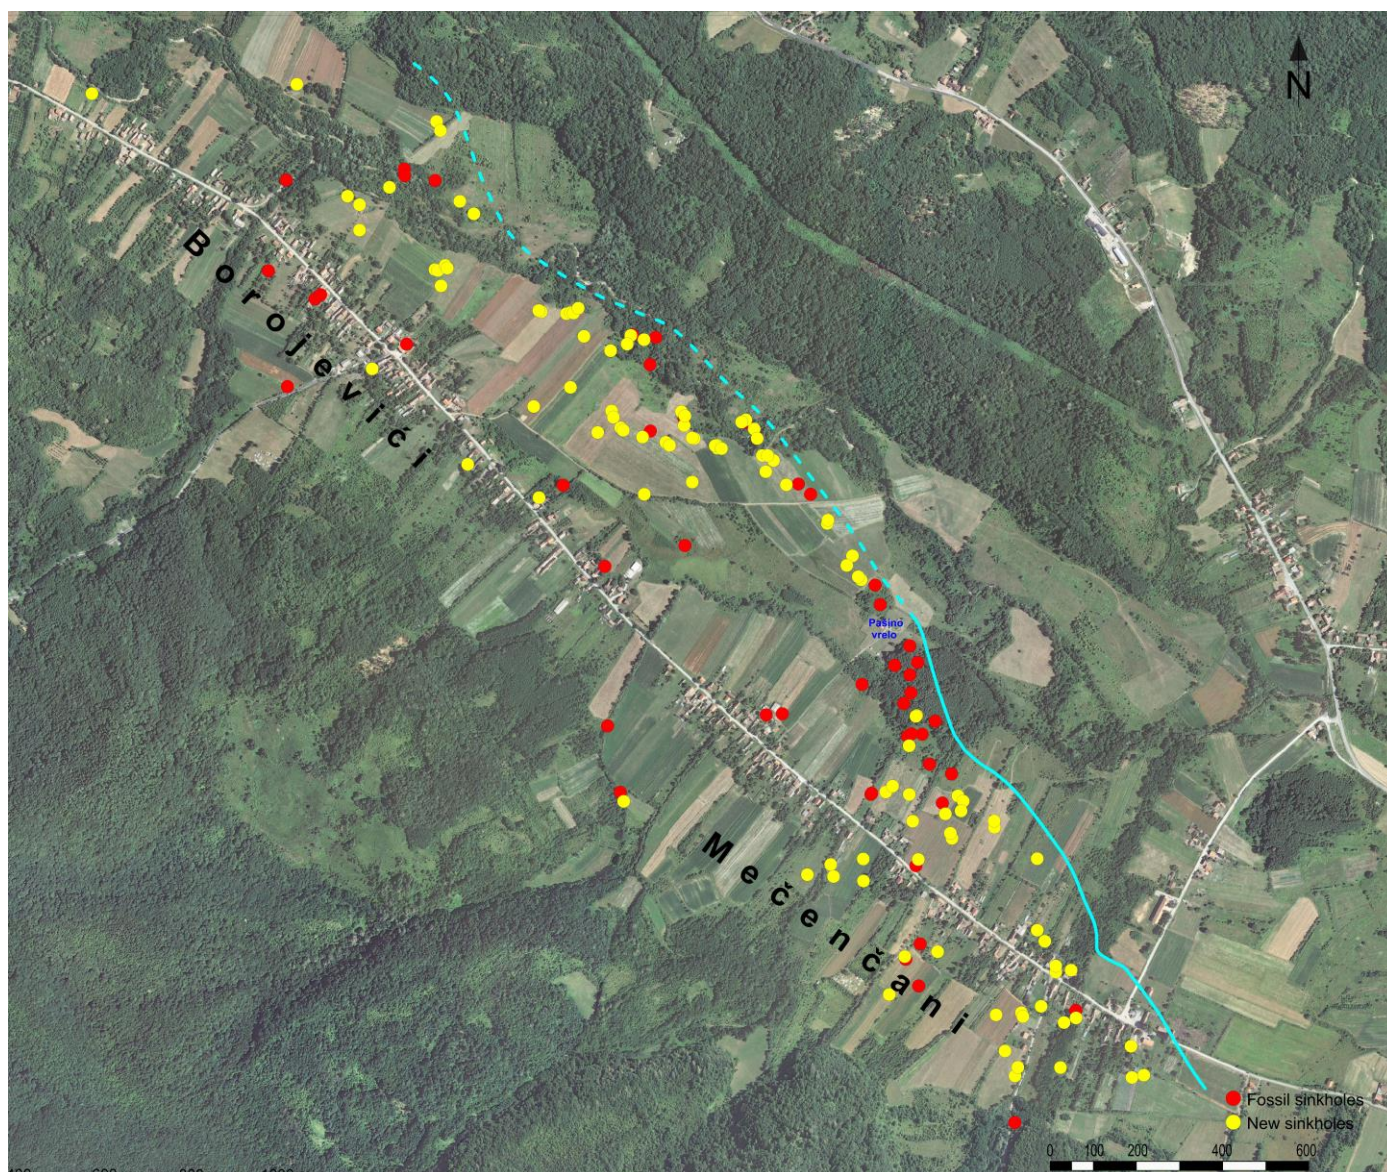
Figure 14. The limited occurrence of cover-collapse sinkholes in the area of Mečenčani correlates exceptionally well with the boundary of geological models identified on the tomographic profiles (solid line). Therefore, across the remaining terrain, in the area of Borojeviči, based on the occurrence of cover-collapse sinkholes, the boundary of geological models (dashed line) can be defined as can the safe area where cover-collapse sinkholes do not occur. New sinkholes (yellow circles) appeared after the Petrinja earthquake, and fossil ones (red circles) prior to the earthquake.

Cover-collapse sinkholes generally appear across a wide area of the rural settlements of Mečenčani and Borojevići, but their concentration is found along contact zones between models GM-1 and GM-2 (Figure 14). In other words, the pressure of the water is greatest at the barrier of clay deposits, which is found in the GM-2 model, representing the strongest mechanical effects of underground water and subsequently the most frequent formation of underground cavities in the clastic covering. Therefore, the boundaries of where the cover-collapse sinkholes appear across the wider area provide evidence of a boundary between the two geological models. It can be clearly seen in Figure 14 that all cover-collapse sinkholes in the area of Mečenčani appear in the GM-1 model under the boundary of the geological models, as determined on the basis of tomographic measurements. In other words, the boundary of the presence of cover-collapse sinkholes follows the boundary of the geological models. Hence, the remaining area of Mečenčani and Borojevići; i.e., to the northwest of Pašino vrelo, the boundary of the two models can be determined by following the boundary demarcating the presence of cover-collapse sinkholes.
